DEPARTMENT OF TRANSPORTATION

Contract #: 04-0120F4Cty: SF/ALA Rte: 80 PM: 13.2/13.9File #: 69.25B**QUALITY ASSURANCE -- NON-CONFORMANCE REPORT****Location:** Changxing Island, Shanghai, P. R. China**Report No:** NCR-000483**Prime Contractor:** American Bridge/Fluor Enterprises, a JV**Date:** 17-Oct-2009**Submitting Contractor:** Zhenhua Port Machinery Company, Ltd (ZPMC), Changxing Island**NCR #:** ZPMC-0456**Type of problem:**

Reference Description: Missed MT Indication by QC on excavated welds prior to welding repair on 1AW/1AAW Side Panel Transverse Splice

Job Name: SAS Superstructure
Document No: 05.03.06-000446

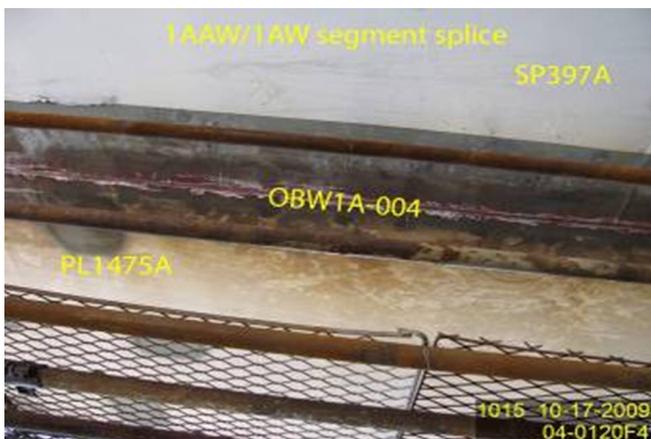
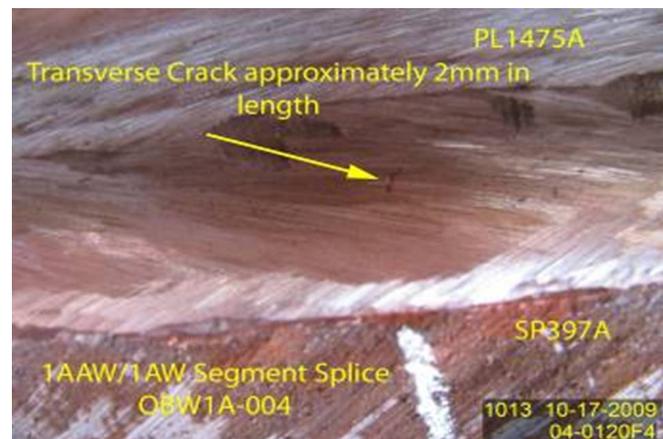
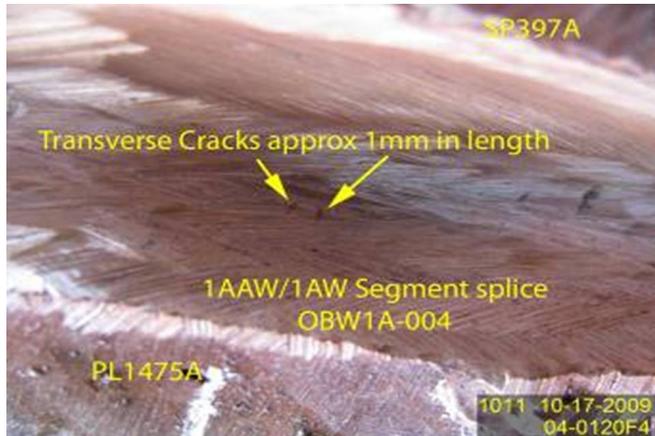
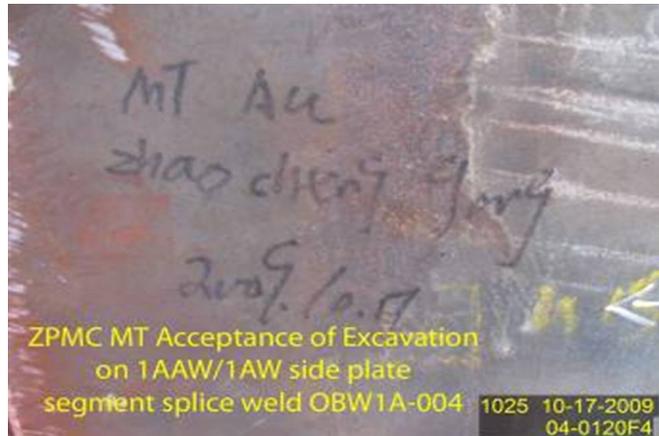
During random visual inspection the QA Inspector performed Magnetic Particle Testing (MT) of an Ultrasonic Testing (UT) reject excavation in the segment CJP Side Plate splice (OBW1A-004), cross beam side joining SP397A (1AW) and PL1475A (1AAW). During this verification the QA Inspector discovered three (3) Transverse Cracks in the excavation. One (1) 2 mm crack was located at Y location 1945mm and two (2) 1mm cracks at Y location 2785mm from the cross beam side Edge Plate.

AWS D1.5-2002 Section 3,7,2,4 Crack in Weld or Base Metal; The extent of the crack shall be ascertained by the use of MT, PT, or other equally positive means; the metal shall be removed for the full length of the crack plus 50mm [2"] beyond the end of each crack and re-welded.

AWS D1.5-2002 Section 6.26.2; "Welds that are subject to RT or MT in addition to visual inspection shall have no cracks and shall be unacceptable if the RT or MT shows any of the types of discontinuities described in 6.26.2.1, 6.26.2.2, 6.26.2.3, or 6.26.2.4".

Submit a repair procedure to the engineer for approval.

Reference Resolution: ZPMC has repaired the indications documented in the NCR. ABFJV and Caltrans has conducted the NDT and found that the welds are acceptable which is included in the attached documents.
