Contract #: 04-0120F4
 Cty: SF/ALA Rte: 80 PM: 13.2/13.9
 File #: 69.25B

QUALITY ASSURANCE -- NON-CONFORMANCE REPORT

Location: Changxing Island, Shanghai, PRC **Report No:** NCR-000485
Prime Contractor: American Bridge/Fluor Enterprises, a JV **Date:** 26-Nov-2009
Submitting Contractor: Zhenhua Port Machinery Company, Ltd (ZPMC), Changxing Island **NCR #:** ZPMC-0458

Reference Description: East Shaft, Lift 4, CD corner seam weld repair without Engineer approval

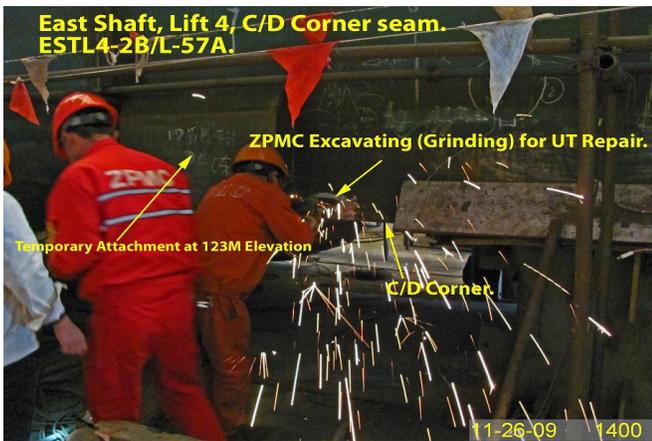
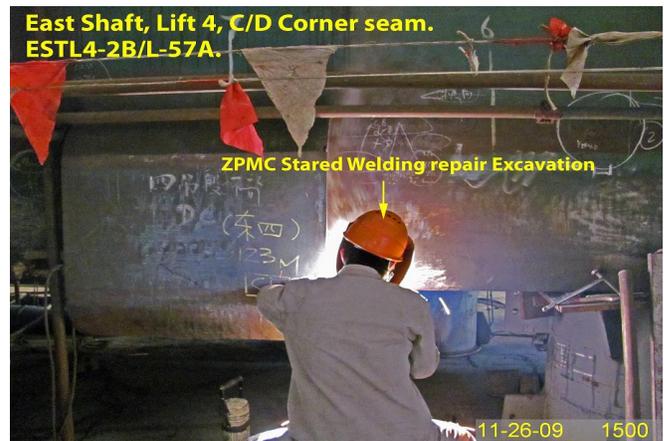
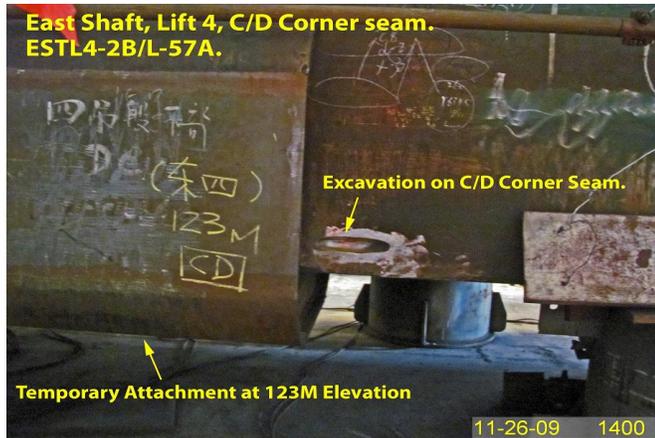
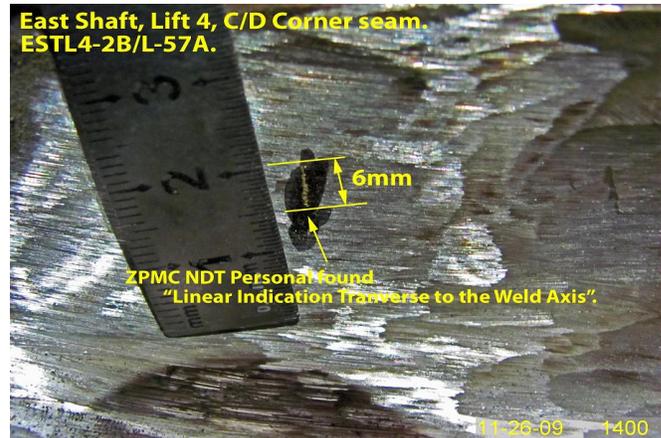
During in-process visual inspection of East Tower, Lift 4, CD corner seam weld repair excavation, QA observed a crack-like linear indication, transverse to the weld axis, approximate 6 mm in length. This excavation was for the repair of a rejectable indication found by ZPMC Ultrasonic Testing (UT) technicians. ZPMC NDT personnel performed Magnetic Particle Testing (MT) on the excavated area, confirmed the crack-like indication, and continued to perform Shielded Metal Arc Welding (SMAW) on the excavated area without prior approval of the Engineer.

Special Provisions, Section 8-3 Welding - "The Engineer shall be notified immediately in writing when welding problems, deficiencies, base metal repairs, or any other type of repairs not submitted in the WQCP are discovered and also of the proposed repair procedures to correct them. For requests to perform repairs, the Contractor shall include an engineering evaluation of the proposed repair. The engineering evaluation, at a minimum, shall include what is causing the defects, why the repairs will not degrade the material properties, and what steps are being taken to prevent similar defects from happening again in the future."

AWS D1.5-2002, Section 3.7.4 - "Prior approval of the Engineer shall be obtained for repairs to base metal, repair of major or delayed cracks, or for a revised design to compensate for deficiencies."

Propose a resolution for the identified non-conformance, documenting that the repaired weld is in compliance with the contract requirements. Documentation provided for the Engineer's review of the acceptability of the weld repair shall at a minimum include the procedure utilized/CWR and the NDT results.

In addition to the material/workmanship non-conformance, address the failure by both Production and Quality Control in proceeding with the repair of the crack without prior approval from the Engineer. Provide documentation of the steps/actions taken by Production and Quality Control to prevent future occurrences.

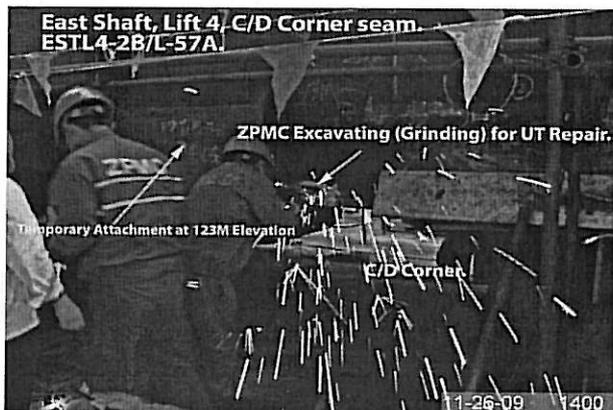
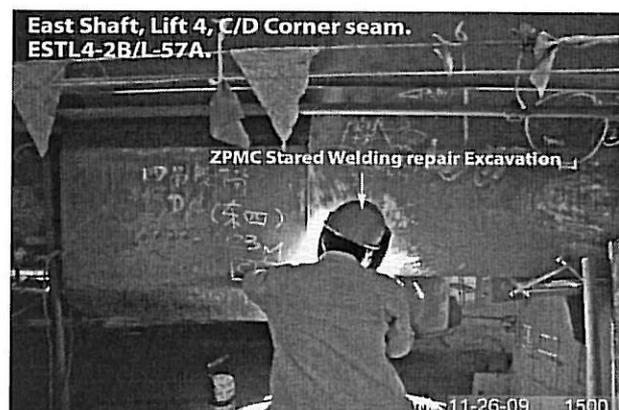
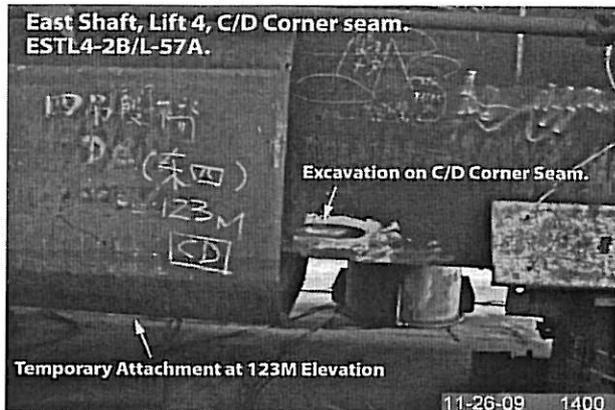
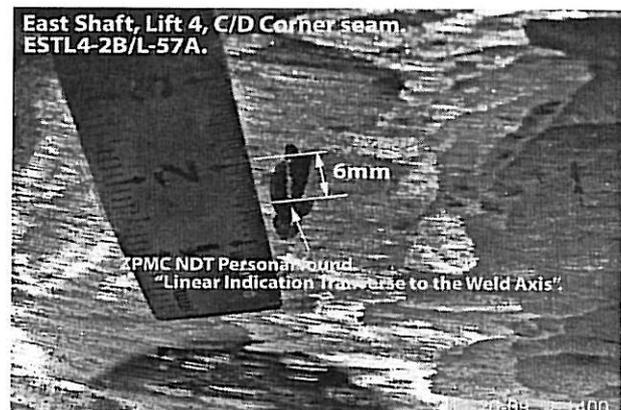
During in-process visual inspection of East Tower, Lift 4, CD corner seam weld repair excavation, QA observed a crack-like linear indication, transverse to the weld axis, approximate 6 mm in length. This excavation was for the repair of a rejectable indication found by ZPMC Ultrasonic Testing (UT) technicians. ZPMC NDT personnel performed Magnetic Particle Testing (MT) on the excavated area, confirmed the crack-like indication, and continued to perform Shielded Metal Arc Welding (SMAW) on the excavated area without prior approval of the Engineer.

Special Provisions, Section 8-3 Welding - "The Engineer shall be notified immediately in writing when welding problems, deficiencies, base metal repairs, or any other type of repairs not submitted in the WQCP are discovered and also of the proposed repair procedures to correct them. For requests to perform repairs, the Contractor shall include an engineering evaluation of the proposed repair. The engineering evaluation, at a minimum, shall include what is causing the defects, why the repairs will not degrade the material properties, and what steps are being taken to prevent similar defects from happening again in the future."

AWS D1.5-2002, Section 3.7.4 - "Prior approval of the Engineer shall be obtained for repairs to base metal, repair of major or delayed cracks, or for a revised design to compensate for deficiencies."

The weld repair was performed and verified by NDT. Documentation for this repair was provided (T-CWR-497 and T-787-UT-2432R4). This issue was discussed with the foreman to prevent reoccurrence.

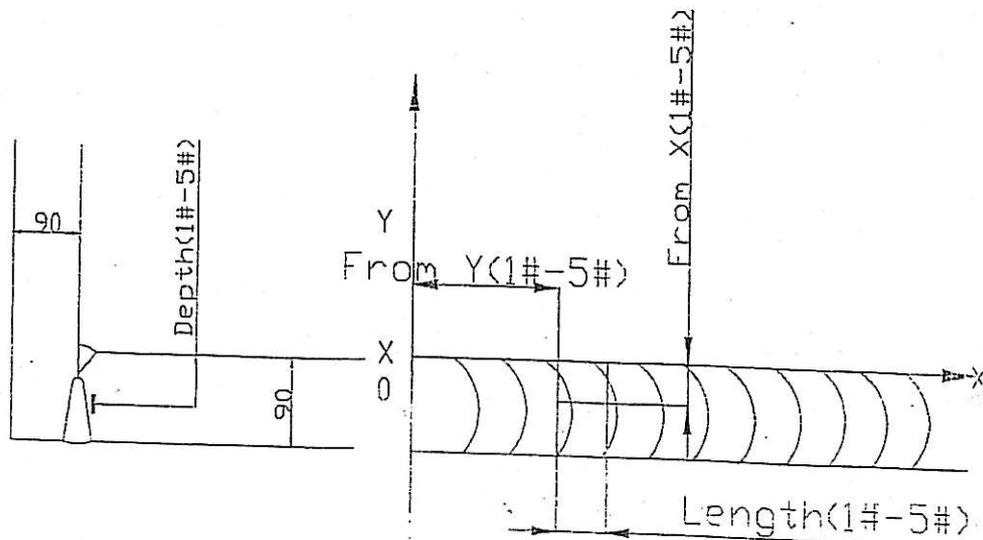
WELD NUMBER: ESTL4-2B/K-57A/B
Please see the detail data from UT report!

Rejected Indication found by ultrasonic inspection at fourth time.

1. The weld defect location may not have been properly identified prior to grinding, i.e, the X and Y location was incorrect or the excavation was not centered on the defect, therefore the excavation did not encompass the whole defect.

1. QC shall monitor and direct the welder and the grinder doing the repair operation.
2. Preheat before gouging; the temperature shall be at least 65°C.
3. Gouge the weld to remove identified defects.
4. Joint details shall refer to the approved WPS repair.
5. Grind the gouged areas to a smooth and shiny surface.
6. Verify with VT and MT to ensure no defects remain in the weld joint prior to welding.
7. QC shall monitor all welding passes being deposited.
8. QC shall ensure all slag has been removed prior the deposition of next pass.
9. Preheat and maintain interpass temperature control in accordance with the WPS.
10. Blend the weld repaired areas into the adjacent weld or base metal by grinding.
11. Perform VT, MT and UT NDT inspection to the repaired areas.

- QC and production to properly lay out the UT defect, mark the X, Y, D on the base metal and the location on the surface of weld by use of rectangle or circle, by doing this, UT operator will verify the exact location of the defect prior to excavation.
 - The UT operator and or CWI will take the responsibility to verify the excavation has completely removed the defect
1. QC和生产部门应该正确的标出缺陷的位置, 在母材上标出缺陷X, Y, D的值, 在焊缝上, 用长方形和圆圈标出缺陷的位置, 在碳刨前, 能够准确的确认缺陷的位置;
2. UT检验员和CWI必须确认缺陷已经完全刨除。
