**DEPARTMENT OF TRANSPORTATION**  
 DIVISION OF ENGINEERING SERVICES  
 Office of Structural Materials  
 Quality Assurance and Source Inspection

Contract #: 04-0120F4  
 Cty: SF/ALA Rte: 80 PM: 13.2/13.9  
 File #: 69.25B

**QUALITY ASSURANCE -- NON-CONFORMANCE REPORT**

**Reference Description:** Fabrication of Segment 9CW not according to the approved fabrication procedure

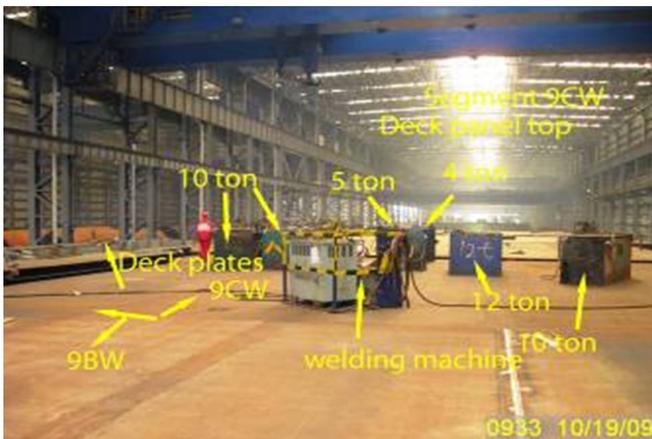
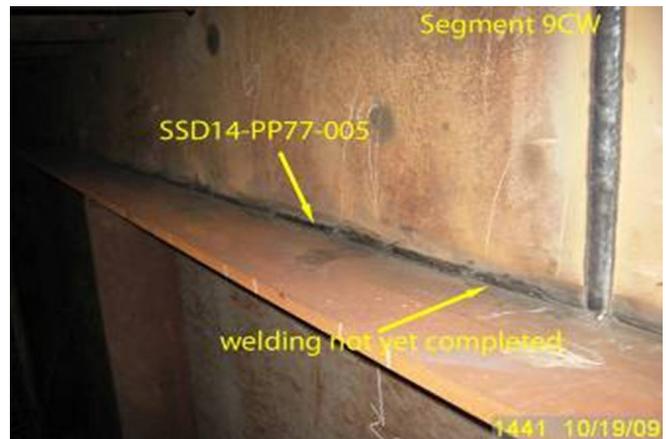
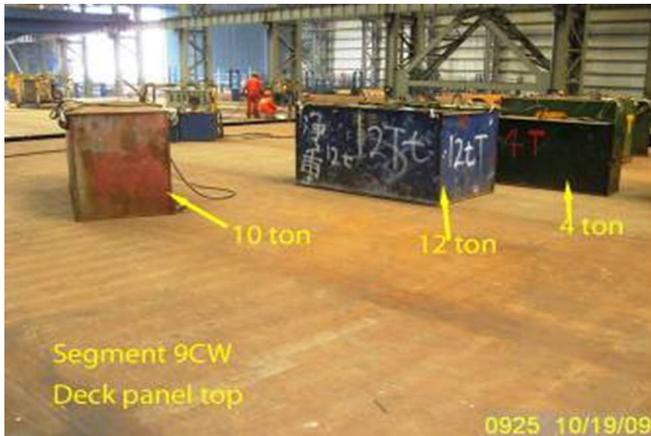
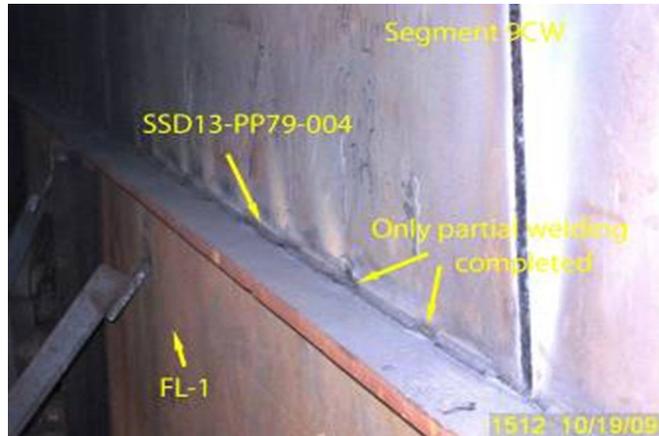
This Quality Assurance (QA) Inspector observed that the contractor welded the deck panel diaphragm to the floor beam top flange by utilizing 51 tons external weight in achieving an acceptable joint fit-up for welding. These additional weights were placed across the exterior surface of the deck panel which helped in the closing the root gap opening for the joint. This incident occurred in Segment 9CW welds SSD13-PP79-004, SSD14-PP77-005 at PP77, 78, and 79 in Bay 14. According to the approved as noted fabrication procedure, the use of additional weight to position the deck panel fit up is not indicated as an acceptable procedure.

“BG103: Typical Box Girder Fabrication Procedure:” Step 10.1- Lift intermediate deck panel A1-1 onto the box girder. Then use adjustable device (i.e. jack) to adjust the position. Then theodolite will be used to check the transverse and longitudinal ACLs of deck plate according to the staff gauge. Tack weld and fix the position.

AWS D1.5 2002 section 3.3.1; “The parts to be joined by fillet welds shall be brought into as close contact as practicable. The root opening shall not exceed 5 mm”.

Submit a repair plan to the engineer for approval.
