Contract #: 04-0120F4Cty: SF/ALA Rte: 80 PM: 13.2/13.9File #: 69.25B**QUALITY ASSURANCE -- NON-CONFORMANCE REPORT****Location:** Changxing Island, Shanghai, P. R. China**Report No:** NCR-000489**Prime Contractor:** American Bridge/Fluor Enterprises, a JV**Date:** 23-Oct-2009**Submitting Contractor:** Zhenhua Port Machinery Company, Ltd (ZPMC), Changxing Island**NCR #:** ZPMC-0462**Type of problem:**

Reference Description: Missed MT indication by QC on Segment 7BE floorbeam flange**Description of Non-Conformance:**

Job Name: SAS Superstructure

Subject: NCR No. ZPMC-0462

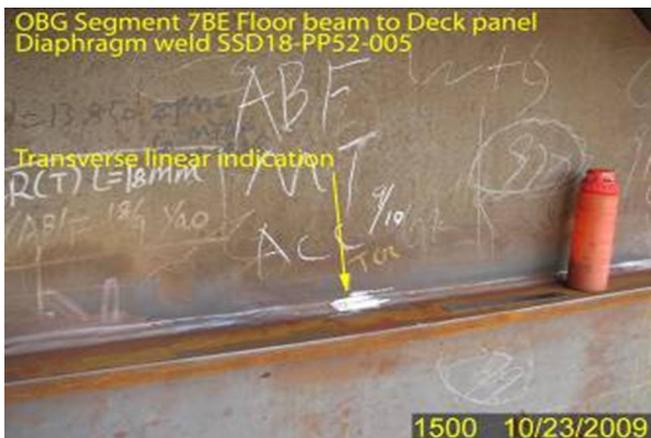
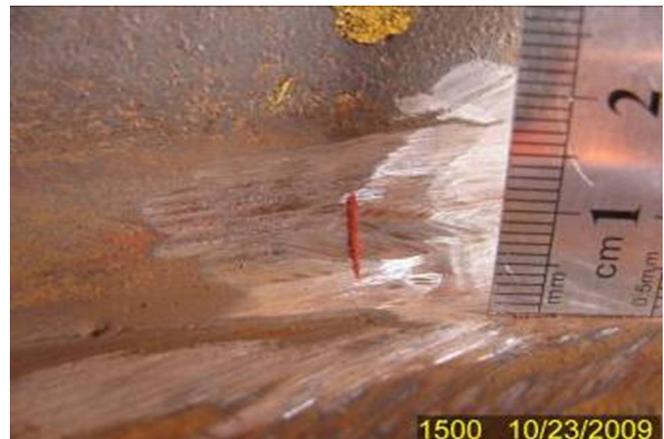
During a random Magnetic Particle (MT) verification of Floor Beam to Deck Panel Diaphragm at OBG Segment 7BE, Caltrans Quality Assurance (QA) Inspector observed one (1) Transverse Crack measuring 10 mm in length on weld SSD18-PP52-005. This weld was previously tested and accepted by ZPMC and ABF Magnetic Particle Testing (MT) technicians.

AWS D1.5 (02) - 6.26.1; "The weld shall have no cracks."

AWS D1.5 (02) Section 6.26.2; "Welds that are subject to MT in addition to visual inspection shall have no cracks."

Submit a repair plan to the engineer for approval. Missing MT indications is a chronic issue. Train the MT inspectors in proper MT techniques and provide a certificate of competency.

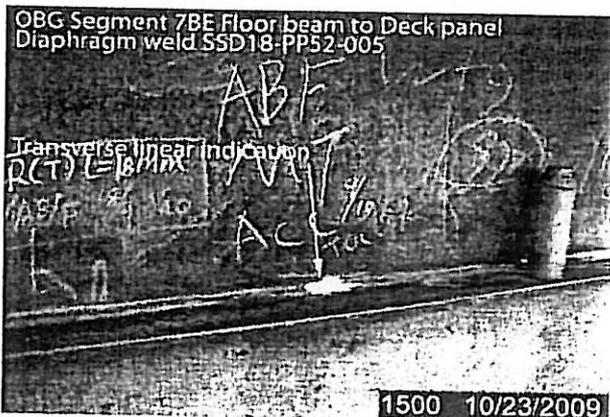
During a random Magnetic Particle (MT) verification of Floor Beam to Deck Panel Diaphragm at OBG Segment 7BE, Caltrans Quality Assurance (QA) Inspector observed one (1) Transverse Crack measuring 10 mm in length on weld SSD18-PP52-005. This weld was previously tested and accepted by ZPMC and ABF Magnetic Particle Testing (MT) technicians.

AWS D1.5 (02) - 6.26.1; "The weld shall have no cracks."

AWS D1.5 (02) Section 6.26.2; "Welds that are subject to MT in addition to visual inspection shall have no cracks."

Submit a repair plan to the engineer for approval. Missing MT indications is a chronic issue. Train the MT inspectors in proper MT techniques and provide a certificate of competency.

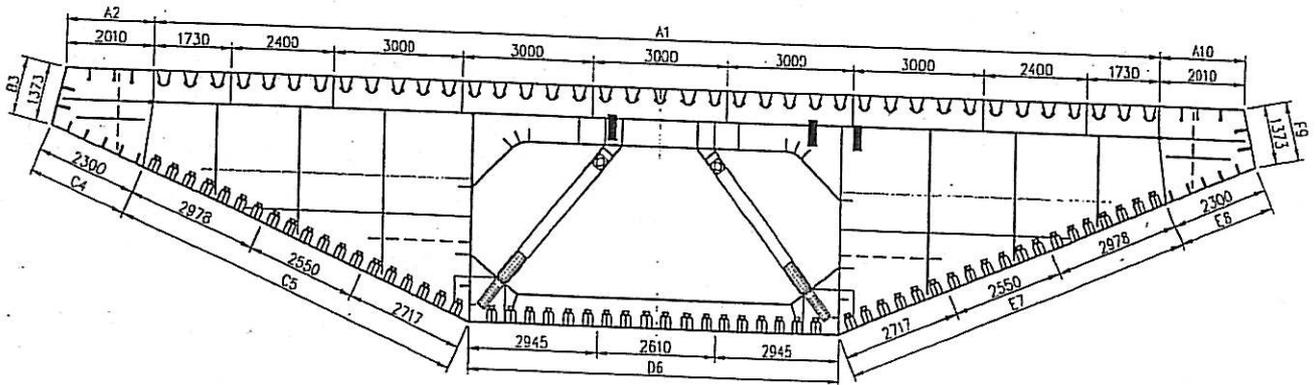
Draft of Welding Discontinuity:

在对SSD18A-PP052-004检测时,发现1处横向裂纹。1、L1=15mm Y1=8950mm.

One transverse crack was found by use of MT on SSD18A-PP052-004

1. 火焰加热时, 水汽没有完全的去掉或者这个区域预热不够;
1. Moisture wasn't completely removed during drying the area wasn't preheated sufficiently.

1. QC and a Lead CWI shall be present, direct and supervise all grinding and welding operations during this repair to ensure the repair is per the disposition requirements.

2. QC and a Lead CWI shall have an approved copy of the CWR in hand prior to the repair.
3. Remove paint ≥ 25 mm in all direction of HAZ prior to MT.
4. Clean the excavation area of all loose debris including MT powder and UT gel. Remove cracks by grinding, repair area shall extend a minimum of 50mm beyond each end of single crack repairs, and 50mm beyond the outermost cracks for multiple crack repairs.

5. If base metal is damaged by grinding, the damaged area shall be ground clean prior to performing weld repair. If gap > 5 mm is found during or after grinding, comply with the notification on changing fillet weld to CJP which is submitted for Engineer's review and approval form.

6. Prepare excavation in accordance with the New Repair Procedure prior to welding.
7. Before this repair, Verify with VT and MT repair areas are defects free, and also MT shall be performed on the base metal laying abroad cracks to ensure that no cracks were propagated to the base metal. Separate CWR approval is needed if cracks are found in the base metal, and only after this new CWR's approval can continue the repair.

8. Clean excavation area of all loose debris including MT powder after excavation. Preheat and weld according to the Table 1 of the New Repair Procedure.

9. Perform post weld heating according to the Table 1 of the New Repair Procedure.
10. Allow the weld to cool to ambient temperature gradually. (SLOWLY COOL DOWN)

11. Grind the repaired area flush with base metal or the adjacent weld after post weld heating.
12. Wait 48 hours after the repair area has cooled to ambient temperature before performing NDT.

13. Perform MT inspection to all repair area according to Contract Drawings along with all additional NDT required by the applicable notes Special Provision Section 10-1.59 'Steel Structure', subsection 'inspection testing'.
