Contract #: 04-0120F4Cty: SF/ALA Rte: 80 PM: 13.2/13.9File #: 69.25B**QUALITY ASSURANCE -- NON-CONFORMANCE REPORT****Location:** Changxing Island, Shanghai, P. R. China**Report No:** NCR-000491**Prime Contractor:** American Bridge/Fluor Enterprises, a JV**Date:** 25-Oct-2009**Submitting Contractor:** Zhenhua Port Machinery Company, Ltd (ZPMC), Changxing Island**NCR #:** ZPMC-0464**Type of problem:**

Reference Description: Missed MT Indications by QC on OBG Segment 6AW DP**Description of Non-Conformance:**

Job Name: SAS Superstructure

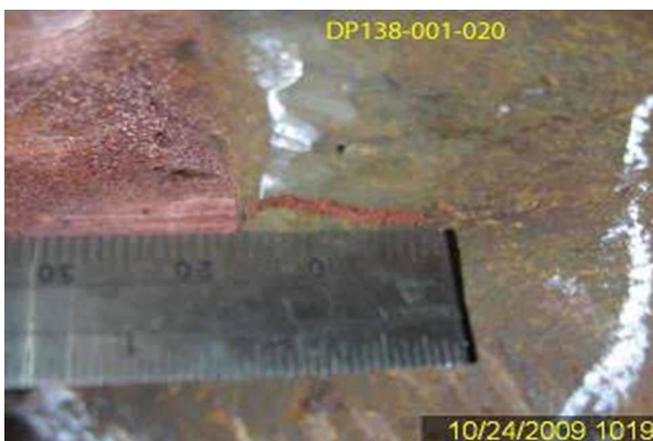
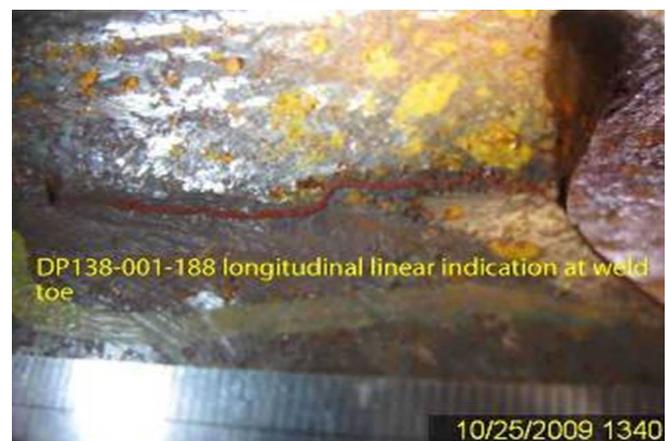
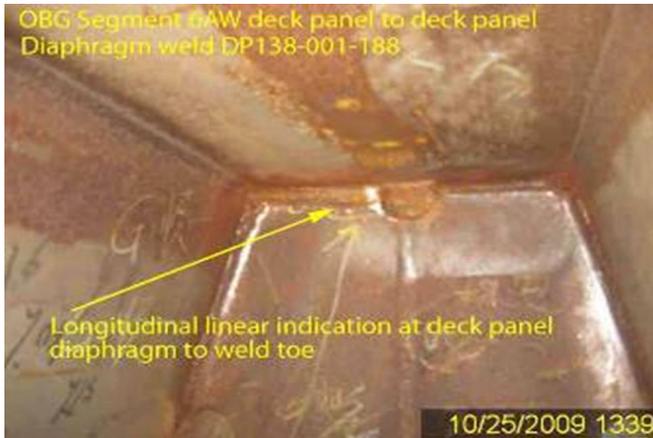
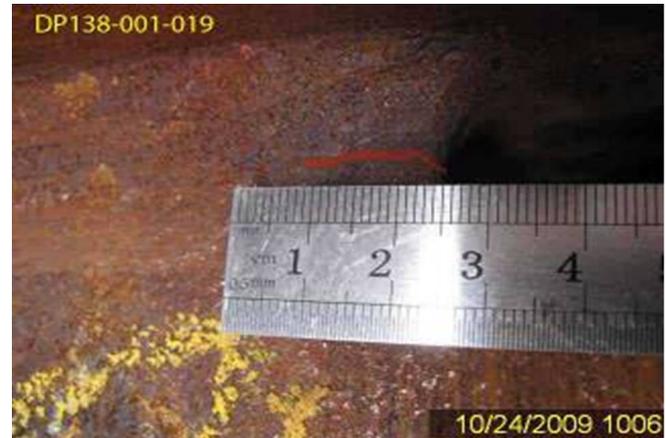
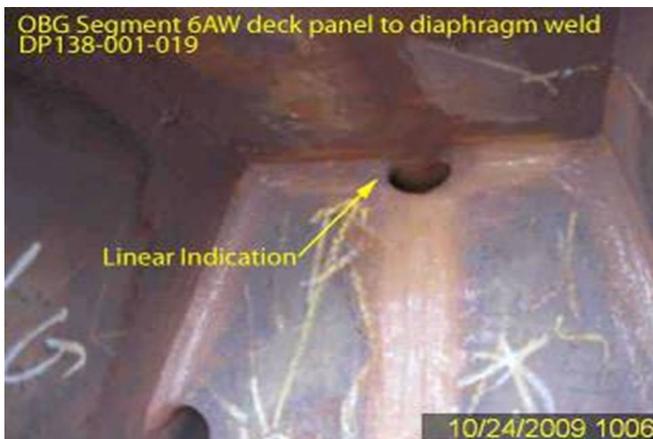
During a random Magnetic Particle (MT) verification (October 25, 2009), of welds at OBG Segment 6AW, Caltrans Quality Assurance (QA) Inspector observed two (2) Longitudinal Cracks on the Deck Panel Diaphragm to Deck Panel fillet welds measuring 40 mm and 15 mm in length. These welds were identified as DP138-001-187 and 188. ZPMC had previously MT tested and accepted these welds mentioned above.

During random MT verification (October 24, 2009) of OBG Segment 6AW, Caltrans QA observed two (2) linear Longitudinal Cracks on Deck Panel Diaphragm to Deck Panel fillet welds measuring 15mm in length each on welds DP138-001-019 and 020. These welds were previously tested and accepted by ZPMC QC MT.

AWS D1.5 (02) Section 6.26.1.1; "The weld shall have no cracks."

AWS D1.5 (02) Section 6.26.2; "Welds that are subject to MT in addition to visual inspection shall have no cracks."

Submit a repair procedure to the engineer for approval. Provide training for the MT technicians and submit training results indicating competency.

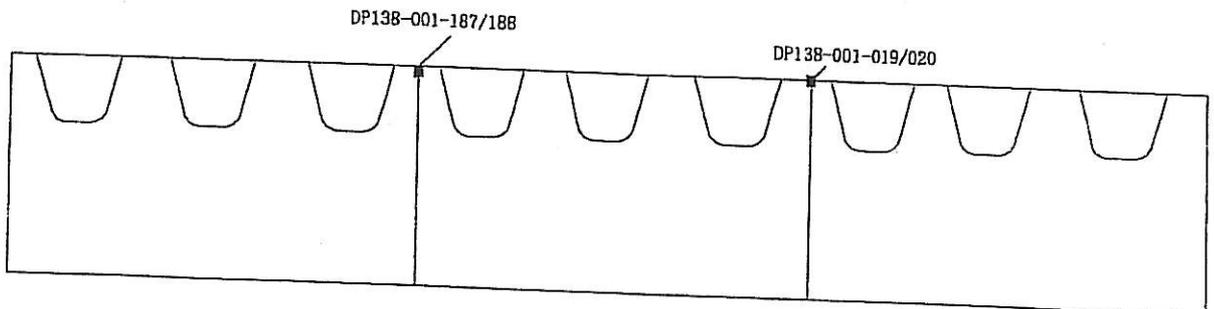
Draft of Welding Discontinuity:

- One longitudinal crack was found by use of MT on DP138-001-187
- One longitudinal crack was found by use of MT on DP138-001-188
- One longitudinal crack was found by use of MT on DP138-001-019
- One longitudinal crack was found by use of MT on DP138-001-020

1. 火焰加热时, 水汽没有完全的去掉或者这个区域预热不够;
1. Moisture wasn't completely removed during drying operation (preheating) or the area wasn't preheated sufficiently.

1. QC and a Lead CWI shall be present, direct and supervise all grinding and welding operations during this repair to ensure the repair is per the disposition requirements

2. QC and a Lead CWI shall have an approved copy of the CWR in hand prior to the repair.
3. Remove paint $\geq 25\text{mm}$ in all direction of HAZ prior to MT.

4. Clean the excavation area of all loose debris including MT powder. Preheat to 65° C before removing cracks by grinding, repair area shall extend a minimum of 50mm beyond each end of single crack repairs.

5. If base metal is damaged by grinding, the damaged area shall be ground clean prior to performing weld repair. If gap $> 5\text{mm}$ is found during or after grinding, comply with the notification on changing fillet weld to CJP which is submitted for Engineer's review and approval form.

6. Prepare excavation in accordance with the New Repair Procedure prior to welding.
7. Before this repair, Verify with VT and MT repair areas are defects free, and also MT shall be performed on the base metal laying abroad cracks to ensure that no cracks were propagated to the base metal. Separate CWR approval is needed if cracks are found in the base metal, and only after this new CWR's approval can continue the repair.

8. Clean excavation area of all loose debris including MT powder after excavation. Preheat and weld according to repair WPS, the preheat shall between 160° C-230° C

9. Perform post weld heating according to repair WPS, the postheat shall between 230° C-315° C and for one hour minimum.
10. Allow the weld to cool to ambient temperature gradually. Control cooling rate after PWHT to no more than 50° C per hour.

11. Grind the repaired area flush with base metal or the adjacent weld after post weld heating.
12. Wait 48 hours at least after the repair area has cooled to ambient temperature before performing NDT.

13. Perform MT inspection to all repair area according to Contract Drawings along with all additional NDT required by the applicable notes Special Provision Section 10-1.59 'Steel Structure', subsection 'inspection testing'. NDT include VT, MT and UT if it is a CJP weld.
