Contract #: 04-0120F4
 Cty: SF/ALA Rte: 80 PM: 13.2/13.9
 File #: 69.25B

QUALITY ASSURANCE -- NON-CONFORMANCE REPORT

Report No: NCR-000493

Reference Description: Repair of cracks without CWR on Cantilever Bike Path Bracket for Lift 5E

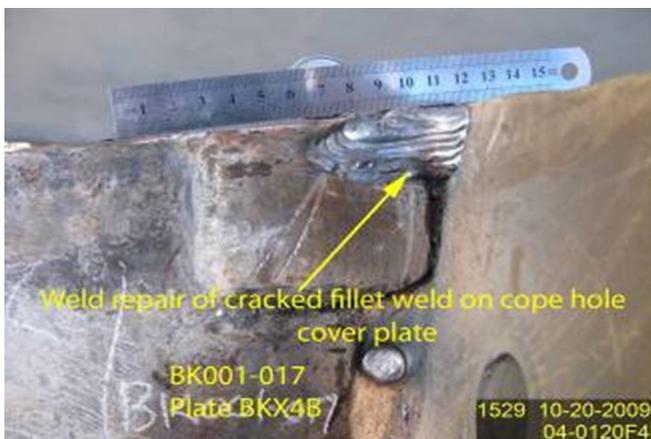
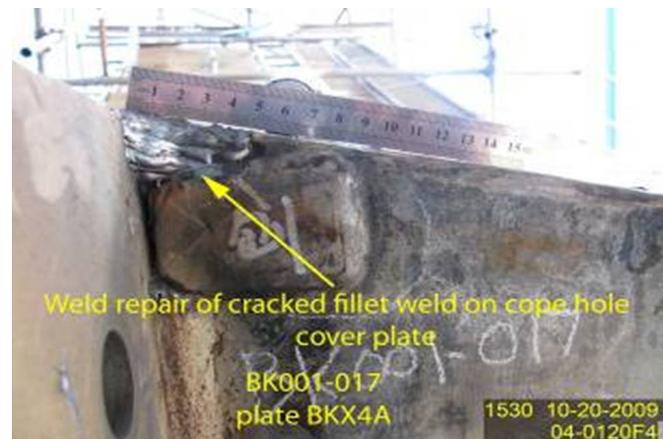
During random visual inspection the Caltrans Quality Assurance (QA) Inspector observed weld repairs were performed on cracks in the fillet welds on the top cope hole cover plates on plates BKX4A and BKX4B of BK001-017. Carbon air arc gouging was used to remove the cracks. NDT was not performed on the excavated area to insure the defect was completely removed. The weld repair was performed with the Flux Cored Arc Welding (FCAW) process. The fillet welds of the cover plate do not have a designated weld numbers for identification. These repairs were performed without an approved welding procedure and the Engineer's approval. These cracks were found on Oct 15, 2009. (see NCR ZPMC-0452)

Submit a repair procedure to the engineer for approval.

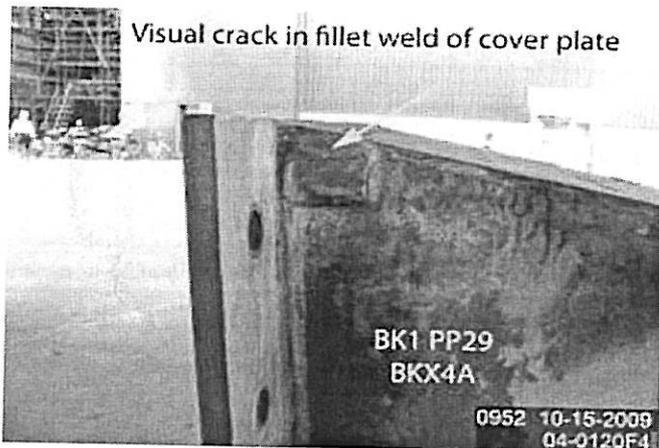
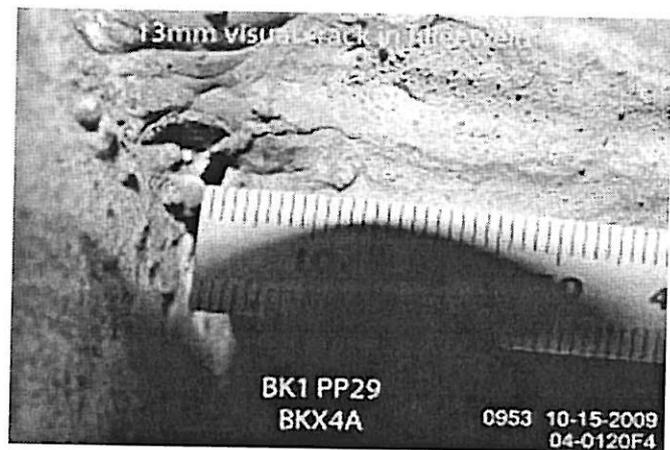
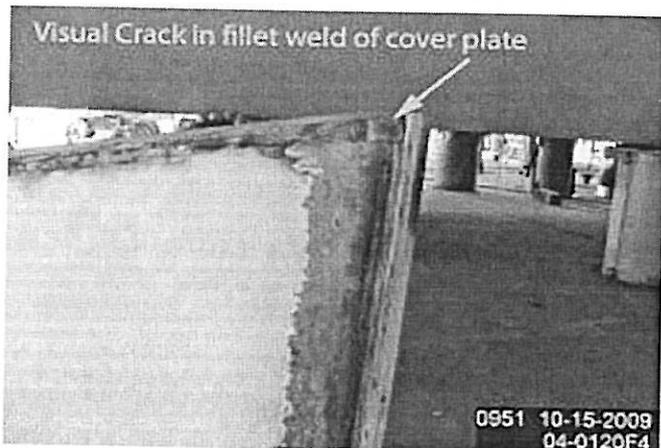
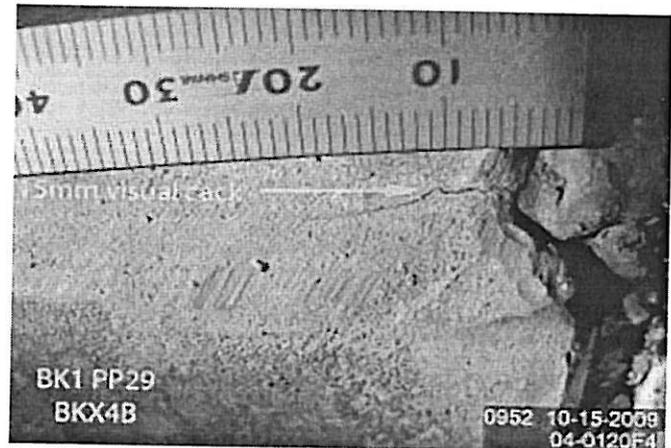
During a random visual inspection of OBG Segment 5AE Bike Path Cantilever Brackets (BK1), Caltrans Quality Assurance (QA) Inspector discovered visual cracks in the fillet welds on the top cope hole cover plates BKX4A and BKX4B at panel point 29. The visual crack observed on BKX4A measured 13mm in length and 15mm in length on BKX4B.

AWS D1.5-2002 Section 6.26.1.1; The weld shall have no cracks.

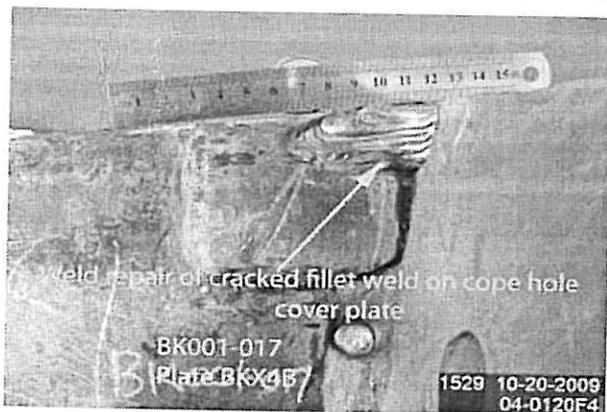
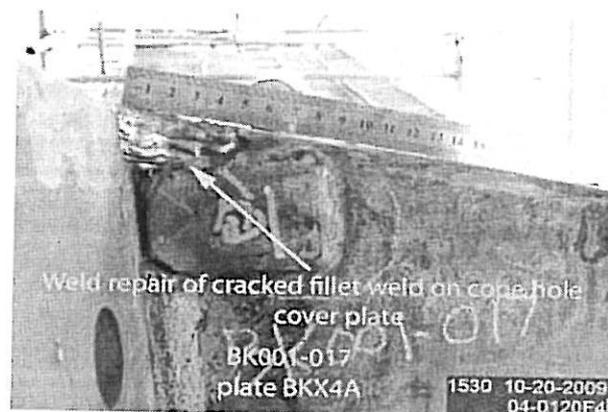
During random visual inspection the Caltrans Quality Assurance (QA) Inspector observed weld repairs were performed on cracks in the fillet welds on the top cope hole cover plates on plates BKX4A and BKX4B of BK001-017. Carbon air arc gouging was used to remove the cracks. NDT was not performed on the excavated area to insure the defect was completely removed. The weld repair was performed with the Flux Cored Arc Welding (FCAW) process. The fillet welds of the cover plate do not have a designated weld numbers for identification. These repairs were performed without an approved welding procedure and the Engineer's approval. These cracks were found on Oct 15, 2009. (see NCR ZPMC-0452)

Provide NDT documentation verifying weld quality

Contractor submitted NDT report verifying welds are now in conformance with Contract specifications.
