QUALITY ASSURANCE -- NON-CONFORMANCE REPORT

Report No: NCR-000498

Reference Description: Missed MT indications by both ZPMC and ABF's QC in Segment 6AW

Job Name: SAS Superstructure

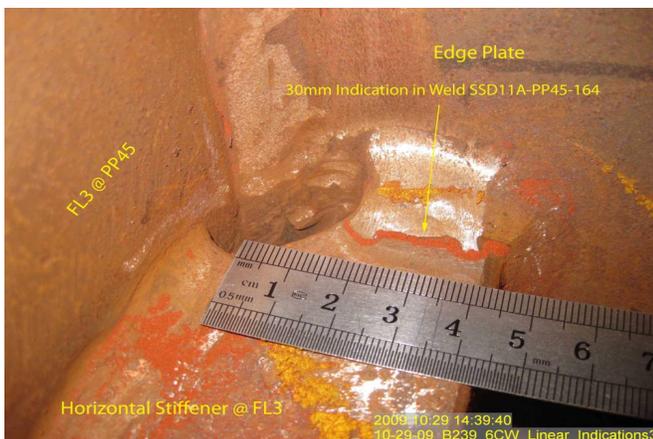
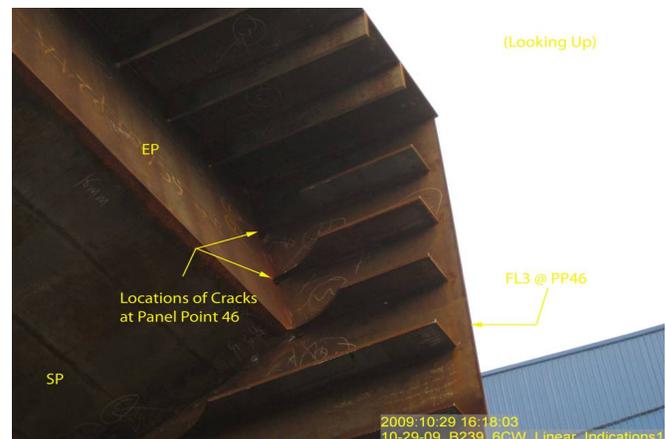
During random verification Magnetic Particle Testing of the internal components of OBG segment 6AW, Caltrans Quality Assurance (QA) Inspector discovered a total of two (4) longitudinal indications that measured from 25mm to 30mm in length. In addition to the (MT) indications these welds were visually rejectable due to notches in the weld toe and at the weld terminations. These welds were previously tested accepted by ZPMC and ABF (MT) technicians.

Horizontal FL3 stiffeners (X8) to edge plate attachment fillet welds (FCW)

Weld No. SSD11A-PP45-164 = (1) 30mm Longitudinal Indication.

Weld No. SSD12A-PP46-170 = (1) 25mm Longitudinal Indication.

Weld No. SSD12A-PP46-175 = (1) 30mm Longitudinal Indication.

Longitudinal Open Rib Stiffener to FL3 Floor beam at PP44 CJP (FCW)

SEG031J-131 (1) 30 mm Longitudinal Indication.

Submit a repair procedure to the engineer for approval. Missed MT indications continue to be a chronic problem. Assure that adequate training of MT technicians occurs so these incidences are reduced.

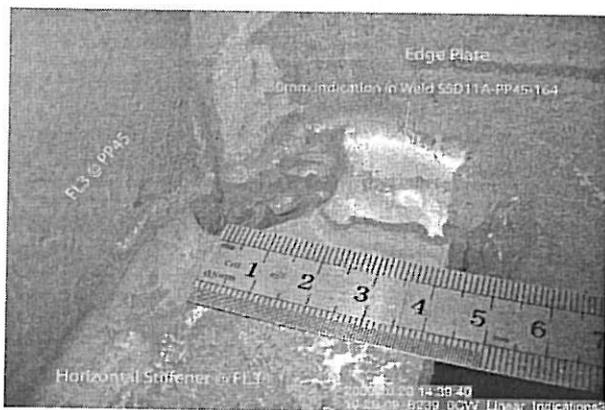
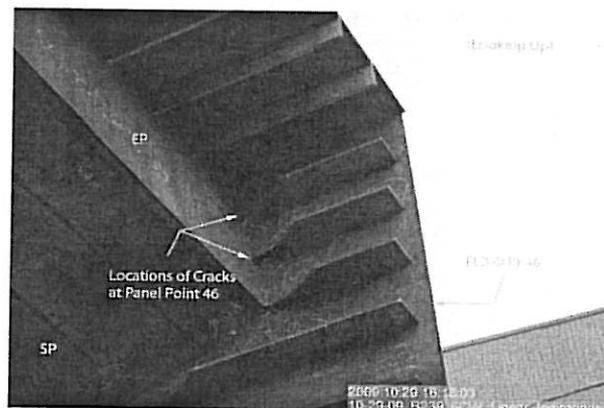
During random verification Magnetic Particle Testing of the internal components of OBG segment 6AW, Caltrans Quality Assurance (QA) Inspector discovered a total of two (4) longitudinal indications that measured from 25mm to 30mm in length. In addition to the (MT) indications these welds were visually rejectable due to notches in the weld toe and at the weld terminations. These welds were previously tested accepted by ZPMC and ABF (MT) technicians.

Horizontal FL3 stiffeners (X8) to edge plate attachment fillet welds (FCW)

Weld No. SSD11A-PP45-164 = (1) 30mm Longitudinal Indication.

Weld No. SSD12A-PP46-170 = (1) 25mm Longitudinal Indication.

Weld No. SSD12A-PP46-175 = (1) 30mm Longitudinal Indication.

Longitudinal Open Rib Stiffener to FL3 Floor beam at PP44 CJP (FCW)

SEG031J-131 (1) 30 mm Longitudinal Indication.
