Contract #: 04-0120F4
 Cty: SF/ALA Rte: 80 PM: 13.2/13.9
 File #: 69.25B

QUALITY ASSURANCE -- NON-CONFORMANCE REPORT

Location: Changxing Island, Shanghai, P.R. China **Report No:** NCR-000503
Prime Contractor: American Bridge/Fluor Enterprises, a JV **Date:** 06-Nov-2009
Submitting Contractor: Zhenhua Port Machinery Company, Ltd (ZPMC), Changxing Island **NCR #:** ZPMC-0476

Reference Description: Missed MT Indication by QC on CB7

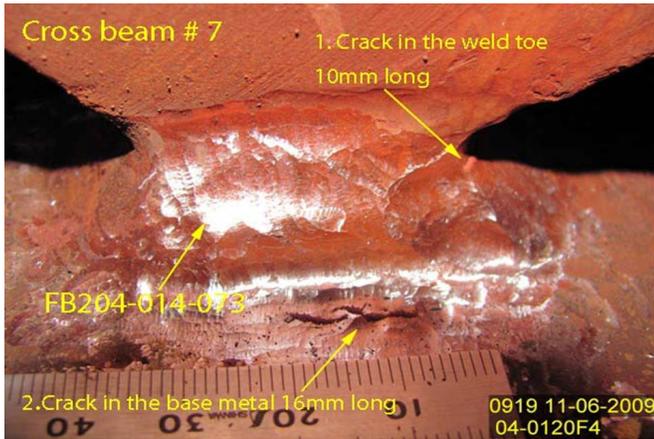
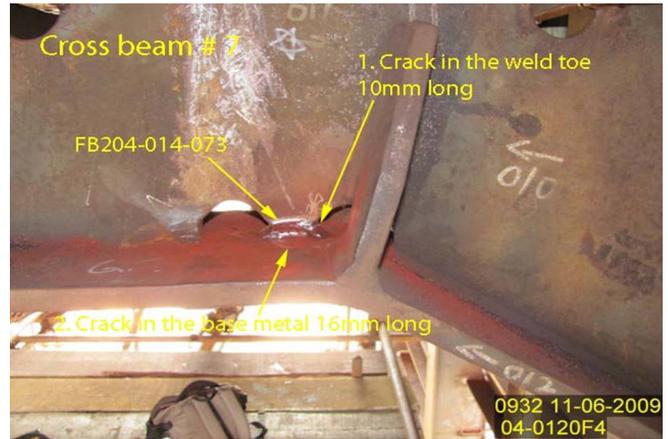
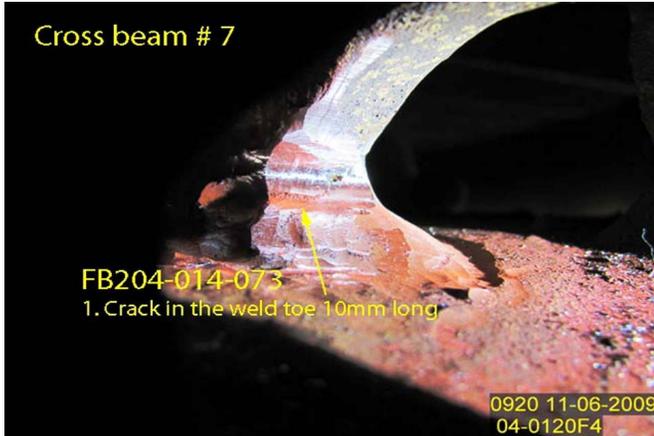
During a random Magnetic Particle Test (MT) verification of Cross Beam # 7, Caltrans Quality Assurance (QA) Inspector observed two (2) linear indications on Floor Beam weld FB204-014-073. Indication one (1) measured 10mm in length on the weld toe and indication two (2) measured 16mm in length at the heat affected zone (HAZ) in the base metal area.

This weld was previously tested and accepted by ZPMC Magnetic Particle Testing (MT) technicians.

-AWS D1.5 (02) - 6.26.1; "The weld shall have no cracks."

-AWS D1.5 (02) Section 6.26.2; "Welds that are subject to MT in addition to visual inspection shall have no cracks."

Submit a repair procedure to the engineer for approval. Missed MT indications are a chronic problem for MT technicians. Provide adequate MT technicians to lessen these occurrences.

Provide refresher training to NDT technicians to improve inspection practices. Repair said indications and perform NDT required to verify weld quality.

Contractor submitted NDT documentation verifying the weld in question meets Contract weld quality requirements and said indications have been repaired. An internal NCR was also issued in regards to this matter in addition to refresher training being provided to NDT technicians.

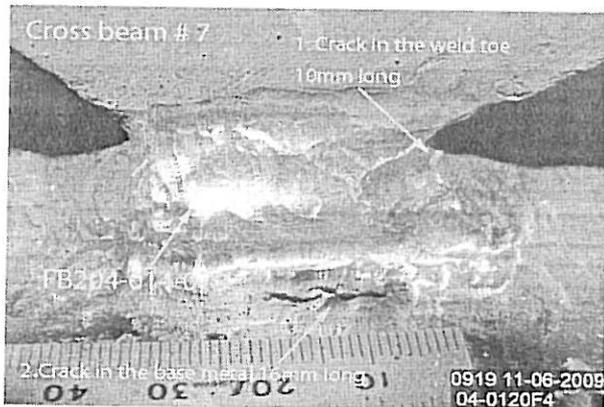
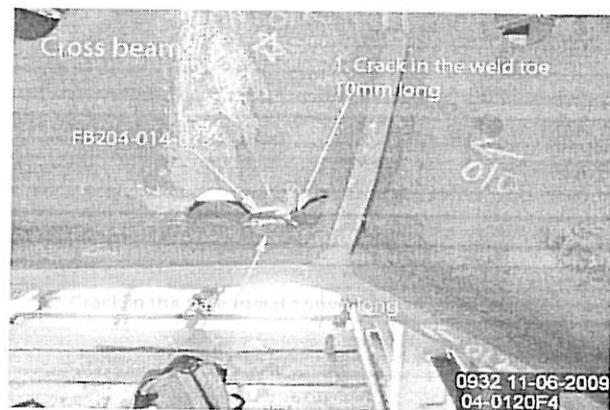
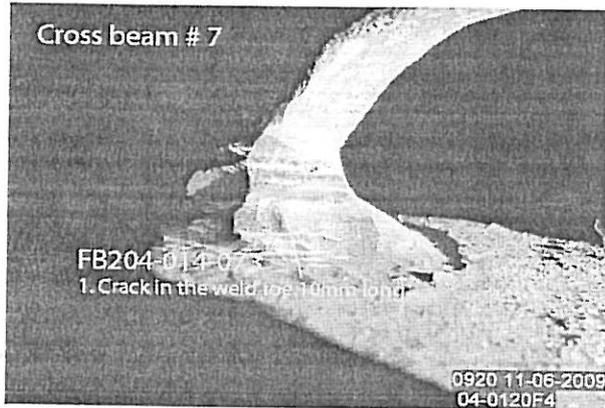
During a random Magnetic Particle Test (MT) verification of Cross Beam # 7, Caltrans Quality Assurance (QA) Inspector observed two (2) linear indications on Floor Beam weld FB204-014-073. Indication one (1) measured 10mm in length on the weld toe and indication two (2) measured 16mm in length at the heat affected zone (HAZ) in the base metal area.

This weld was previously tested and accepted by ZPMC Magnetic Particle Testing (MT) technicians.

-AWS D1.5 (02) - 6.26.1; "The weld shall have no cracks."

-AWS D1.5 (02) Section 6.26.2; "Welds that are subject to MT in addition to visual inspection shall have no cracks."

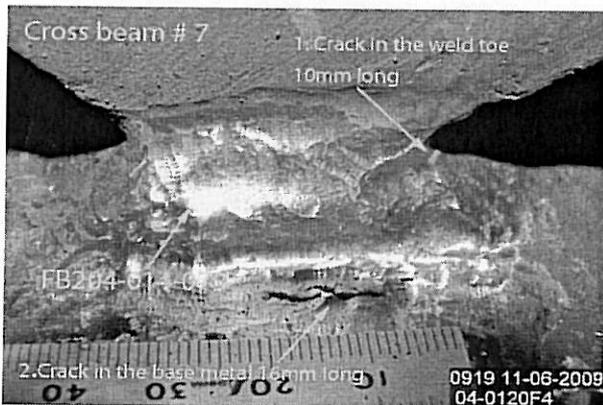
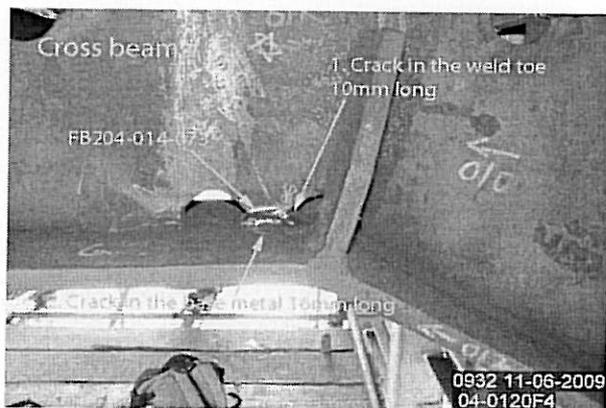
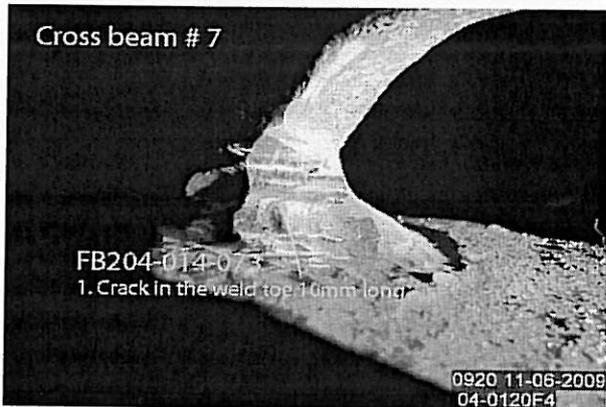
During a random Magnetic Particle Test (MT) verification of Cross Beam # 7, Caltrans Quality Assurance (QA) Inspector observed two (2) linear indications on Floor Beam weld FB204-014-073. Indication one (1) measured 10mm in length on the weld toe and indication two (2) measured 16mm in length at the heat affected zone (HAZ) in the base metal area.

This weld was previously tested and accepted by ZPMC Magnetic Particle Testing (MT) technicians.

-AWS D1.5 (02) - 6.26.1; "The weld shall have no cracks."

-AWS D1.5 (02) Section 6.26.2; "Welds that are subject to MT in addition to visual inspection shall have no cracks."
