Contract #: 04-0120F4Cty: SF/ALA Rte: 80 PM: 13.2/13.9File #: 69.25B**QUALITY ASSURANCE -- NON-CONFORMANCE REPORT****Location:** Changxing Island, Shanghai, P.R. China**Report No:** NCR-000504**Prime Contractor:** American Bridge/Fluor Enterprises, a JV**Date:** 12-Nov-2009**Submitting Contractor:** Zhenhua Port Machinery Company, Ltd (ZPMC), Changxing Island**NCR #:** ZPMC-0477**Type of problem:**

Reference Description: Corner Assembly components X37 for Lift 9W were damaged due to improper handling and storage.

Job Name: SAS Superstructure

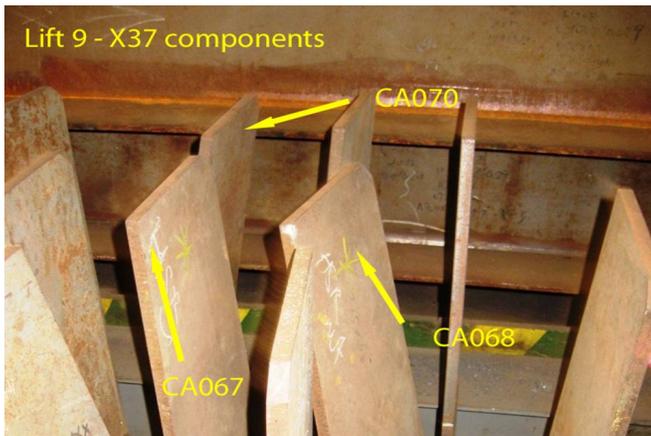
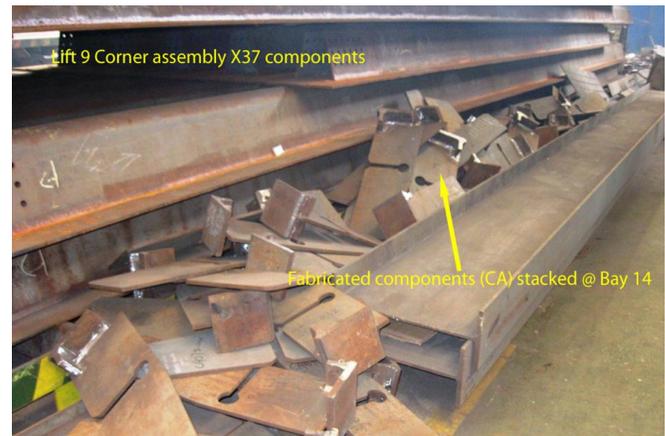
During in-process visual inspection of the fabrication of X37 for Lift 9 West, Caltrans Quality Assurance Inspector observed that Corner Assembly components CA067, CA068, and CA070 identified as X37 were damaged. The storage and handling of these X37 components are not according to the requirement as indicated in the Standard Specifications.

Caltrans Standard Specifications, July 1999, Section 55-1.04: In handling of the steel work, every care shall be taken to avoid bending, scraping or overstressing the pieces. All pieces bent or otherwise injured will be rejected.

Caltrans Standard Specifications, July 1999, Section 55-3.09: Finished members shall be true to line and free from twists, bends and open joints.

Submit storage correction plan and a repair procedure to the engineer for approval.

ZPMC acknowledges that these pieces were damaged due to improper storage. ZPMC QC will pay greater attention to storage of components prior to assembly. When corrected, ZPMC will provide documentation of the repairs and NDT to show the pieces are acceptable. ZPMC requests that this action be approved with actions pending.

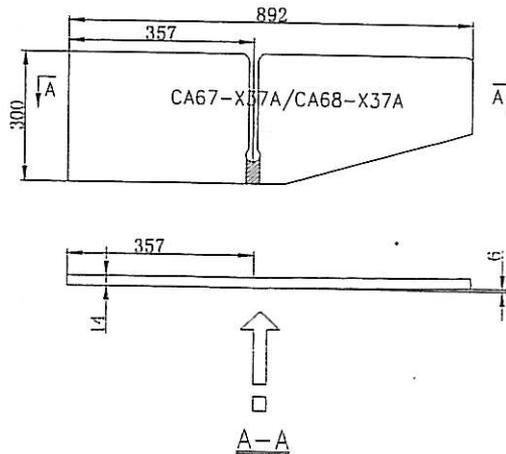
简图 Sketch

| Cause 原因 | Welding distortion 焊接变形 |
| Type of Defect 缺陷类型 | Welding distortion 焊接变形 |

注: 最大变形量约6mm, 校火宽度20~50mm.

NOTE: the max deformation is about 6mm, heat straightening the width is 20~50mm.

缺陷去除方法(Defect Removal Method): Flame Straightening by oxygen acetylene 运用氧乙炔进行校火

后续NDE(Post-Removal NDE): After finishing heat straightening, the weld of the heat area shall perform NDT according to the approved shop drawing 校火后, 根据图纸要求对热影响区域进行NDT检测。

纠正措施(Corrective Action(s)): Control current, voltage and weld speed according to relevant WPS. If necessary anti-deformation or hold down device can be added. 依据相应的WPS的要求控制电流, 电压和焊接速度。如有必要, 可使用反变形设施进行校正。

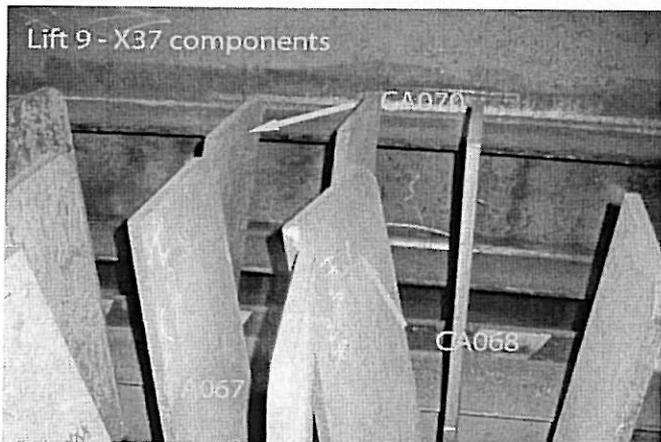
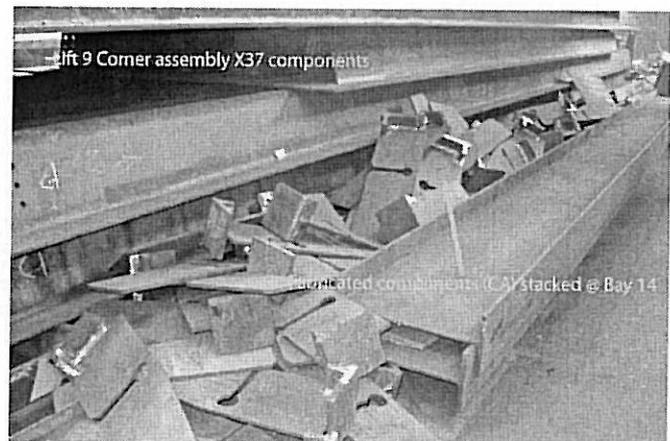
During in-process visual inspection of the fabrication of X37 for Lift 9 West, Caltrans Quality Assurance Inspector observed that Corner Assembly components CA067, CA068, and CA070 identified as X37 were damaged. The storage and handling of these X37 components are not according to the requirement as indicated in the Standard Specifications.

Caltrans Standard Specifications, July 1999, Section 55-1.04: In handling of the steel work, every care shall be taken to avoid bending, scraping or overstressing the pieces. All pieces bent or otherwise injured will be rejected.

Caltrans Standard Specifications, July 1999, Section 55-3.09: Finished members shall be true to line and free from twists, bends and open joints.

Submit storage correction plan and a repair procedure to the engineer for approval.
