Contract #: 04-0120F4Cty: SF/ALA Rte: 80 PM: 13.2/13.9File #: 69.25B**QUALITY ASSURANCE -- NON-CONFORMANCE REPORT****Location:** Changxing Island, Shanghai, P.R. China**Report No:** NCR-000506**Prime Contractor:** American Bridge/Fluor Enterprises, a JV**Date:** 15-Nov-2009**Submitting Contractor:** Zhenhua Port Machinery Company, Ltd (ZPMC), Changxing Island**NCR #:** ZPMC-0479**Type of problem:**

Reference Description: SPCM base material repair on CB8 performed without prior Engineer's approval**Description of Non-Conformance:**

Job Name: SAS Superstructure

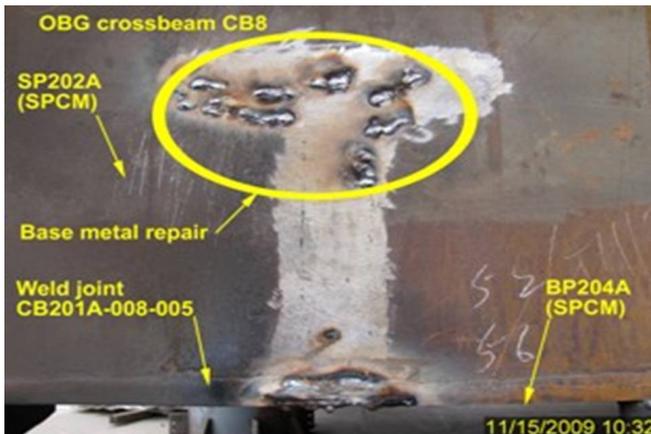
This Quality Assurance (QA) inspector observed ZPMC personnel performing base metal weld repairs on material designated as SPCM on the approved shop drawings without prior Engineer's approval. The areas being repaired were damaged while removing temporary lifting lug welds at the corners of this crossbeam. The component is identified as Orthotropic Box Girder (OBG) crossbeam CB8. The Seismic Performance Critical Member (SPCM) panels affected are identified as side panel SP202A and bottom panel BP204A.

Submit a repair plan to the engineer for approval.

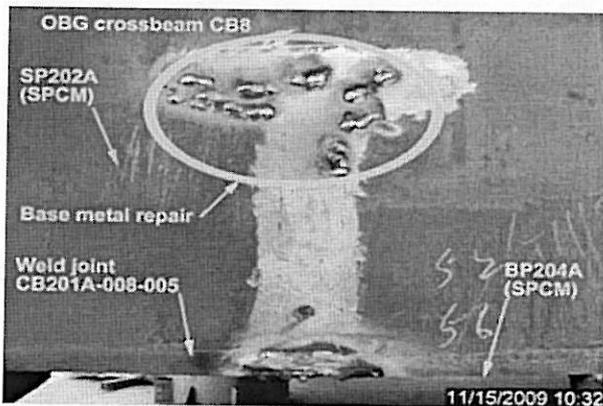
This Quality Assurance (QA) inspector observed ZPMC personnel performing base metal weld repairs on material designated as SPCM on the approved shop drawings without prior Engineer's approval. The areas being repaired were damaged while removing temporary lifting lug welds at the corners of this crossbeam. The component is identified as Orthotropic Box Girder (OBG) crossbeam CB8. The Seismic Performance Critical Member (SPCM) panels affected are identified as side panel SP202A and bottom panel BP204A.

Submit a repair plan to the engineer for approval.

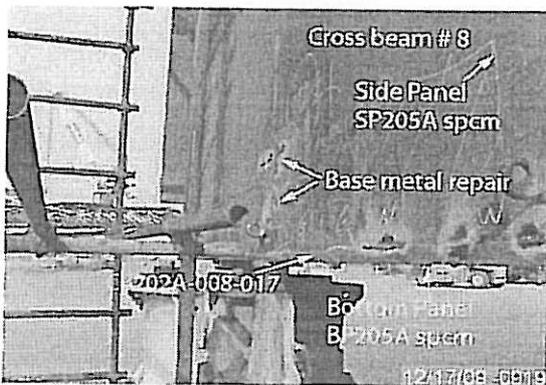
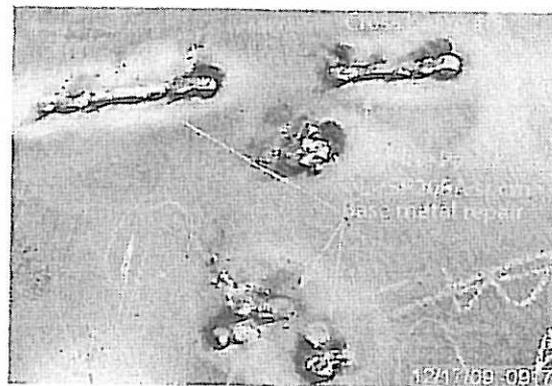
During a random visual inspection of the Orthotropic Box Girder (OBG) Crossbeam CB8, the Caltrans Quality Assurance (QA) Inspector observed ZPMC personnel performing un-approved Seismic Performance Critical Member (SPCM) base metal repairs on the Side Panel (SP) of Crossbeam CB8 without the Engineer's approval.

- The BP was identified as: BP205A
- The SP was identified as: SP205A
- The weld number between the SP and BP is identified as: CB202A-008-017
- The material utilized is A709 Grade 345 SPCM.
- The welding process used was SMAW.

Submit a repair procedure to the engineer for approval. A response for the resolution of this issue is expected within 7 days.
