DEPARTMENT OF TRANSPORTATION

Office of Structural Materials

Contract #: 04-0120F4Cty: SF/ALA Rte: 80 PM: 13.2/13.9File #: 69.25B**QUALITY ASSURANCE -- NON-CONFORMANCE REPORT****Location:** Changxing Island, Shanghai, P.R. China**Report No:** NCR-000509**Prime Contractor:** American Bridge/Fluor Enterprises, a JV**Date:** 16-Nov-2009**Submitting Contractor:** Zhenhua Port Machinery Company, Ltd (ZPMC), Changxing Island**NCR #:** ZPMC-0482**Type of problem:****Welding****Concrete****Other****Welding****Curing****Procedural****Bridge No:** 34-0006**Joint fit-up****Coating****Other****Component:** Segment 6AW, OBG Upper Floor Beam Flange**Procedural****Procedural****Description:****Reference Description:** Heat Straightening performed without Engineer's Approval in Segment 6AW PP38**Description of Non-Conformance:**

Reference Description: Heat Straightening performed without Engineer's Approval in Segment 6AW PP38

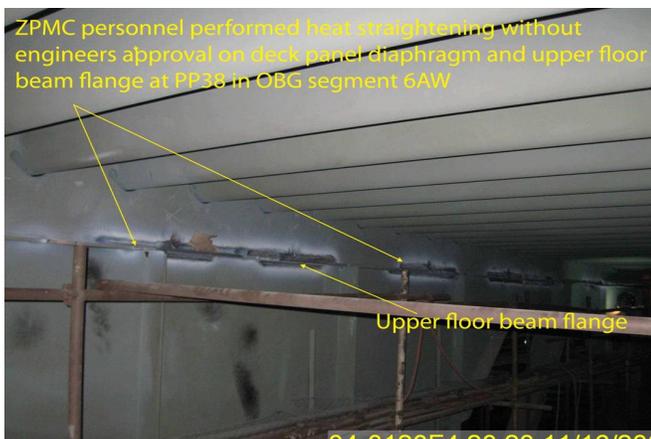
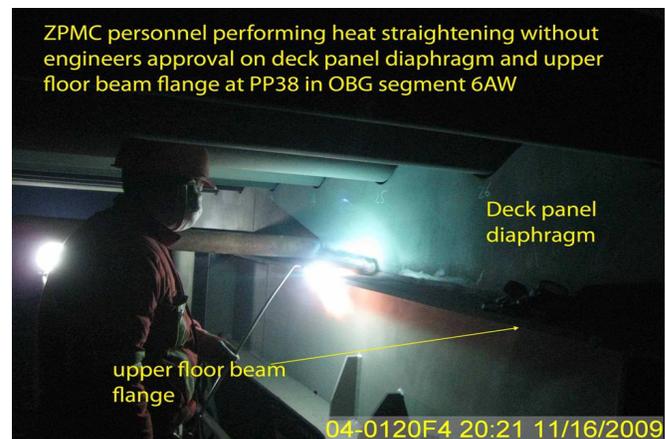
During random visual inspection this Caltrans Quality Assurance (QA) Inspector observed that ZPMC personnel were performing heat straightening on various locations on deck panel diaphragm and the upper floor beam flange in OBG segment 6AW at panel point 38. ZPMC QC or CWI were not present during the time of heat straightening. The non-conforming issues were noted:

1. No prior approval of the Engineer for the Heat Straightening Record. The maximum distortion noted on the flange is 20mm over the width of 170mm along the flange.
2. The heat straightening work performed was deviated from the HSR1(B)-7886 approved internally by ZPMC.

-Contract Special Provisions, Section 8.3: "For material less than or equal to 16 mm thick, the Contractor shall not heat straighten members more than 6 in 1000 without prior approval of the Engineer."

Obtain prior approval from the engineer before performing the work using an approved HSR. Submit a repair procedure to the engineer for approval.

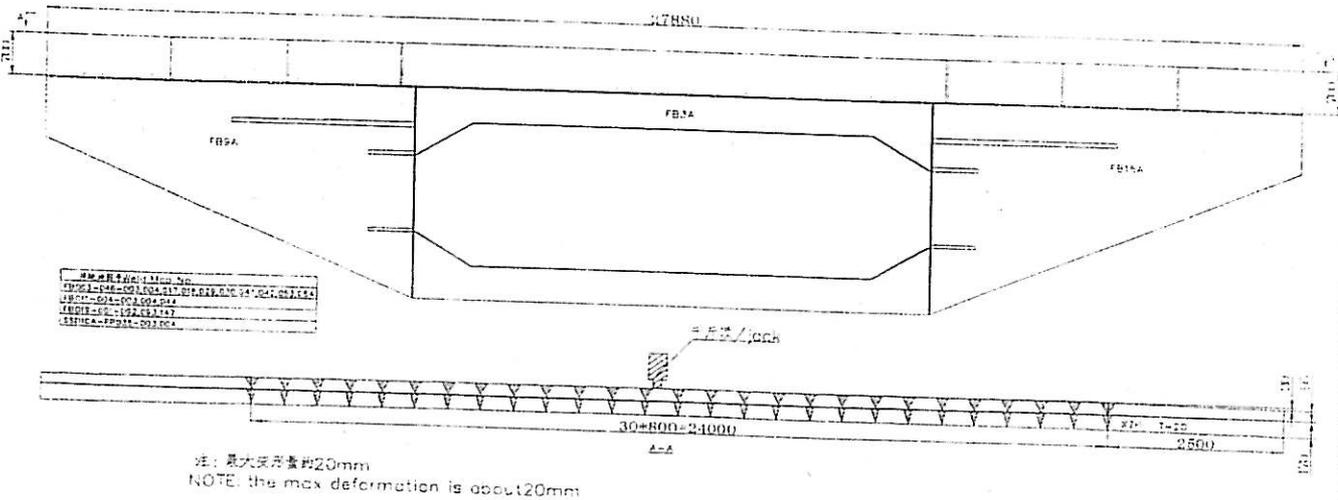
简图 Sketch

Welding distortion 焊接变形

After finishing heat straightening, the weld of the heat area shall perform NDT according to the approved shop drawing 校火后, 根据图纸要求对热影响区域进行NDT检测。

Control current, voltage and weld speed according to relevant WPS. If necessary anti-deformation or hold down device can be added 依据相应的WPS的要求控制电流, 电压和焊接速度, 如有必要, 可使用反变形设施进行校正。
