QUALITY ASSURANCE -- NON-CONFORMANCE REPORT

Report No: NCR-000511

Reference Description: OBG 6AW Floorbeam FB019-001 does not meet the flatness requirement

Job Name: SAS Superstructure

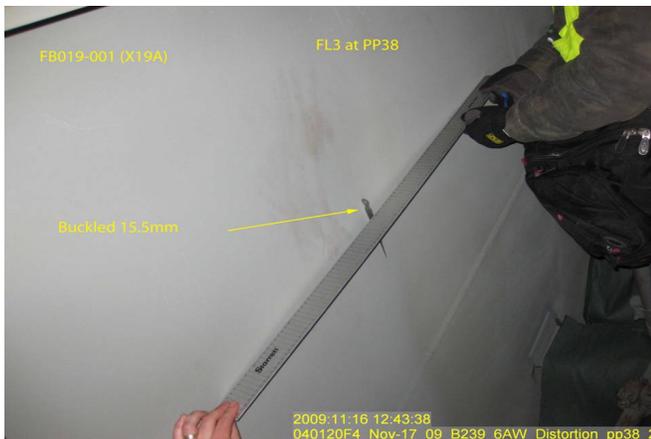
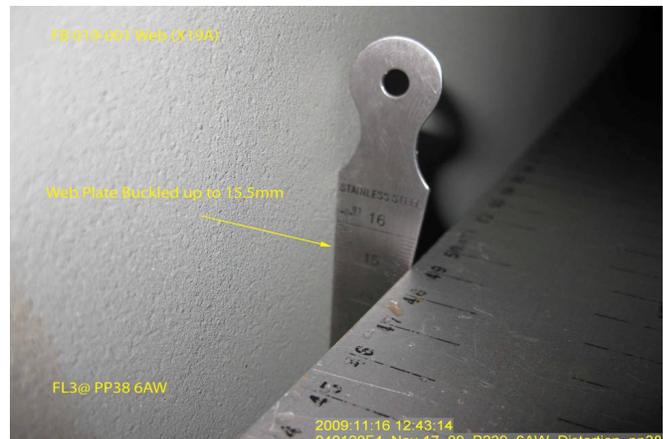
During random visual inspection of OBG Segment 6AW at panel point 38, this QA Inspector observed the following distortion. The FL3 floor beam FB019-001 web plate designated as X19A was found distorted up to 15.5mm over 1000mm. The measurement was taken about 900mm below the upper flange plate.

AASHTO 11.4.13.2 Flatness of Panels: "The maximum deviation from detailed flatness or curvature of a panel shall not exceed the greater of 5mm or $D/(144 \cdot vT)$.

Submit a repair procedure to the engineer for approval.

Perform Heat Straightening to correct said dimensional issues.

Heat Straightening was performed at said location to correct Floorbeam flatness issue. Subsequent Heat Straightening efforts were made to address dimensional issues with the Deck Plate Diaphragm. Additional reinforcement and NDT required in accordance with RFI2083 will be addressed in Oakland.

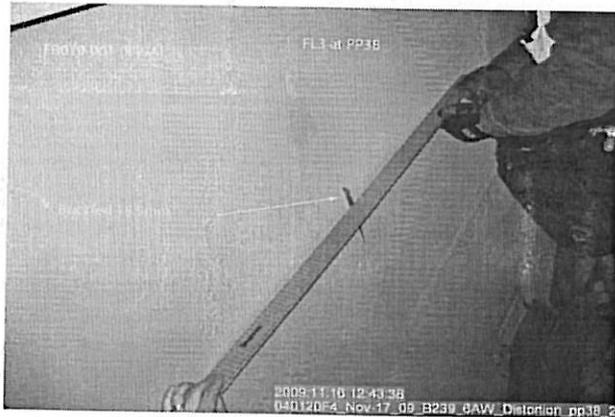
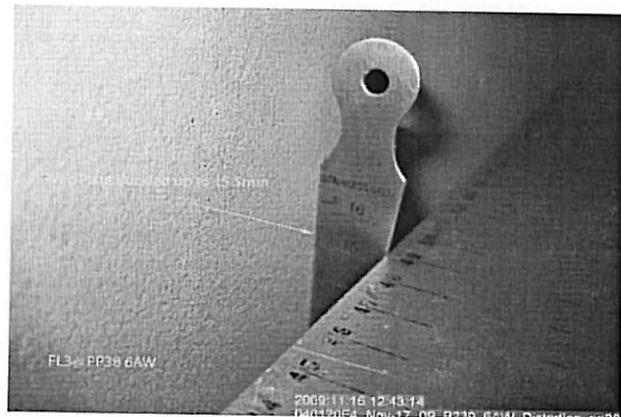
During random visual inspection of OBG Segment 6AW at panel point 38, this QA Inspector observed the following distortion. The FL3 floor beam FB019-001 web plate designated as X19A was found distorted up to 15.5mm over 1000mm. The measurement was taken about 900mm below the upper flange plate.

AASHTO 11.4.13.2 Flatness of Panels: "The maximum deviation from detailed flatness or curvature of a panel shall not exceed the greater of 5mm or $D/(144 \cdot vT)$."

Submit a repair procedure to the engineer for approval.
