Contract #: 04-0120F4
 Cty: SF/ALA Rte: 80 PM: 13.2/13.9
 File #: 69.25B

QUALITY ASSURANCE -- NON-CONFORMANCE REPORT

Location: Changxing Island, Shanghai, P.R. China **Report No:** NCR-000521
Prime Contractor: American Bridge/Fluor Enterprises, a JV **Date:** 23-Nov-2009
Submitting Contractor: Zhenhua Port Machinery Company, Ltd (ZPMC), Changxing Island **NCR #:** ZPMC-0494

Reference Description: The contractor did not perform the required NDT after Heat Straightening for Segment 7BW

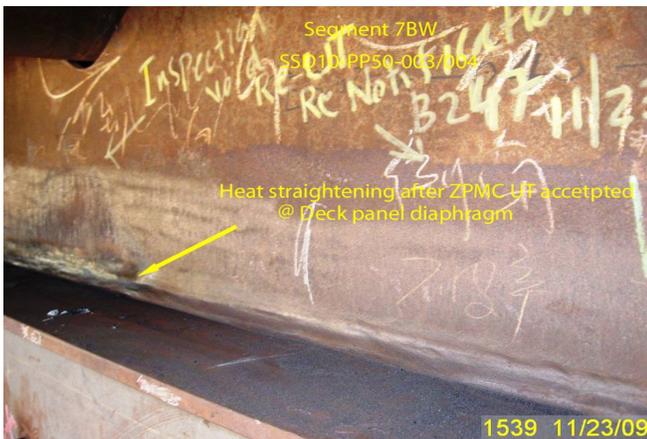
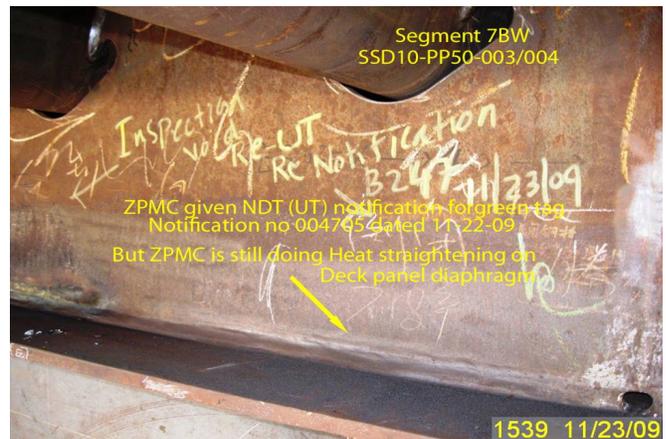
This QA inspector received Notice of Inspection number 004705 on 11-22-09 for the Ultrasonic Testing (UT) of the deck panel diaphragm to floor beam flange Complete Joint Penetration weld after heat straightening for OBG segment 7BW. Upon arrival to the component this QA observed that ZPMC personnel did not complete the required NDT after heat straightening prior to notifying QA of inspection. The weld designation affected number is SSD10-PP50-003/004.

ZPMC WQCP Section 11.2.5.1- Final NDT shall be performed after heat straightening.

Provide notification to the engineer when UT is to be completed. A response for the resolution of this issue is expected within 7 days.

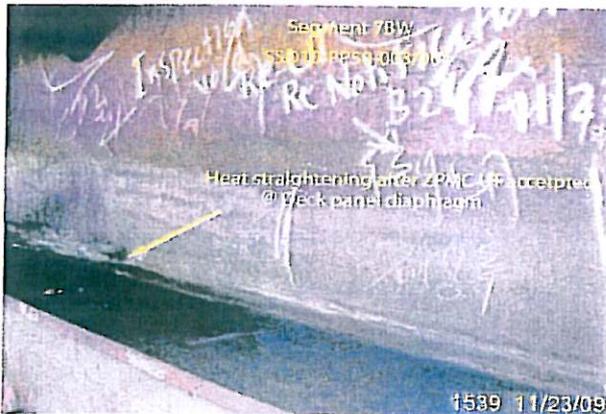
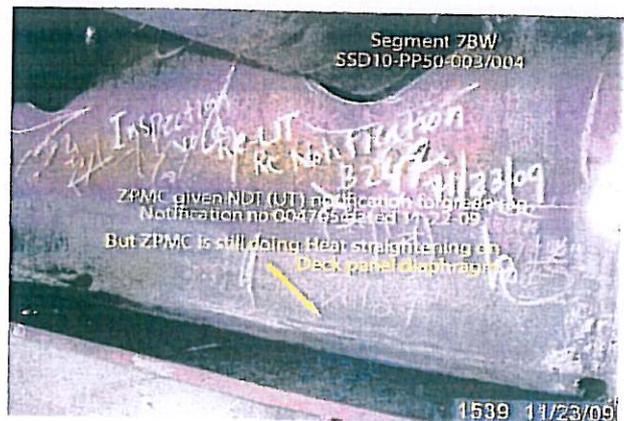
This QA inspector received Notice of Inspection number 004705 on 11-22-09 for the Ultrasonic Testing (UT) of the deck panel diaphragm to floor beam flange Complete Joint Penetration weld after heat straightening for OBG segment 7BW. Upon arrival to the component this QA observed that ZPMC personnel did not complete the required NDT after heat straightening prior to notifying QA of inspection. The weld designation affected number is SSD10-PP50-003/004.

ZPMC WQCP Section 11.2.5.1- Final NDT shall be performed after heat straightening.

The Contractor submitted a WRR referencing repairs made to the weld after the NCR was issued along with NDT documentation verifying the weld is in compliance with Contract specifications. ZPMC also issued an internal NCR regarding this issue. The weld maps have been revised to show the new weld number resulting from the fillet to CJP change, and the weld will be incorporated into the as-built drawings.

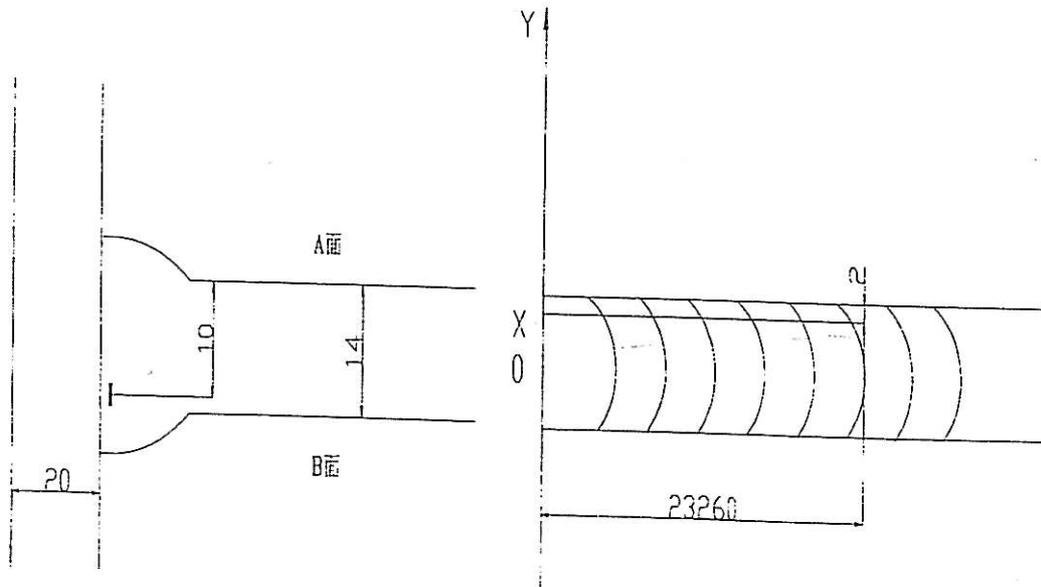
WELD NUMBER: SSD10-PP050-003

Rejected indication found by ultrasonic inspection is less than the maximum allowance aggregate length.

1. Did not clear the weld pass completely in time.

1. Gouge or grind from nearer side from metal edge ($D \leq 0.65T$, "D" is depth of defects, "T" is thickness of metal) to remove all defects;

2. Follow repair WPS for joint preparation, preheat, and weld deposit;

3. Verify with VT no defects remain in the weld joint prior to welding;

4. Grind the repaired area flush with base metal or the adjacent weld;

5. Check the welds according to the working drawings.
