QUALITY ASSURANCE -- NON-CONFORMANCE REPORT

Location: Changxing Island, Shanghai, P.R. China **Report No:** NCR-000522
Prime Contractor: American Bridge/Fluor Enterprises, a JV **Date:** 28-Nov-2009
Submitting Contractor: Zhenhua Port Machinery Company, Ltd (ZPMC), Changxing Island **NCR #:** ZPMC-0495

Welding	Concrete	Other	
Welding	Curing	Procedural	Bridge No: 34-0006
Joint fit-up	Coating	Other	Component: Crossbeam CB 11 Weld # FB204-032-069
Procedural	Procedural	Description: Missed UT indication

Job Name: SAS Superstructure

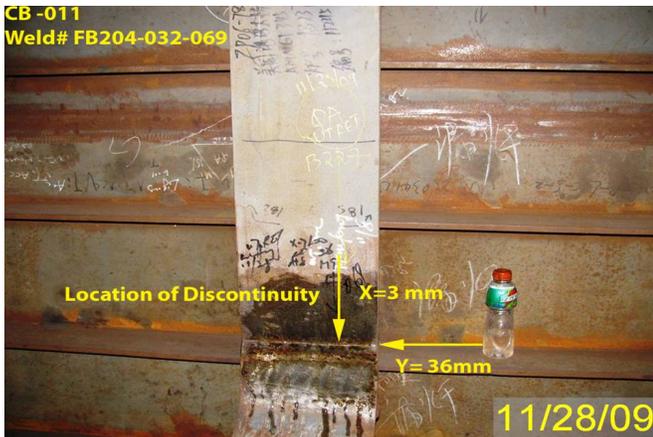
During random verification of Ultrasonic Testing (UT) on Complete Joint Penetration (CJP) butt joint on Crossbeam identified as CB11, this Quality Assurance Inspector (QA) discovered the following:

- One (1) Class "A" non conforming longitudinal indication measuring approximately 20 mm in length.
- The weld designation is identified as FB204-032-069.
- The CJP weld is joining floor beam diaphragm flanges identified as X206B to X203A.
- The member is located in Bay 5.
- The indication is in an area previously tested and accepted by ZPMC QC UT technicians.
- The Notice of Witness Inspection Number (NWIT) is 4753.
- Material thickness is 16mm.
- The discontinuity rating is +9, Class "A" reject
- Depth of the discontinuity from face A is approximately 9mm.

AWS D1.5-2002, Section 6, Table 6.3. specifies for material thicknesses 8mm through 20mm, a decibel (dB) indication rating of 10 dB or less shall be categorized as a Class A (large flaws) and any indication in this category shall be rejected (regardless of length).

Submit a repair plan to the engineer for approval.

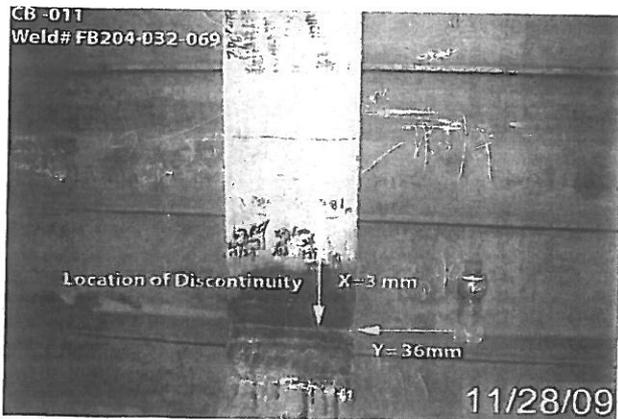
- During random verification of Ultrasonic Testing (UT) on Complete Joint Penetration (CJP) butt joint on Crossbeam identified as CB11, this Quality Assurance Inspector (QA) discovered the following:
- One (1) Class "A" non conforming longitudinal indication measuring approximately 20 mm in length.
 - The weld designation is identified as FB204-032-069.
 - The CJP weld is joining floor beam diaphragm flanges identified as X206B to X203A.
 - The member is located in Bay 5.
 - The indication is in an area previously tested and accepted by ZPMC QC UT technicians.
 - The Notice of Witness Inspection Number (NWIT) is 4753.
 - Material thickness is 16mm.
 - The discontinuity rating is +9, Class "A" reject
 - Depth of the discontinuity from face A is approximately 9mm.

AWS D1.5-2002, Section 6, Table 6.3. specifies for material thicknesses 8mm through 20mm, a decibel (dB) indication rating of 10 dB or less shall be categorized as a Class A (large flaws) and any indication in this category shall be rejected (regardless of length).

Repair said indication and perform NDT required to verify weld quality.

Contractor supplied WRR used during repair work along with subsequent NDT documentation verifying the weld now meets Contract weld quality requirements. Supplemental training was provided to NDT technicians by the Contractor's QCM as a means of enhancing technique to prevent future occurrences.

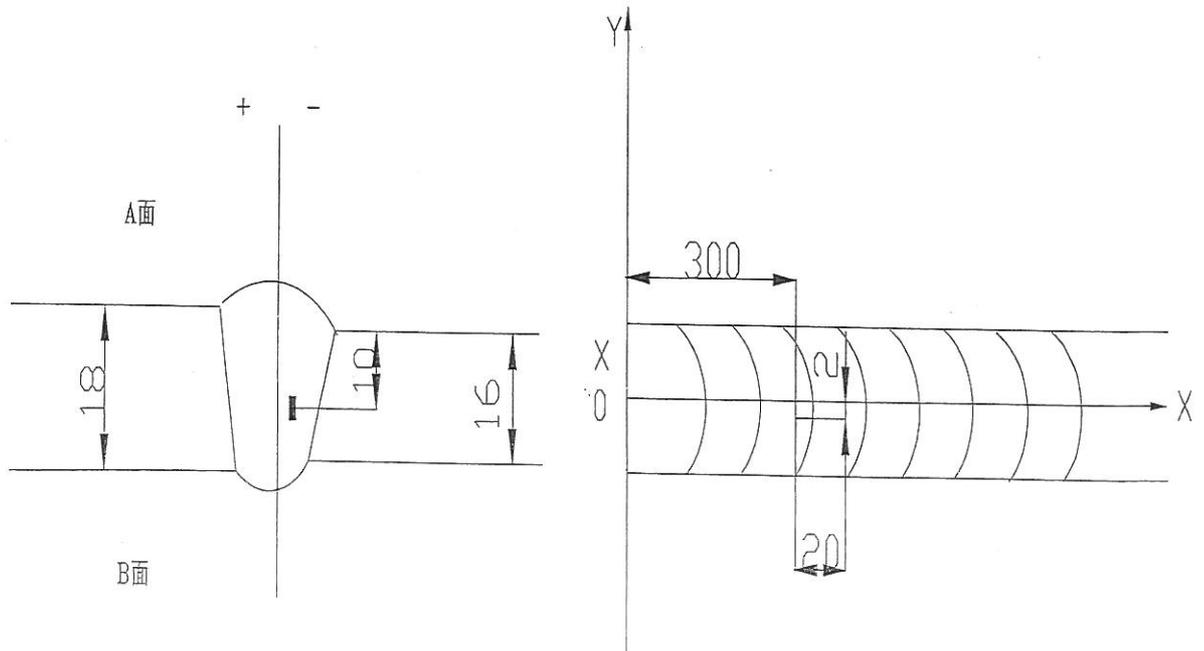
WELD NUMBER: FB204-032-069

Rejected indication found by ultrasonic inspection is less than the maximum allowance aggregate length.

1. Did not clear the weld pass completely in time.

1. Gouge or grind from nearer side from metal edge ($D \leq 0.65T$, "D" is depth of defects, "T" is thickness of metal) to remove all defects;

2. Follow repair WPS for joint preparation, preheat, and weld deposit;

3. Verify with VT no defects remain in the weld joint prior to welding;

4. Grind the repaired area flush with base metal or the adjacent weld;

5. Perform UT inspection to the weld along with 50mm on each end of the repair area;

1. Improve monitoring of welding and interpass cleaning.
