**QUALITY ASSURANCE -- NON-CONFORMANCE REPORT**

**Location:** Changxing Island, Shanghai, P.R. China**Report No:** NCR-000529**Prime Contractor:** American Bridge/Fluor Enterprises, a JV**Date:** 07-Dec-2009**Submitting Contractor:** Zhenhua Port Machinery Company, Ltd (ZPMC), Changxing Island**NCR #:** ZPMC-0502**Type of problem:**

<b>Welding</b>	<b>Concrete</b>	<b>Other</b>	
<b>Welding</b>	<b>Curing</b>	<b>Procedural</b>	<b>Bridge No:</b> 34-0006
<b>Joint fit-up</b>	<b>Coating</b>	<b>Other</b>	<b>Component:</b> OBG 5AW Deck Plate to Floor Beam
<b>Procedural</b>	<b>Procedural</b>	<b>Description:</b> Missed MT indication

**Reference Description:** MT indications discovered after the contractor has tested and accepted the welds in Segment 5AW

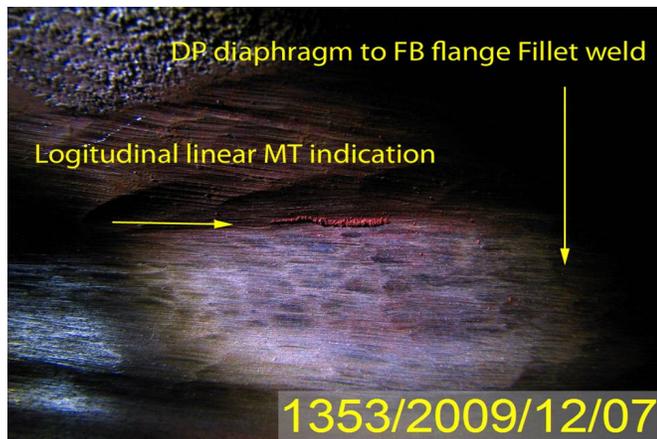
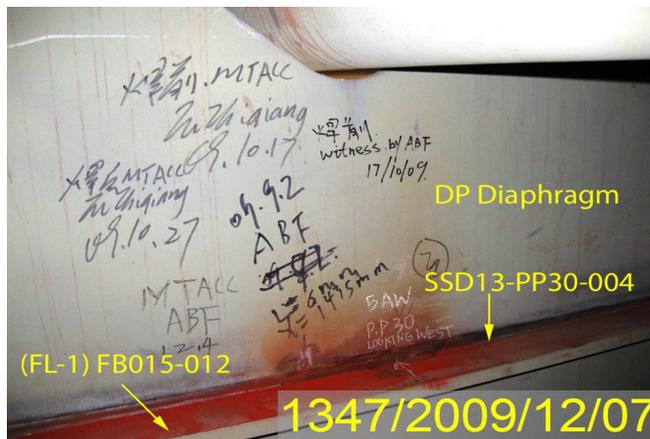
During the Quality Assurance Magnetic Particle Testing (MT) review of welds located in Segment 5AW on the Deck Plate (DP) diaphragm to Floor Beam (FB) flange repair areas, this Quality Assurance Inspector (QA) discovered the following issues:

- Two (2) longitudinal linear indications measuring approximately between 8mm to 11mm in length respectively.
- The welds are identified as: Weld # SSD13-PP30-004 and SSD14-PP31-005.
- The welds are Fillet welds joining the DP diaphragm web to the FB flange member.
- The member is located in the OBG Trial Assembly yard.

The Notice of Witness Inspection Number (NWIT) is ABF repair areas over check per MT report 12-05-09. The indication is located inside the area that has been previously tested and accepted by ZPMC Quality Control (QC) personnel. As per the contract documents, ZPMC's QC personnel are required to perform 100% inspection of this weld.

AWS D1.5 (02) Section 6.26.2 – “Welds that are subject to MT in addition to visual inspection shall have no cracks.

Submit a repair procedure to the engineer for approval. Missed MT indications are a chronic problem. Provide training for ZPMC MT technicians to improve competency and submit documentation of training. A response for the resolution of this issue is expected within 7 days.

ZPMC acknowledges the indication was missed by MT. The indication was removed by slight grinding and inspected and verified by CT as removed. As for the missed indications by MT, the ABF QCM has conducted MT training and discussed the several NCR's of missed indications with both the NDT operators and the ZPMC QA department. ZPMC requests closure of this NCR.
