**DEPARTMENT OF TRANSPORTATION**

Contract #: 04-0120F4Cty: SF/ALA Rte: 80 PM: 13.2/13.9File #: 69.25B**QUALITY ASSURANCE -- NON-CONFORMANCE REPORT****Location:** Changxing Island, Shanghai, P.R. China**Report No:** NCR-000533**Prime Contractor:** American Bridge/Fluor Enterprises, a JV**Date:** 11-Dec-2009**Submitting Contractor:** Zhenhua Port Machinery Company, Ltd (ZPMC), Changxing Island**NCR #:** ZPMC-0506**Type of problem:**

**Reference Description:** The fit-up of Floor Beam welds and cope holes deviated from the contract drawings in Segment 11EE

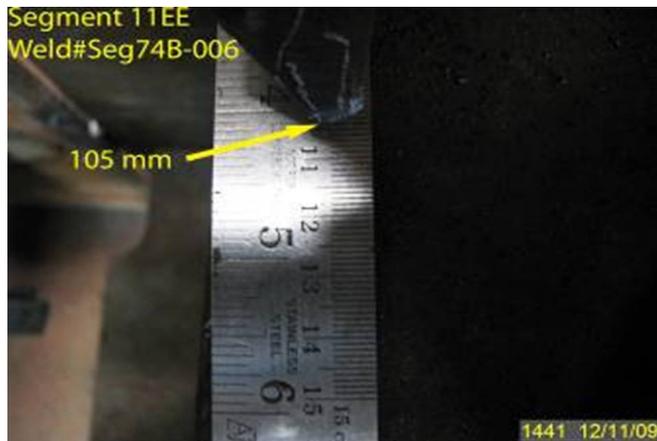
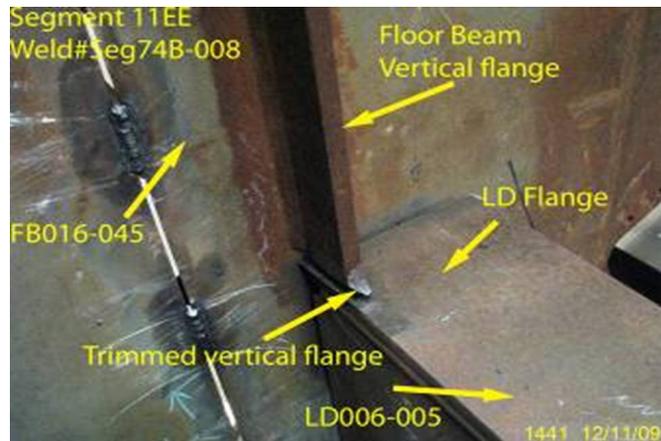
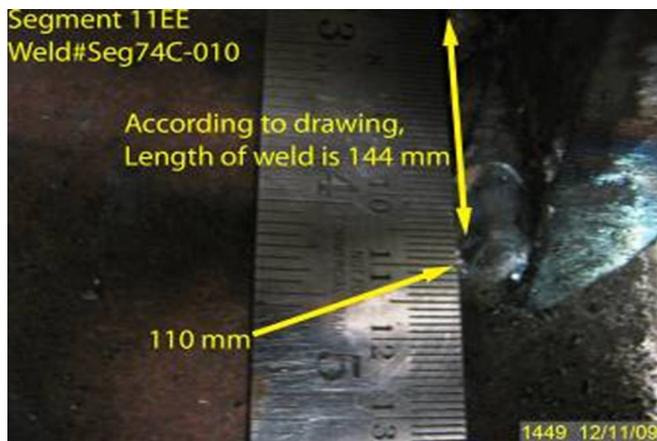
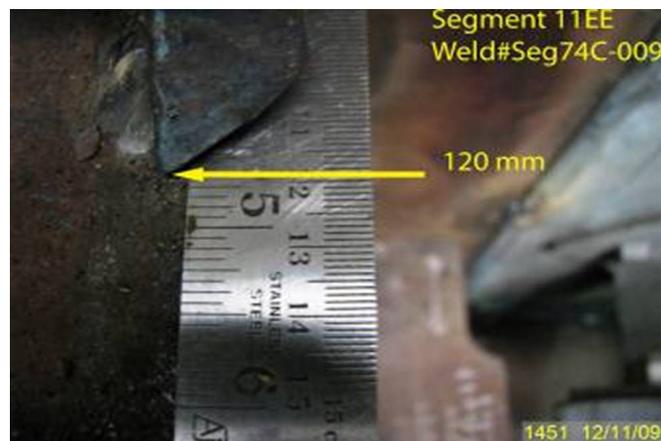
During a random visual inspection of segment 11EE located in Bay 14 of the Floor Beam (FB) vertical flanges to the Longitudinal Diaphragm (LD) flanges, the Quality Assurance (QA) Inspector discovered the following issues:

Due to fit-up issues, ZPMC has trimmed the FB vertical flanges, which reduced the designed radius and length of the partial joint penetration (PJP) welds. According to approved drawing the FB vertical flange should have a 50mm radius and the PJP welds should be 144 mm in length. This fabrication observed does not comply with approved drawing identified as X-7J.

1. Seg074B-006, @ Panel Point (PP)-107, Length of weld is 105 mm.
2. Seg074B-007, @ Panel Point (PP)-108, Length of weld is 115 mm.
3. Seg074B-008, @ Panel Point (PP)-108, Length of weld is 110 mm.
4. Seg074C-009, @ Panel Point (PP)-108, Length of weld is 120 mm.
5. Seg074C-010, @ Panel Point (PP)-108, Length of weld is 110 mm.
6. Seg074C-015, @ Panel Point (PP)-107, Length of weld is 115 mm.

AWS D1.5 2002 Section 3.1.4: Size and lengths of welds shall be no less than those specified by design requirements and detailed drawings except as by 6.26.1.7. The location of the welds shall not be changed without approval.

submit a repair procedure to the engineer for approval. A response for the resolution of this issue is expected within 7 days.

Where the base metal of the flange PL has been altered by any mechanical means (cut, grind, burn, etc.), the reentrant corner shall be transitioned at a 1:1 slope for the height of the PJP 11(8). A smooth transition of radius 25 mm or greater shall be provided at the start and finish of the 1:1 transition.

Reentrant corner was found to be acceptable with a minimum radius of 25mm. Reference ABF-RFI-002075R0

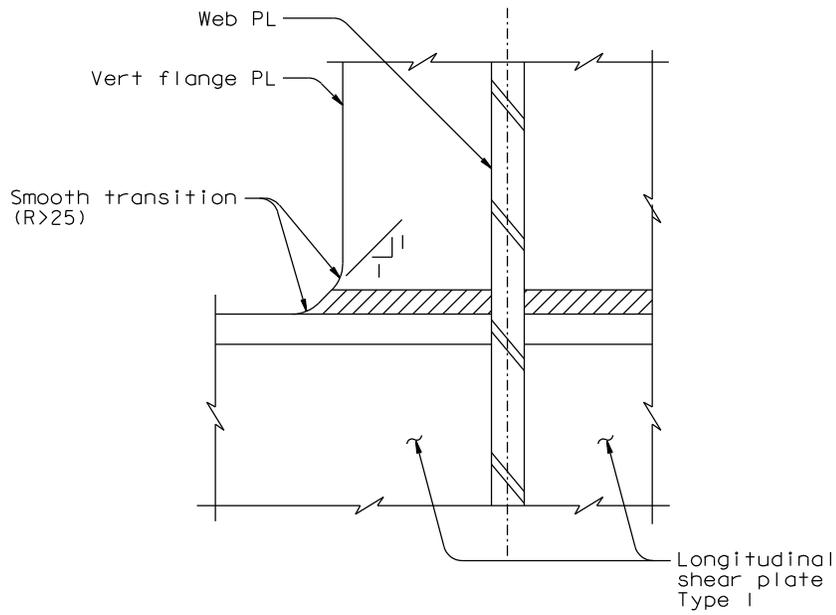
**DETAIL 2**  
NTS

The reentrant corner (flare) in the approved drawings specify a 50mm radius for the connection between vertical floorbeam flange (stiffener) X7J and Longitudinal Diaphragm flange plate X42A. It has been noted that at some locations the as-built reentrant corner is less than 50mm in radius. Per AWS D1.5 Section 3.2.4, ABFJV considers the minimum acceptable radius for a reentrant corner as 25mm provided there is a smooth transition that meets the adjacent edges. Please confirm this understanding is correct.

Where the base metal of the vertical flange PL has not been altered (cut, grind, burn, etc) after initial welding was preformed and the welding passed the NDT testing, no action is needed.

See attached sketch SK 2075R0-1.
