Contract #: 04-0120F4Cty: SF/ALA Rte: 80 PM: 13.2/13.9File #: 69.25B**QUALITY ASSURANCE -- NON-CONFORMANCE REPORT****Location:** Changxing Island, Shanghai, P.R. China**Report No:** NCR-000539**Prime Contractor:** American Bridge/Fluor Enterprises, a JV**Date:** 17-Dec-2009**Submitting Contractor:** Zhenhua Port Machinery Company, Ltd (ZPMC), Changxing Island**NCR #:** ZPMC-0512**Type of problem:**

**Reference Description:** Missed UT Indication by QC, Segment 8BW**Description of Non-Conformance:**

**Subject:** NCR No. ZPMC-0512

**Job Name:** SAS Superstructure

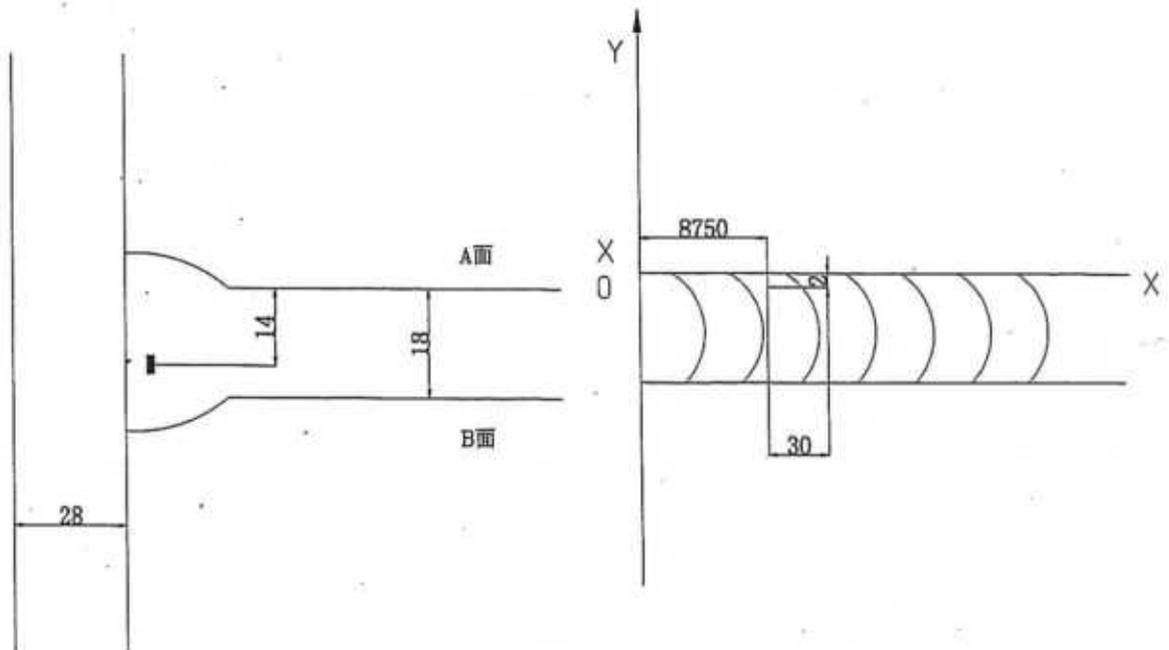
WELD NUMBER: CA053-003

Rejected indication found by ultrasonic inspection is less than the maximum allowance aggregate length.

(UT探伤发现的缺陷总长度小于最大允许长度。) CA053-003

1. 从缺陷距离端面较近一侧 ( $D \leq 0.65T$ , D为缺陷深度, T为板厚) 采用碳刨或打磨的方法去除焊缝缺陷;
  2. 参照返修焊接工艺规程 (WPS) 准备正确的接头型式, 预热和焊接;
  3. 焊前对修补区域进行VT检测保证缺陷完全被消除;
  4. 将修补区域打磨到与母材或邻近焊缝平齐;
  5. 对焊缝进行UT检测, 检测范围为返修区域以及其两端各延长50mm.
- 
1. Gouge or grind from nearer side from metal edge ( $D \leq 0.65T$ , "D" is depth of defects, "T" is thickness of metal) to remove all defects;
  2. Follow repair WPS for joint preparation, preheat, and weld deposit;
  3. Verify with VT no defects remain in the weld joint prior to welding;
  4. Grind the repaired area flush with base metal or the adjacent weld;
  5. Perform UT inspection to the weld along with 50mm on each end of the repair area;

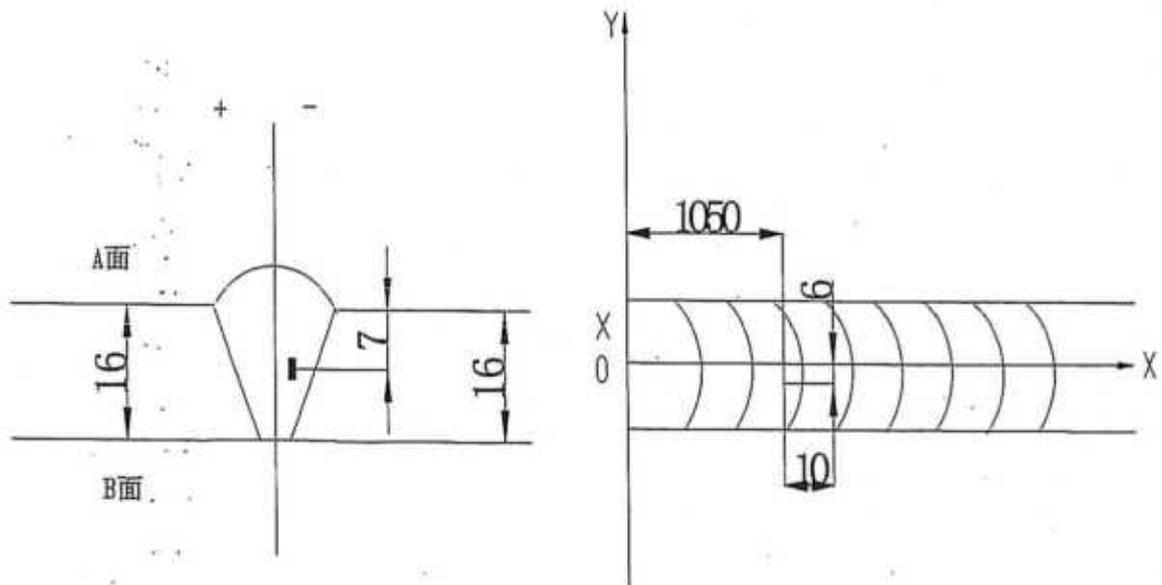
WELD NUMBER: SEG047B-013

Rejected indication found by ultrasonic inspection is less than the maximum allowance aggregate length.

(UT探伤发现的缺陷总长度小于最大允许长度。) SEG047B-013

1. Gouge or grind from nearer side from metal edge ( $D \leq 0.65T$ , "D" is depth of defects, "T" is thickness of metal) to remove all defects;

2. Follow repair WPS for joint preparation, preheat, and weld deposit;

3. Verify with VT no defects remain in the weld joint prior to welding;

4. Grind the repaired area flush with base metal or the adjacent weld;

5. Perform UT inspection to the weld along with 50mm on each end of the repair area;
