**DEPARTMENT OF TRANSPORTATION**  
 DIVISION OF ENGINEERING SERVICES  
 Office of Structural Materials  
 Quality Assurance and Source Inspection

## QUALITY ASSURANCE -- NON-CONFORMANCE REPORT

**Report No:** NCR-000540

**Reference Description:** Fillet Weld Excavation with Final QC Acceptance, Crossbeam CB17

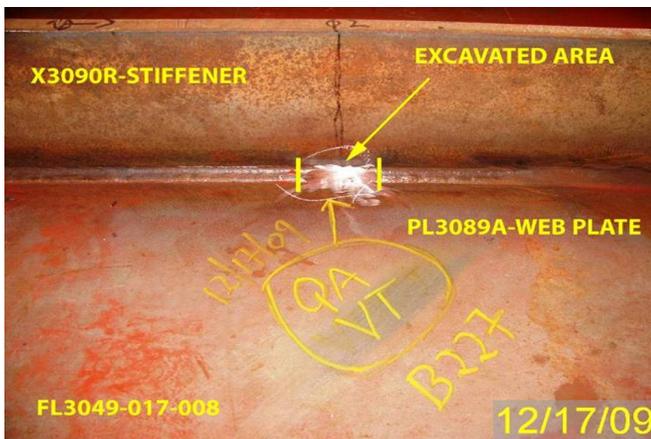
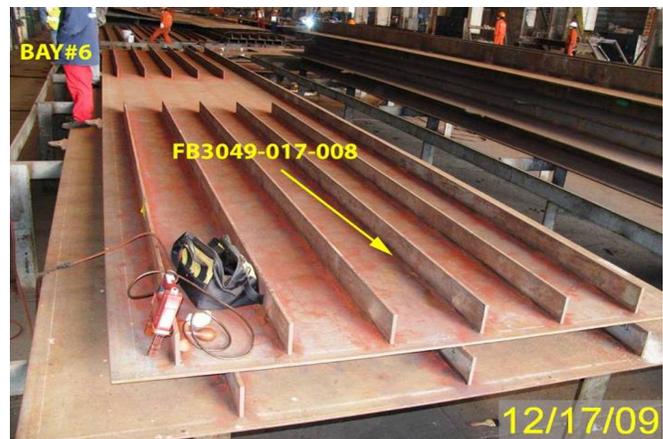
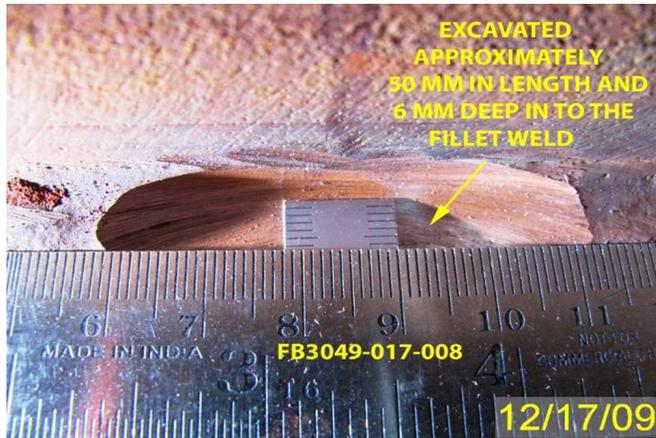
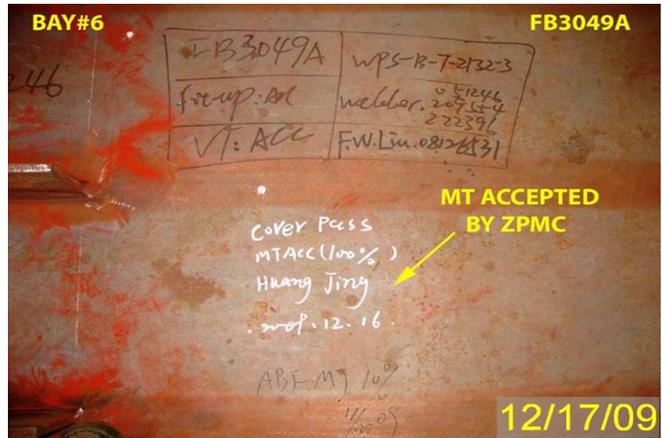
During a random in-process visual verification prior to performing Magnetic Particle Testing (MT) on a Floor Beam (FB) for Crossbeam CB17 located at Bay # 6, the Caltrans Quality Assurance (QA) Inspector observed a fillet weld that had been excavated approximately 50 mm in length and 6 mm in depth. The contractor (ZPMC) offered a formal NDT Inspection Notification Sheet, acknowledging the weld was complete and that ZPMC MT technicians had tested and accepted 100% MT on this FB. Additional information identifying the non-conformance is listed below.

- The Floor Beam is identified as FB3049-017-008.
- The fillet weld connects the FB Web Plate (PL3089A) to FB Stiffener (X3090R).
- The fillet weld size is 6 mm in size per the approved contract drawings.
- The NDT Inspection Notification Sheet request number was identified as: 004835

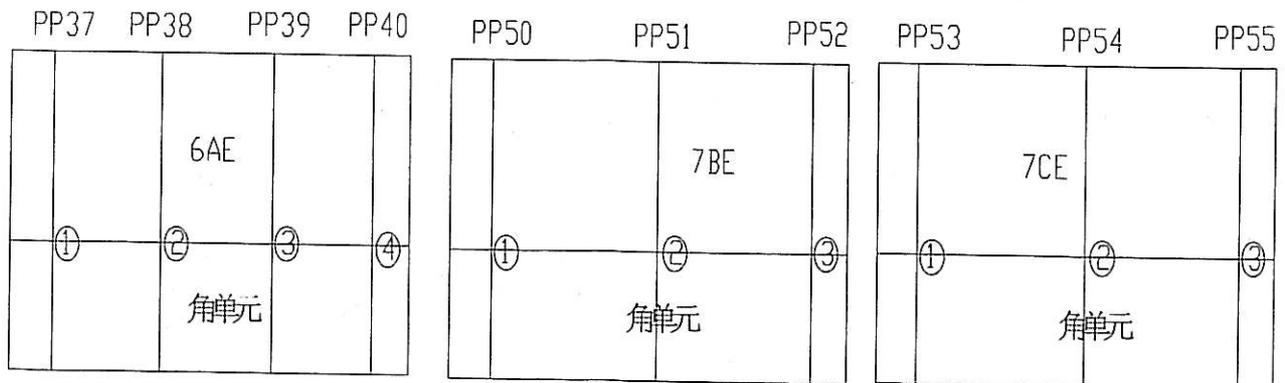
**Draft of welding discontinuity:**

According to inspection report 1075# disposition, it shall build up 6AE/7BE/7CE relevant position to ensure flatness, see the following draft.

Weld distortion and fabricate error.

1. Remove all the defects according to the approved repair WPS by means of grinding.
2. Verify with MT and VT no defects remain in the repair area prior to weld;
3. Preheat and weld according to the relevant WPS.
4. Grind the weld flush with base metal after welding.
5. Perform VT and MT inspection of the repaired area.

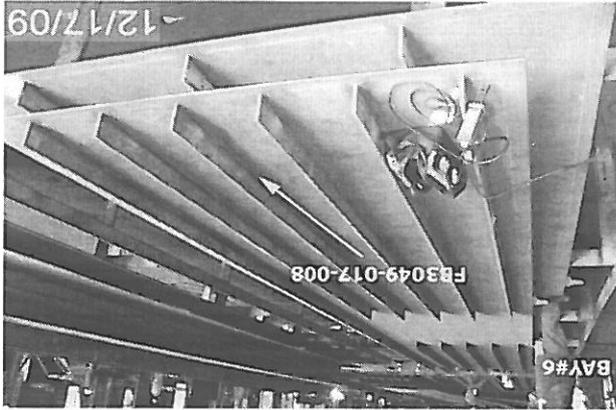
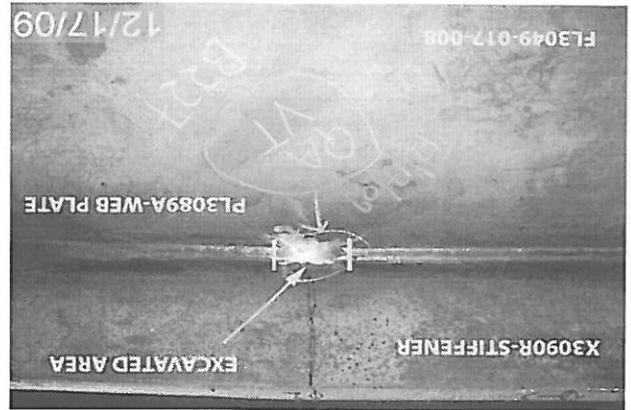
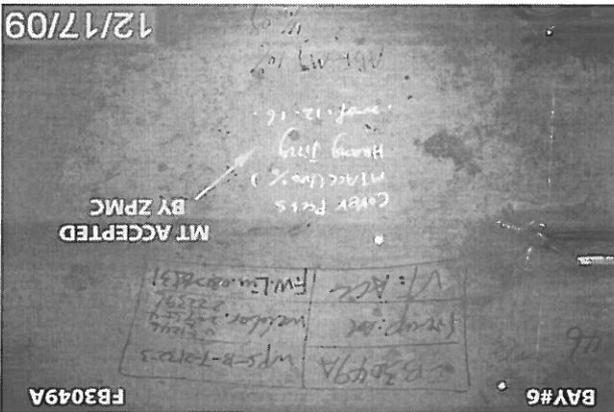
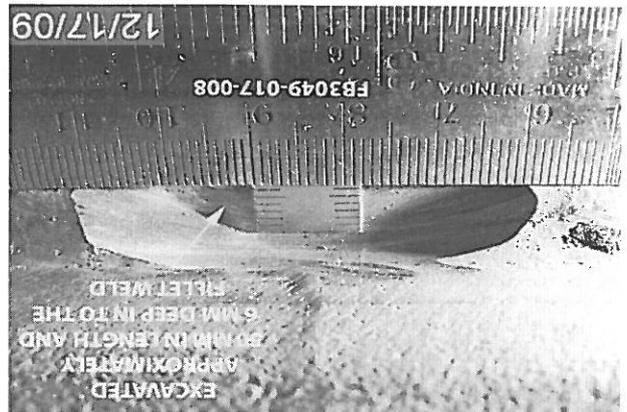
- The Floor Beam is identified as FB3049-017-008.
- The fillet weld connects the FB Web Plate (PL3089A) to FB Stiffener (X3090R).
- The fillet weld size is 6 mm in size per the approved contract drawings.
- The NDT Inspection Notification Sheet request number was identified as: 004835

During a random in-process visual verification prior to performing Magnetic Particle Testing (MT) on a Floor Beam (FB) for Crossbeam CB17 located at Bay # 6, the Caltrans Quality Assurance (QA) Inspector observed a fillet weld that had been excavated approximately 50 mm in length and 6 mm in depth. The contractor (ZPMC) offered a formal NDT Inspection Notification Sheet, acknowledging the weld was complete and that ZPMC MT technicians had tested and accepted 100% MT on this FB. Additional information identifying the non-conformance is listed below.

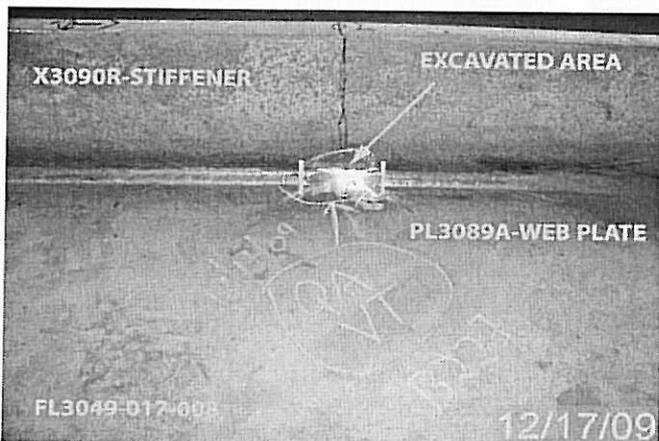
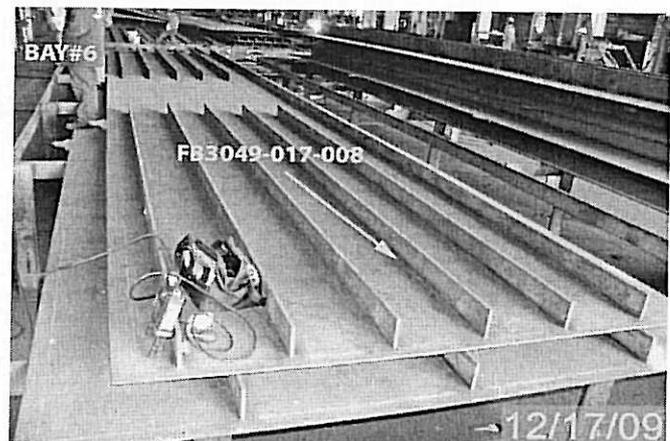
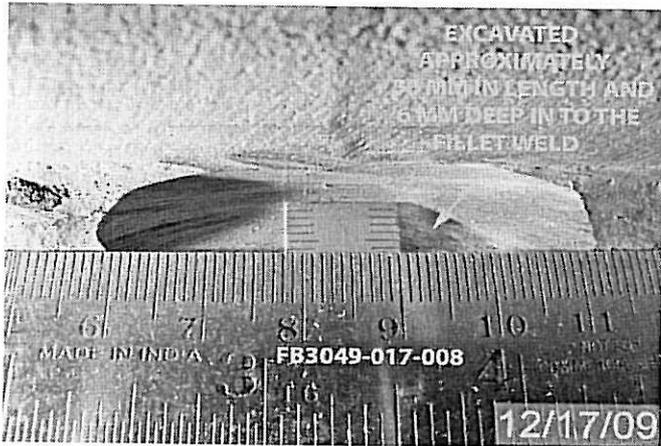
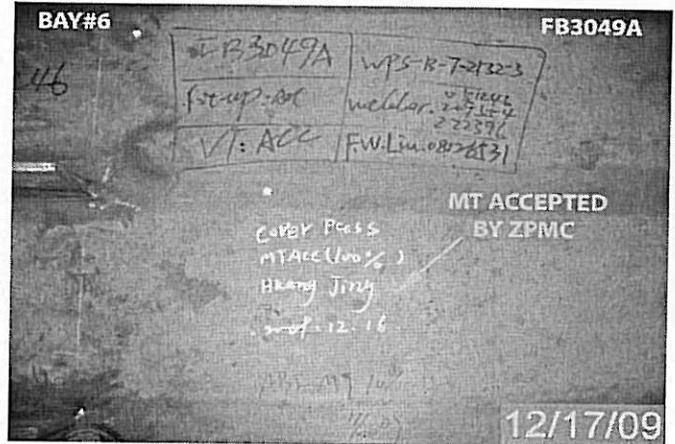
During a random in-process visual verification prior to performing Magnetic Particle Testing (MT) on a Floor Beam (FB) for Crossbeam CB17 located at Bay # 6, the Caltrans Quality Assurance (QA) Inspector observed a fillet weld that had been excavated approximately 50 mm in length and 6 mm in depth. The contractor (ZPMC) offered a formal NDT Inspection Notification Sheet, acknowledging the weld was complete and that ZPMC MT technicians had tested and accepted 100% MT on this FB. Additional information identifying the non-conformance is listed below.

- The Floor Beam is identified as FB3049-017-008.
- The fillet weld connects the FB Web Plate (PL3089A) to FB Stiffener (X3090R).
- The fillet weld size is 6 mm in size per the approved contract drawings.
- The NDT Inspection Notification Sheet request number was identified as: 004835

Repair said excavation and perform NDT required to verify weld quality.
