Contract #: 04-0120F4  
 Cty: SF/ALA Rte: 80 PM: 13.2/13.9  
 File #: 69.25B

**QUALITY ASSURANCE -- NON-CONFORMANCE REPORT**

**Location:** Changxing Island, Shanghai, P.R. China **Report No:** NCR-000547  
**Prime Contractor:** American Bridge/Fluor Enterprises, a JV **Date:** 15-Dec-2009  
**Submitting Contractor:** Zhenhua Port Machinery Company, Ltd (ZPMC), Changxing Island **NCR #:** ZPMC-0520

**Reference Description:** Missed UT Indication by QC, Segment 7CW

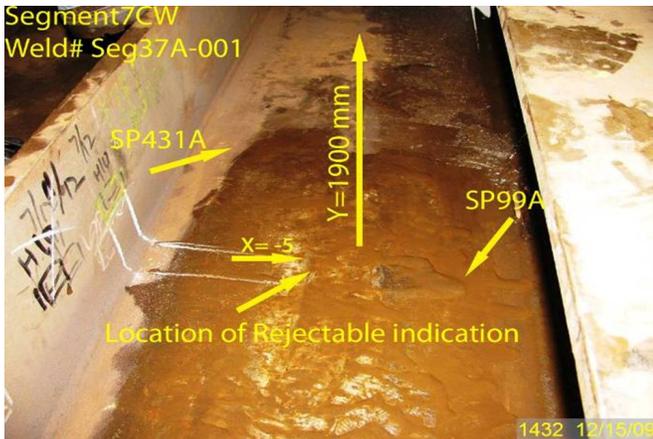
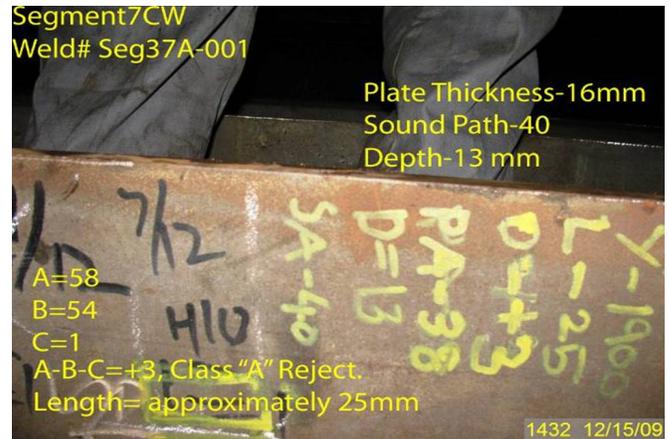
During the Quality Assurance Ultrasonic Testing (UT) review of weld located on OBG Segment 7CW, this Quality Assurance Inspector (QA) discovered the following issue:

- A total of one (1) rejectable Class "A" indication measuring approximately 25mm in length.
  - The Weld is a complete joint penetration (CJP) Butt Weld joining Side Plate SP99A to SP431A and is identified as SEG37A-001.
  - The Segment is located in the repair yard north of the blast shop.
- The Notice of Witness Inspection Number (NWIT) is 004866. The indication is located inside the area that has been previously tested and accepted by ZPMC Quality Control (QC) personnel. As per the contract documents, ZPMC's QC personnel are required to perform 100% (UT) inspection of this splice weld.

Submit a repair plan to the engineer for approval. A response for the resolution of this issue is expected within 7 days.

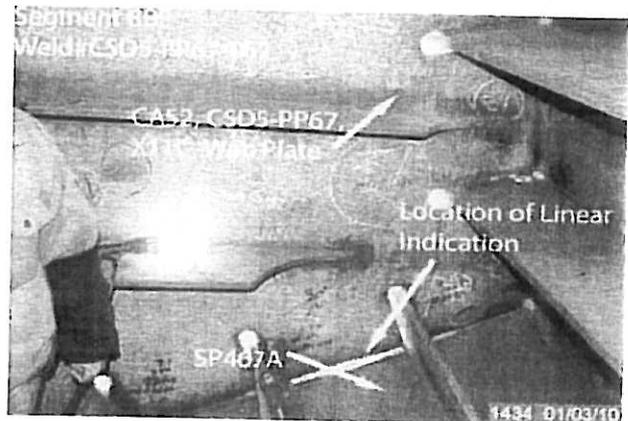
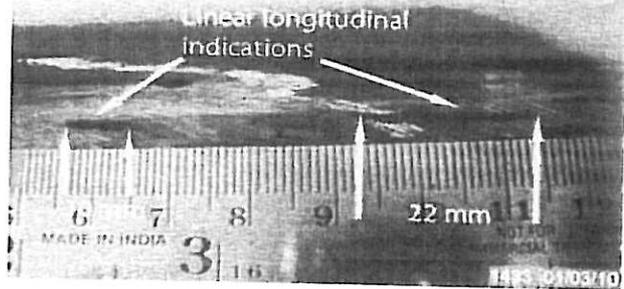
- Two (2) Longitudinal linear indication measuring approximately 22mm and 35mm in length.
- The welds are identified as: CSD5-PP67-052 (22 mm) and CSD5-PP67-026 (35 mm).
- The welds are a Fillet Weld type joining the Side Plate (SP467A) and Edge Plate (EP95A) stiffeners to Corner Assembly (CA52A) web plates.
- The OBG 8BE segment is located outside in front of the Blast Shop.

The Notice of Witness Inspection Number (NWIT) is 004978. The indication is located inside the area that has been previously tested and accepted by ZPMC Quality Control (QC) personnel. ZPMC's QC personnel are required to perform twenty five (25%) percent MT inspection of this weld.
