Contract #: 04-0120F4  
 Cty: SF/ALA Rte: 80 PM: 13.2/13.9  
 File #: 69.25B

## QUALITY ASSURANCE -- NON-CONFORMANCE REPORT

**Report No:** NCR-000548

**Reference Description:** Improper Weld Preheat, Segment 9BW

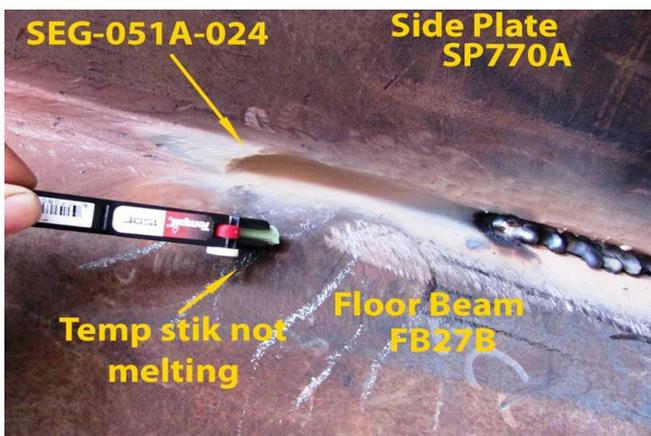
During a random visual inspection of Shielded Metal Arc Welding (SMAW 4G) on Segment 9BW, the Caltrans Quality Assurance (QA) Inspector observed ZPMC personnel in-process of welding a complete joint penetration (CJP) weld without achieving the required preheat temperature of 60 degree C as per approved welding procedure specification (WPS).

- 1) The WPS was identified as: WPS-B-C-2214-Tc-U4b-FCM-1
- 2) The weld joint was identified as: SEG-051A-024
- 3) Side Panel (SP) plate is identified as: SP770A
- 4) Floor Beam (FB) plate is identified as: FB27B
- 5) The welder was identified as: Welder ID # 066413
- 6) This material being welded is A709 Grade 345 Seismic Performance Critical Material (SPCM).
- 7) The weld is located between the SP770A to FB27B Cross Beam (CB) side at PP76.

Submit a repair procedure to the engineer for approval. Instruct welder regarding how to achieve the correct preheat. A response for the resolution of this issue is expected within 7 days.
