QUALITY ASSURANCE -- NON-CONFORMANCE RESOLUTION

Location: Changxing Island, Shanghai, P.R. China**Report No:** NCS-000523**Prime Contractor:** American Bridge/Fluor Enterprises, a JV**Date:** 11-Mar-2010**Submitting Contractor:** Zhenhua Port Machinery Company, Ltd (ZPMC), Changxing Island **NCR #:** ZPMC-0522**Type of problem:**

Job Name: SAS Superstructure
Document No: 05.03.06-000510

Reference Description: Missed UT Indication by QC, Segment 7CW

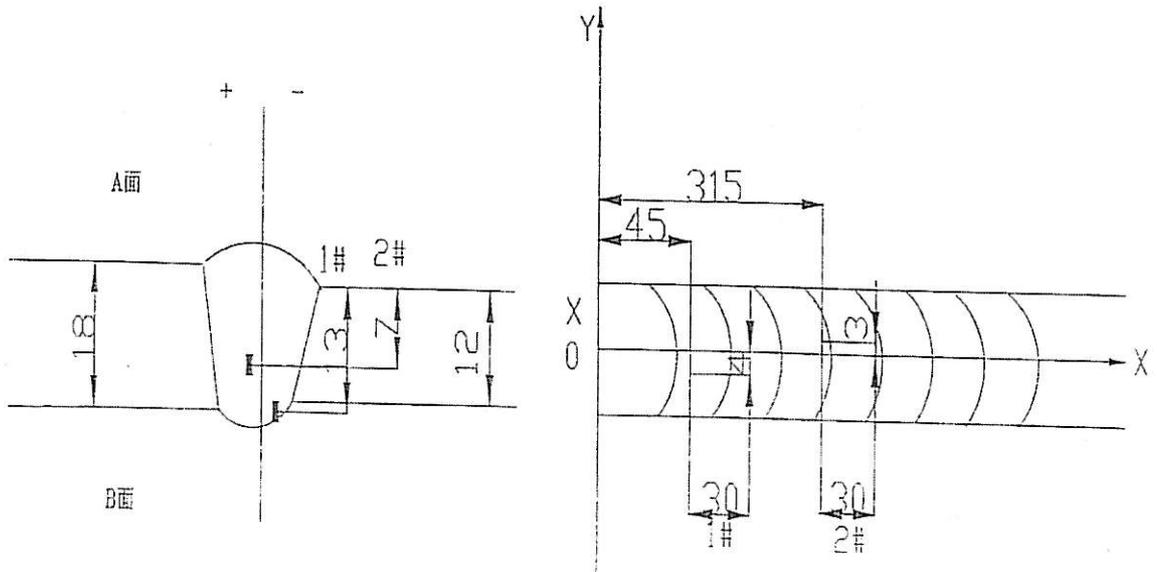
WELD NUMBER: SSD13A-PP54-007

Rejected indication found by ultrasonic inspection is less than the maximum allowance aggregate length.

(UT探伤发现的缺陷总长度小于最大允许长度。) SSD13A-PP54-007

1、焊道未及时处理干净。

1. Did not clear the weld pass completely in time.

1. 从缺陷距离端面较近一侧 ($D \leq 0.65T$, D为缺陷深度, T为板厚) 采用碳刨或打磨的方法去除焊缝缺陷;
2. 参照返修焊接工艺规程 (WPS) 准备正确的接头型式, 预热和焊接;
3. 焊前对修补区域进行VT检测保证缺陷完全被消除;
4. 将修补区域打磨到与母材或邻近焊缝平齐;
5. 对焊缝进行UT检测, 检测范围为返修区域以及其两端各延长50mm。

1. Gouge or grind from nearer side from metal edge ($D \leq 0.65T$, "D" is depth of defects, "T" is thickness of metal) to remove all defects;
2. Follow repair WPS for joint preparation, preheat, and weld deposit;
3. Verify with VT no defects remain in the weld joint prior to welding;
4. Grind the repaired area flush with base metal or the adjacent weld;
5. Perform UT inspection to the weld along with 50mm on each end of the repair area.

1. Improve monitoring of welding and interpass cleaning.
