Contract #: 04-0120F4  
 Cty: SF/ALA Rte: 80 PM: 13.2/13.9  
 File #: 69.25B

## QUALITY ASSURANCE -- NON-CONFORMANCE REPORT

**Report No:** NCR-000550

**Reference Description:** Base Metal Repairs without Engineer's Approval, Segment 9AW

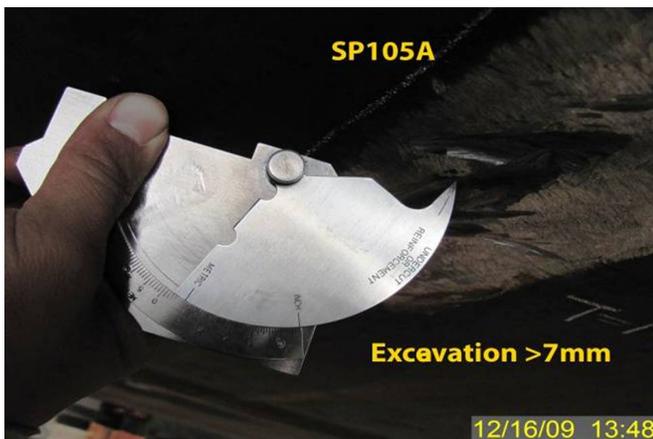
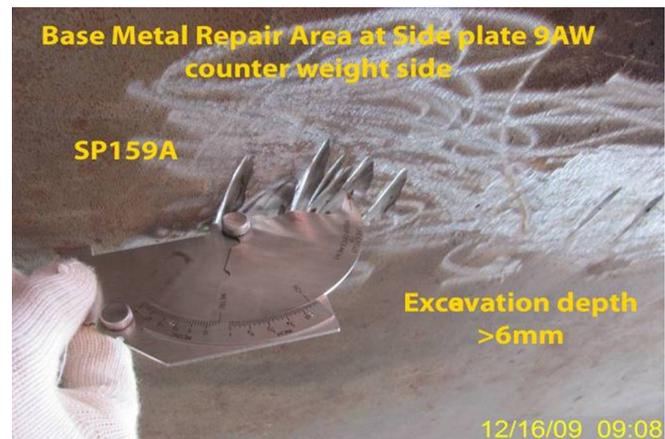
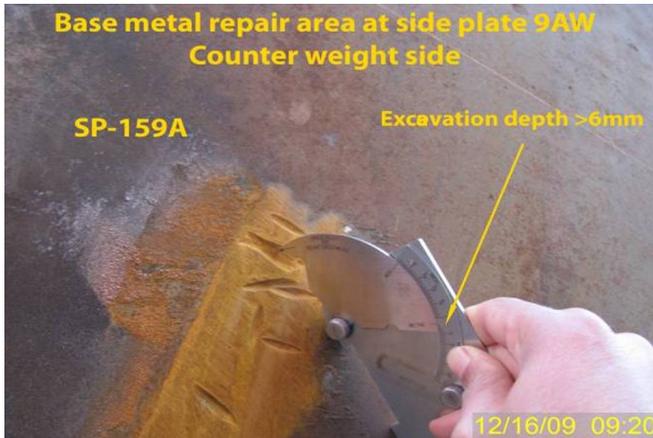
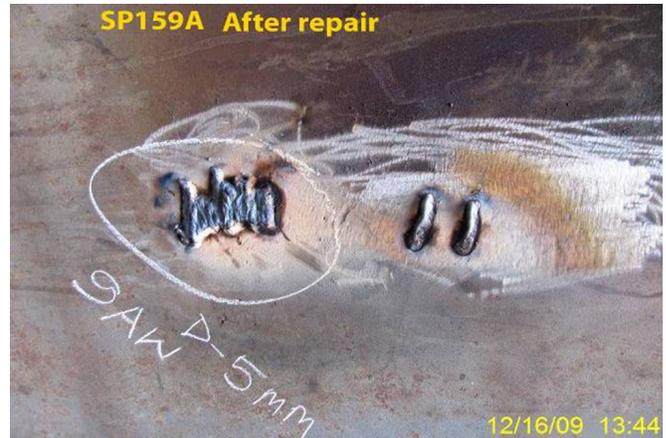
During a random in-process visual inspection at Segment 9AW of Side Panel (SP) temporary attachment removal areas, the Caltrans Quality Assurance (QA) Inspector observed ZPMC personnel performing excavations and Shielded Metal Arc Welding (SMAW) for approximately fifty (50) base metal repairs on SP's without prior approval of the Engineer.

- 1) The Side Plates were identified as: SP105A, SP132A and SP159A
- 2) The un-approved base metal repairs were located between PP72 and PP73 on the Counter Weight side.
- 3) These base metal repairs were caused by removal of temporary attachments.
- 4) ZPMC performed base metal repairs without the prior approval of the Engineer.

Submit a repair procedure to the engineer for approval. A response for the resolution of this issue is expected within 7 days.

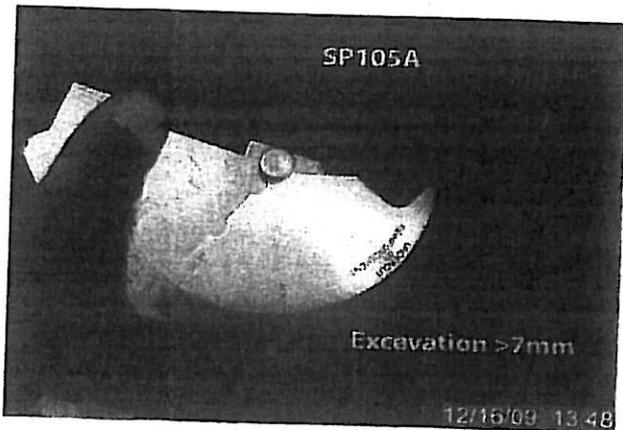
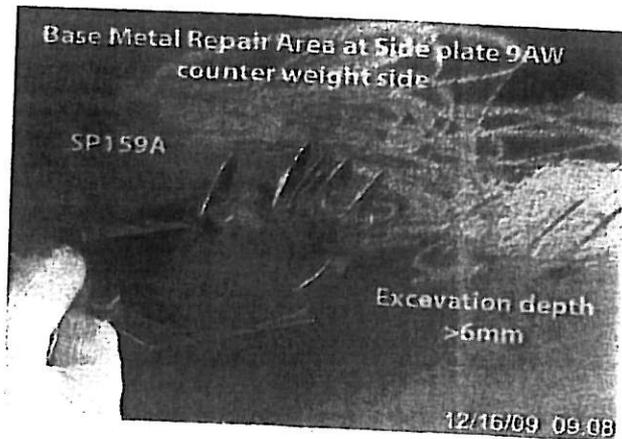
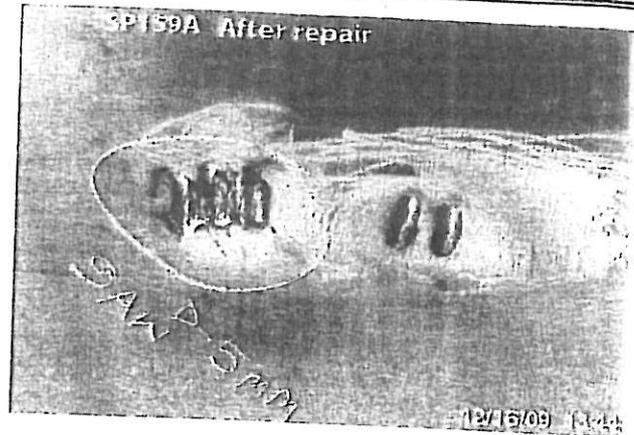
During a random in-process visual inspection at Segment 9AW of Side Panel (SP) temporary attachment removal areas, the Caltrans Quality Assurance (QA) Inspector observed ZPMC personnel performing excavations and Shielded Metal Arc Welding (SMAW) for approximately fifty (50) base metal repairs on SP's without prior approval of the Engineer.

- 1) The Side Plates were identified as: SP105A, SP132A and SP159A
- 2) The un-approved base metal repairs were located between PP72 and PP73 on the Counter Weight side.
- 3) These base metal repairs were caused by removal of temporary attachments.
- 4) ZPMC performed base metal repairs without the prior approval of the Engineer.

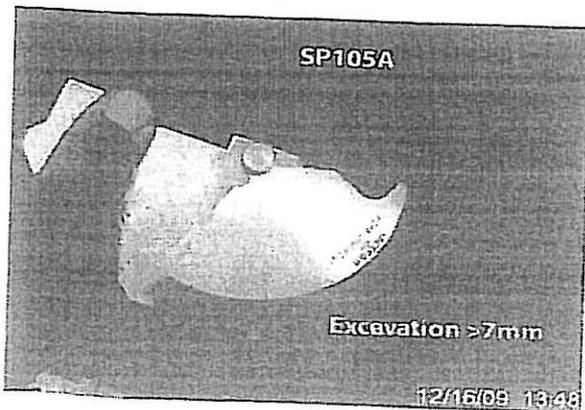
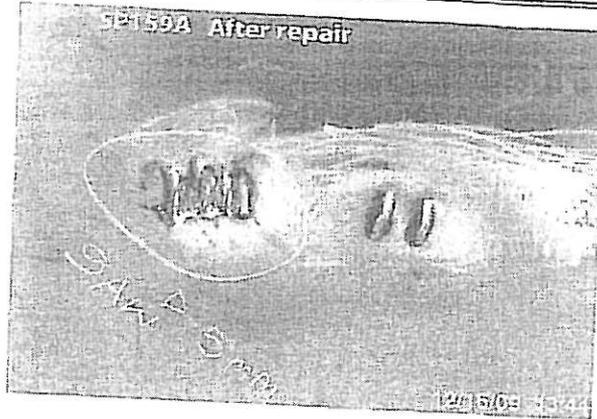
During a random in-process visual inspection at Segment 9AW of Side Panel (SP) temporary attachment removal areas, the Caltrans Quality Assurance (QA) Inspector observed ZPMC personnel performing excavations and Shielded Metal Arc Welding (SMAW) for approximately fifty (50) base metal repairs on SP's without prior approval of the Engineer.

- 1) The Side Plates were identified as: SP105A, SP132A and SP159A
- 2) The un-approved base metal repairs were located between PP72 and PP73 on the Counter Weight side.
- 3) These base metal repairs were caused by removal of temporary attachments.
- 4) ZPMC performed base metal repairs without the prior approval of the Engineer.
