Contract #: 04-0120F4Cty: SF/ALA Rte: 80 PM: 13.2/13.9File #: 69.25B**QUALITY ASSURANCE -- NON-CONFORMANCE REPORT****Location:** Changxing Island, Shanghai, P.R. China**Report No:** NCR-000552**Prime Contractor:** American Bridge/Fluor Enterprises, a JV**Date:** 19-Dec-2009**Submitting Contractor:** Zhenhua Port Machinery Company, Ltd (ZPMC), Changxing Island**NCR #:** ZPMC-0525**Type of problem:****Welding****Concrete****Other****Welding****Curing****Procedural****Bridge No:** 34-0006**Joint fit-up****Coating****Other****Component:** Segment 8CE Bottom Panels**Procedural****Procedural****Description:**

**Reference Description:** ZPMC performed base metal repairs on Segment 8CE Side panels without the prior approval of the Engineer

**Job Name:** SAS Superstructure

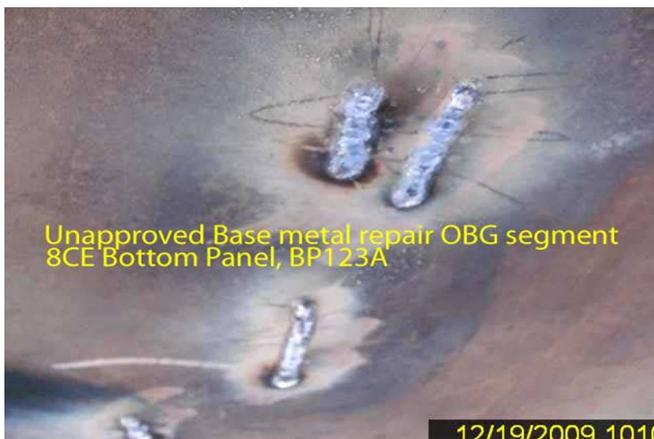
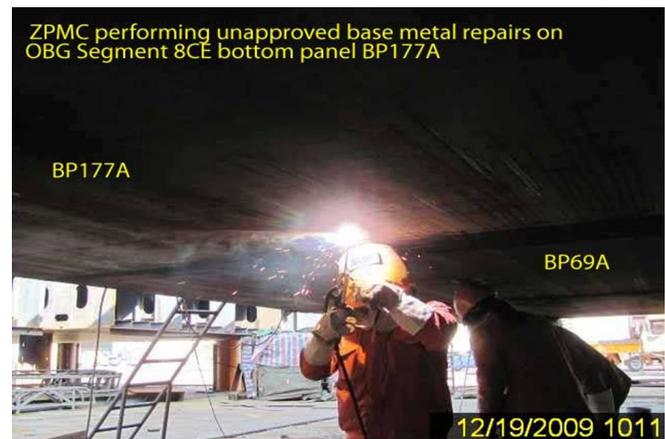
During a random visual inspection at OBG Segment 8CE of Seismic Performance Critical Members (SPCM) Bottom Panels (BP), the Quality Assurance (QA) Inspector observed ZPMC performing unapproved base metal repairs on SPCM BP's at temporary attachment removal areas. Approximately fifty (50) areas have been excavated and ten (10) areas have been welded prior to the QA inspector's arrival. Additional information about the non-conforming base metal repairs are listed below.

- 1) The BP's are identified as: BP177A, BP069A and BP123A
- 2) The material was identified as: A709 Grade 345 SPCM
- 3) The locations of these non-conformance were located between PP67 to PP71.
- 4) ZPMC performed base metal repairs without the prior approval of the Engineer.

For all subsequent base metal repairs, notify the engineer prior to the start of work. Submit weld test information to the engineer for this repair. A response for the resolution of this issue is expected within 7 days.

**Reference Resolution:** ZPMC is providing NDT documentation of the base metal after repairs to show that it is acceptable. In the future prior notification will be given to Caltrans to prevent this from occurring again.
