Contract #: 04-0120F4
 Cty: SF/ALA Rte: 80 PM: 13.2/13.9
 File #: 69.25B

QUALITY ASSURANCE -- NON-CONFORMANCE REPORT

Location: Changxing Island, Shanghai, P.R. China **Report No:** NCR-000554
Prime Contractor: American Bridge/Fluor Enterprises, a JV **Date:** 21-Dec-2009
Submitting Contractor: Zhenhua Port Machinery Company, Ltd (ZPMC), Changxing Island **NCR #:** ZPMC-0527

Reference Description: Segment 12AE, Two Transverse Indications discovered with the MT method after the contractor's acceptance

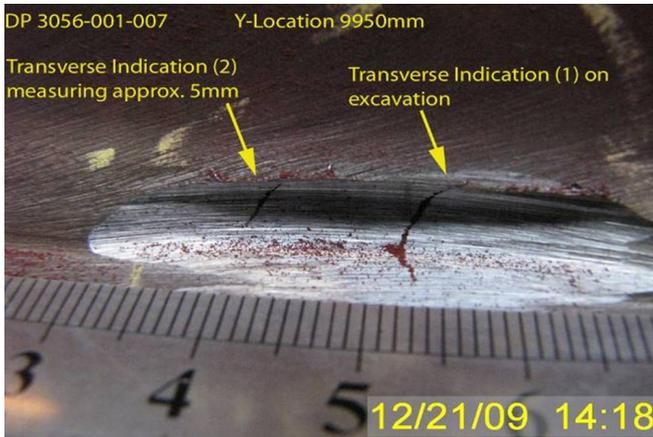
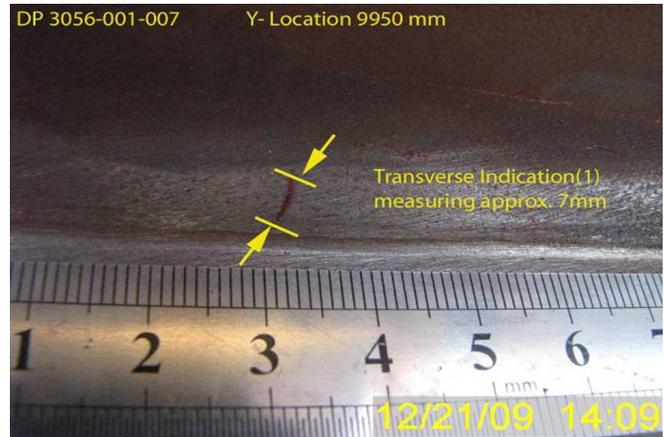
- Two (2) transverse indications measuring approximately 7mm in length at Y location 9950mm.
- The weld is identified as: DP 3056-001-007.
- The Weld is a Partial Joint Penetration (PJP) tee weld joining the rib stiffener (RS3032C) to the deck plate (PL3119A).
- The member is located in the deck panel repair yard.

The Notice of Witness Inspection Number (NWIT) is 004908. The indication is located inside the area that has been previously tested and accepted by ZPMC Quality Control (QC) personnel. As per the contract documents, ZPMC's QC personnel are required to perform twenty-five (25) percent MT inspection of this weld.

AWS D1.5 (02) Section 6.26.2 – “Welds that are subject to MT in addition to visual inspection shall have no cracks.

Submit a repair procedure to the engineer for approval. Missed MT indications are a chronic problem. Provide training for the ZPMC MT technician that missed these two indications and provide documentation of such training to the engineer. A response for the resolution of this issue is expected within 7 days.

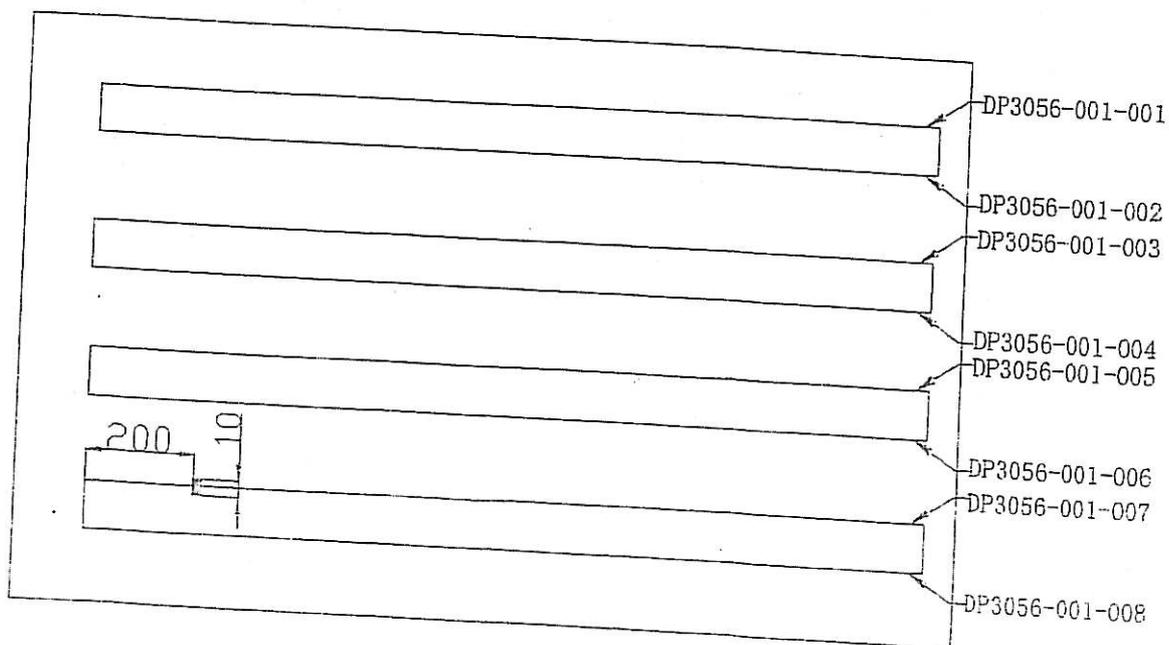
One transverse crack was found by use of MT on DP3056-001-007.

1. 火焰加热时, 水汽没有完全的去除或者这个区域预热不够;
1. Moisture wasn't completely removed during drying operation (preheating) or the area wasn't preheated sufficiently.

12. 在焊缝冷却至环境温度至少经过48小时以后进行NDT检查;
 13. 返修后根据图纸进行MT检测, 并按照合同10-1.59“钢结构”中的“检测和试验”要求进行附加MT检测。
1. QC and a Lead CWI shall be present, direct and supervise all grinding and welding operations during this repair to ensure the repair is per the disposition requirements

2. QC and a Lead CWI shall have an approved copy of the CWR in hand prior to the repair.
 3. Remove paint ≥ 25 mm in all direction of HAZ prior to MT.
 4. Clean the excavation area of all loose debris including MT powder. Preheat to 65° C before removing cracks by grinding, repair area shall extend a minimum of 50mm beyond each end of single crack repairs.

5. If base metal is damaged by grinding, the damaged area shall be ground clean prior to performing weld repair. If gap > 5mm is found during or after grinding, comply with the notification on changing fillet weld to CJP which is submitted for Engineer's review and approval form.

6. Prepare excavation in accordance with the New Repair Procedure prior to welding.
 7. Before this repair, Verify with VT and MT repair areas are defects free, and also MT shall be performed on the base metal laying abroad cracks to ensure that no cracks were propagated to the base metal. Separate CWR approval is needed if cracks are found in the base metal, and only after this new CWR's approval can continue the repair.

8. Clean excavation area of all loose debris including MT powder after excavation. Preheat and weld according to repair WPS, the preheat shall between 160° C—230° C.

9. Perform post weld heating according to repair WPS, the postheat shall between 230° C—315° C and for one hour minimum.
 10. Allow the weld to cool to ambient temperature gradually. Control cooling rate after PWHT to no more than 50° C per hour.

11. Grind the repaired area flush with base metal or the adjacent weld after post weld heating.
 12. Wait 48 hours at least after the repair area has cooled to ambient temperature before performing NDT.

13. Perform MT inspection to all repair area according to Contract Drawings along with all additional NDT required by the applicable notes Special Provision Section 10-1.59 'Steel Structure', subsection 'inspection testing'.
