Contract #: 04-0120F4Cty: SF/ALA Rte: 80 PM: 13.2/13.9File #: 69.25B**QUALITY ASSURANCE -- NON-CONFORMANCE REPORT****Location:** Changxing Island, Shanghai, P.R. China**Report No:** NCR-000556**Prime Contractor:** American Bridge/Fluor Enterprises, a JV**Date:** 22-Dec-2009**Submitting Contractor:** Zhenhua Port Machinery Company, Ltd (ZPMC), Changxing Island**NCR #:** ZPMC-0529**Type of problem:****Welding****Concrete****Other****Welding****Curing****Procedural****Bridge No:** 34-0006**Joint fit-up****Coating****Other****Component:** OBG Segments 6AW/6BW**Procedural****Procedural****Description:****Reference Description:** Base Metal Repairs without Engineer's Approval, Segments 6AW/6BW**Description of Non-Conformance:**

Job Name: SAS Superstructure

Subject: NCR No. ZPMC-0529

Reference Description: Base Metal Repairs without Engineer's Approval, Segments 6AW/6BW

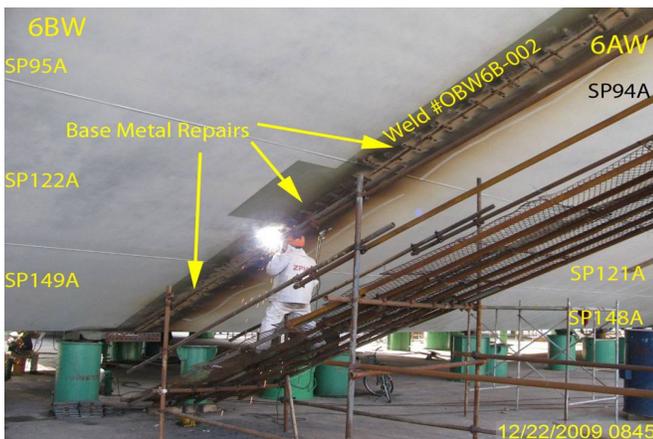
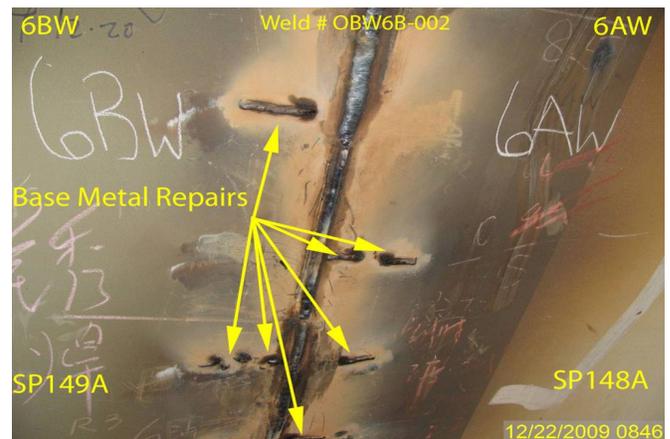
The Caltrans Quality Assurance (QA) Inspector observed Base Metal Repairs were performed without prior approval from the Engineer. Base Metal Repairs were performed using the Shielded Metal Arc Welding (SMAW) process where temporary fit up attachments were removed in multiple locations at the 6AW/6BW Side Plate Segment splice, weld # OBW6B-002 (counter weight side).

The following Side Plates were repaired:

For 6AW: SP148A, SP121A, SP94A

For 6BW: SP149A, SP122A, SP95A

AWS D1.5-2002 Section 3.7.4; "Prior approval of the Engineer shall be obtained for repairs to base metal"

For subsequent reports inform the engineer prior to starting the work. Submit weld inspection documentation to the engineer. A response for the resolution of this issue is expected within 7 days.

Reference Resolution: The areas where temporary attachments were removed have been repaired and NDT has been performed to show that the areas are acceptable. Based on this ZPMC requests closure of this NCR.

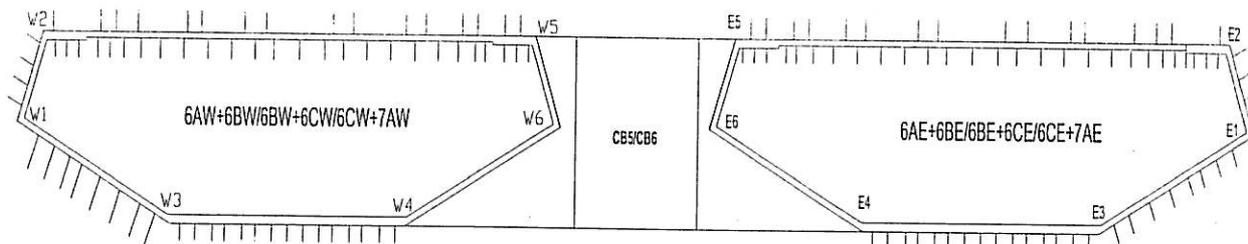
焊缝返修位置示意图:

After inspection west linear 6AW+6BW/6BW+6CW/6CW+7AW and east linear 6AE+6BE/6BE+6CE/6CE+7AE lifting bottom plate and side plate, edge plate without face strut plate, deck plate, the base metal was gouged after removing temporary attachment, the detail sees the following draft.

Worker operator error caused base metal gouged.

6. 将杂物以及MT检测遗留的残留物清理干净;
 7. 根据批准的焊接返修工艺规程 (WPS) 进行预热及焊接;
 8. 将焊接区域打磨至与母材平齐;
 9. 在NDT检测前口头通知QA。对返修区域作100%MT和100%VT检查。
-
1. QC and CWI should be present to witness the repair, direct and supervise all repair operations during this repair to ensure the repair is per the disposition requirements, and the AWS D1.5 code requirements.

2. Grind the repair area to a smooth finish according to the approved repair WPS.
 3. Prepare the joint according to the approved WPS.
 4. Notify QA verbally prior to NDT. Perform 100%MT and 100%VT of the repair area.

5. Remove all defects by grinding to ensure all defects are completely removed if defects still exist, and repeat "step 4" to assure complete removal of all defects if necessary.

6. Clean the repair area of all loose debris including MT powder.
 7. Preheat and weld according to the approved WPS.
 8. Grind the weld flush after welding.

9. Notify QA verbally prior NDT. Perform 100%MT and 100%VT of the repair area.
