Contract #: 04-0120F4
 Cty: SF/ALA Rte: 80 PM: 13.2/13.9
 File #: 69.25B

QUALITY ASSURANCE -- NON-CONFORMANCE REPORT

Report No: NCR-000559

Reference Description: Base Metal Repairs without Engineer's Approval, CB16

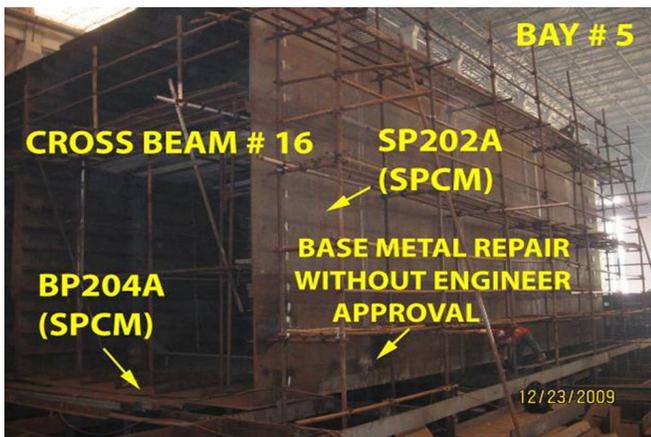
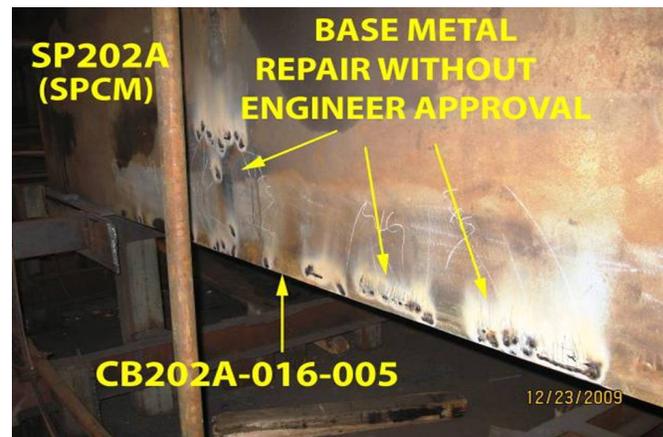
During a random visual inspection of the Orthotropic Box Girder (OBG) Crossbeam CB16, the Caltrans Quality Assurance (QA) Inspector observed ZPMC personnel performing Seismic Performance Critical Member (SPCM) base metal repairs on the Side Panel (SP) of Crossbeam CB16 without the Engineer's approval.

-The Bottom Panel (BP) was identified as: BP204A

-The SP was identified as: SP202A

-The weld number between the SP and BP is identified as: CB202A-016-005

-The WPS used was WPS-345-SMAW-3G (3F)-Repair.

On subsequent repairs, notify the engineer prior to the start of work. Submit weld repair records for this repair to the engineer. A response for the resolution of this issue is expected within 7 days.

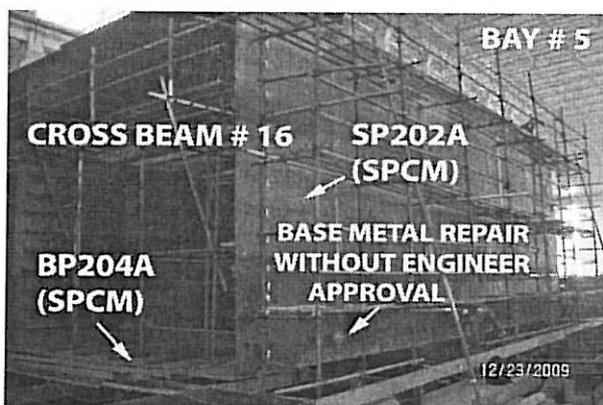
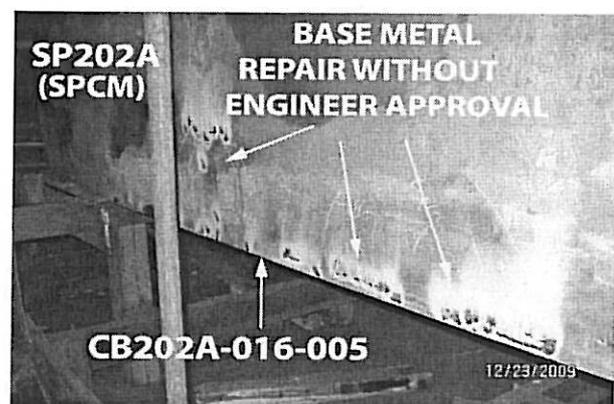
During a random visual inspection of the Orthotropic Box Girder (OBG) Crossbeam CB16, the Caltrans Quality Assurance (QA) Inspector observed ZPMC personnel performing Seismic Performance Critical Member (SPCM) base metal repairs on the Side Panel (SP) of Crossbeam CB16 without the Engineer's approval.

-The Bottom Panel (BP) was identified as: BP204A

-The SP was identified as: SP202A

-The weld number between the SP and BP is identified as: CB202A-016-005

-The WPS used was WPS-345-SMAW-3G (3F)-Repair.

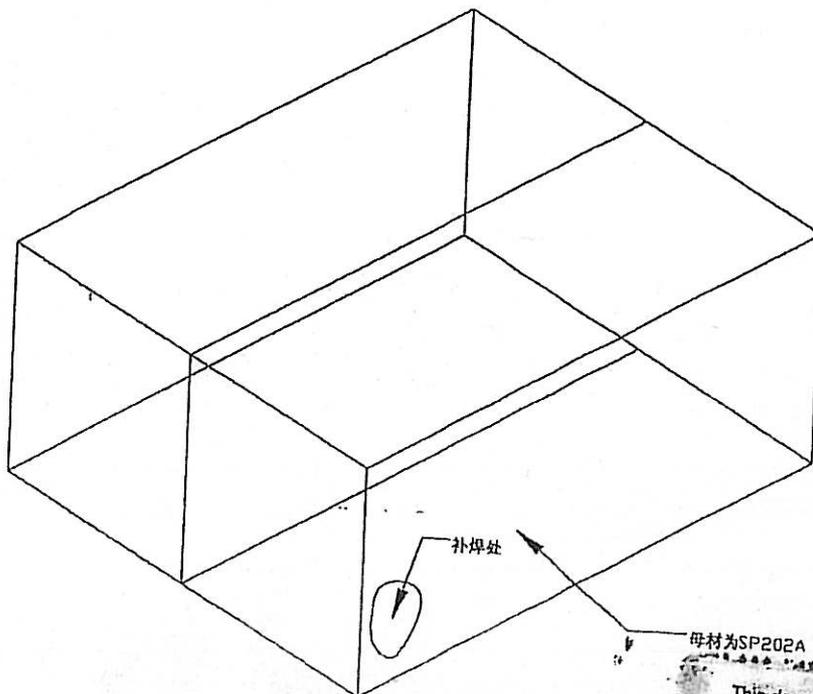
母材为SP202A

刘斌施工队制作的CB16横梁, 在临时构件割除后伤到了母材, 并且母材为FCM, 要进行补焊, 母材的编号为: SP202A.
 CB16 fabricated by work team: Liu Bin ,the base metal was gouged after removed temporary attachment and needed to build up, part No.:SP202A.

1. 碳刨时, 操作工操作失误, 吊耳拆除后, 母材损伤;
1. A gouging operated error and base metal was gouged after removed lifting.

6. 将杂物以及MT检测遗留的残留物清理干净;
 7. 根据批准的焊接返修工艺规程(WPS)进行预热及焊接;
 8. 将焊接区域打磨至与母材平齐;
 9. 在NDT检测前口头通知QA。对返修区域作100%MT和100%VT检查。
1. QC and CWI should be present to witness the repair, direct and supervise all repair operations during this repair to ensure the repair is per the disposition requirements, and the AWS D1.5 code requirements.

2. Grind the repair area to a smooth finish according to the approved repair WPS.
 3. Prepare the joint according to the approved WPS.
 4. Notify QA verbally prior to NDT. Perform 100%MT and 100%VT of the repair area.

5. Remove all defects by grinding to ensure all defects are completely removed if defects still exist, and repeat "step 4" to assure complete removal of all defects if necessary.

6. Clean the repair area of all loose debris including MT powder.
 7. Preheat and weld according to the approved WPS.
 8. Grind the weld flush with base metal after welding.

9. Notify QA verbally prior NDT. Perform 100%MT and 100%VT of the repair area.
