Contract #: 04-0120F4
 Cty: SF/ALA Rte: 80 PM: 13.2/13.9
 File #: 69.25B

QUALITY ASSURANCE -- NON-CONFORMANCE REPORT

Report No: NCR-000562

Reference Description: ZPMC performed base metal repairs without the prior approval of the Engineer on End Plates at OBG Sub-Assembly Bay 5

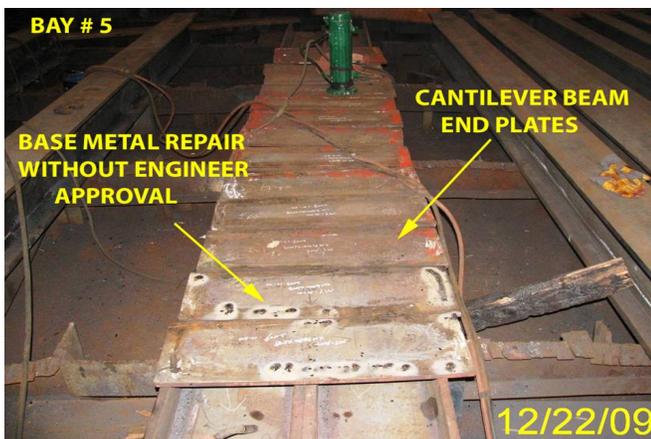
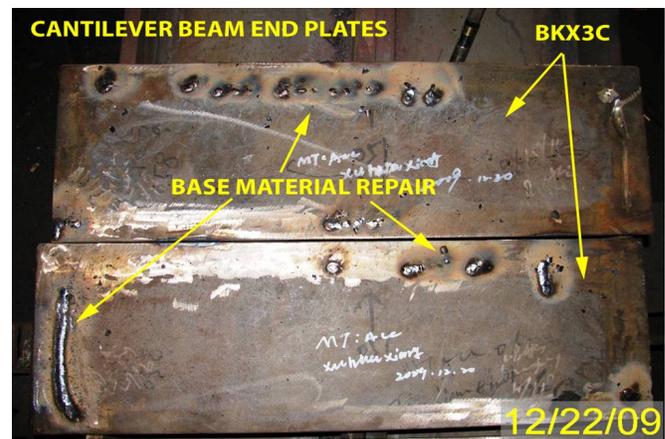
During random in-process visual inspection of the Orthotropic Box Girder (OBG) Bikepath Cantilever Bracket End Plates in fabrication Bay 5, the Caltrans Quality Assurance (QA) Inspector observed ZPMC personnel performing base metal repairs on two (2) End Plates without the Engineer's approval.

-The End Plates are identified as: BKX3C

-The Welding Procedure Specification (WPS) used was WPS-345-SMAW-1G (1F)-Repair.

For subsequent base metal repairs, notify the engineer prior to the start of work. Provide weld test information for this repair to the engineer. A response for the resolution of this issue is expected within 7 days.

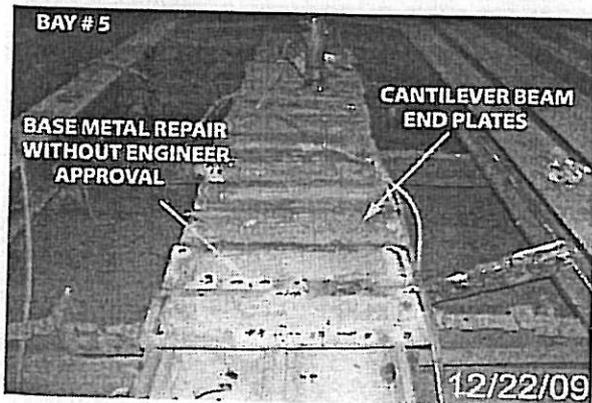
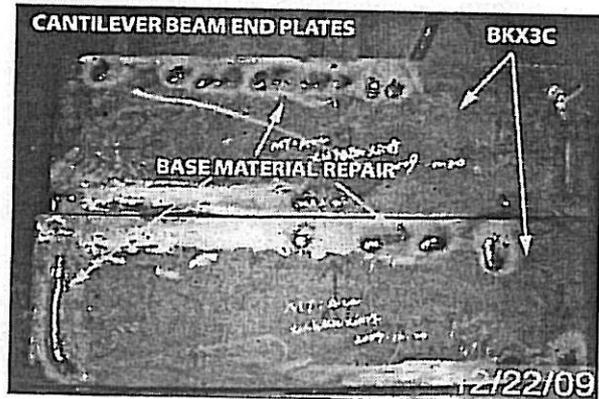
During random in-process visual inspection of the Orthotropic Box Girder (OBG) Bikepath Cantilever Bracket End Plates in fabrication Bay 5, the Caltrans Quality Assurance (QA) Inspector observed ZPMC personnel performing base metal repairs on two (2) End Plates without the Engineer's approval.

-The End Plates are identified as: BKX3C

-The Welding Procedure Specification (WPS) used was WPS-345-SMAW-1G (1F)-Repair.

For subsequent base metal repairs, notify the engineer prior to the start of work. Provide weld test information for this repair to the engineer. A response for the resolution of this issue is expected within 7 days.

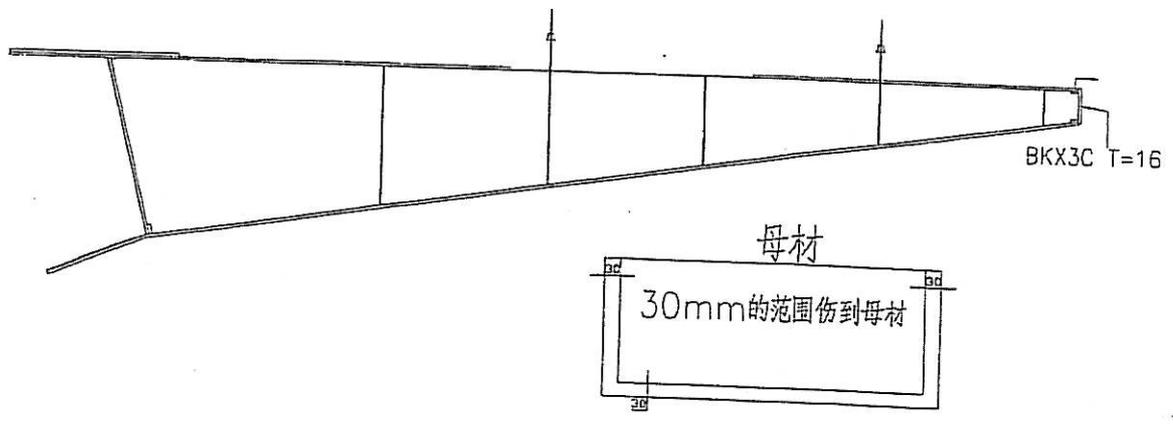
焊缝返修位置示意图:
Draft of Welding Discontinuity:

焊缝缺陷描述:
Description of Welding Discontinuity:
刘斌施工队制作的悬臂梁支架PP85-PP111(取奇数), 在去除前端的封板时伤到母材2-7mm不等。
Suspending bracket PP85-PP111(only including odd) fabricated by work team: Liu Bin, the base metal was gouged after removing seal plate, 2-7mm in depth.

Base metal gouged 30mm in area.

Worker operated error caused base metal gouged.

1. QC和CWI在整个修补过程中都应在场并指导以确保返修工作顺利进行;
 2. 按照焊接返修工艺规程 (WPS) 打磨缺陷区域;
 3. 准备一个正确的接头形式, 具体参见返修的WPS;
 4. 对该区域作100%MT检查, 确保缺陷全部去除;
 5. 根据批准的焊接返修工艺规程 (WPS) 进行预热及焊接;
 6. 将焊接区域打磨至与母材平齐;
 7. 根据图纸要求进行相应的NDT(VT、MT 和UT)检测;
-
1. QC and CWI should be present to witness the repair, direct and supervise all repair operations during this repair to ensure the repair is per the disposition requirements.
 2. Grind the repair area to a smooth finish according to the approved repair WPS.
 3. Prepare an right joint according to the approved WPS.
 4. Verify with MT and VT no defects remain in the repair area prior to welding;
 5. Preheat and weld according to the relevant WPS.
 6. Grind the weld flush with base metal after welding.
 7. Perform NDT inspection(VT、MT and UT) of the weld according to the working drawings.

Train and educate operator to improve operation skill.
