QUALITY ASSURANCE -- NON-CONFORMANCE REPORT

Report No: NCR-000573

Welding	Concrete	Other	
Welding	Curing	Procedural	Bridge No: 34-0006
Joint fit-up	Coating	Other	Component: Segment 7CW Corner Assembly
Procedural	Procedural	Description: Missed MT indication by QC

Job Name: SAS Superstructure

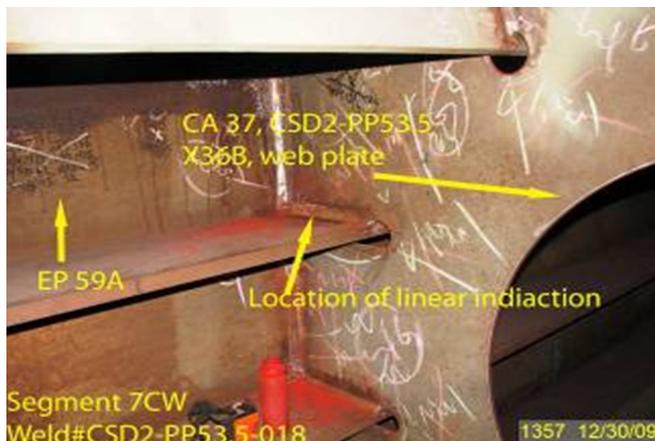
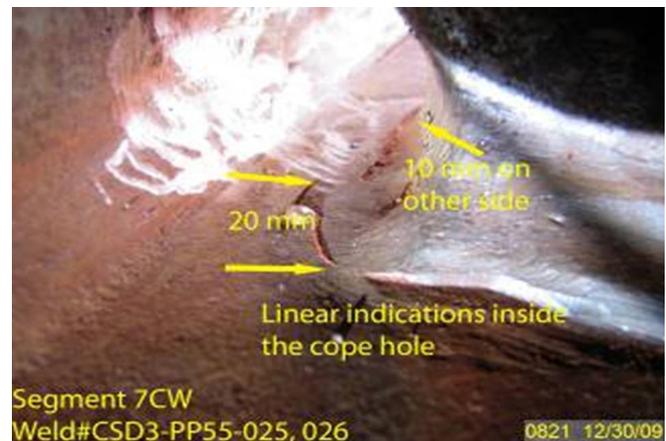
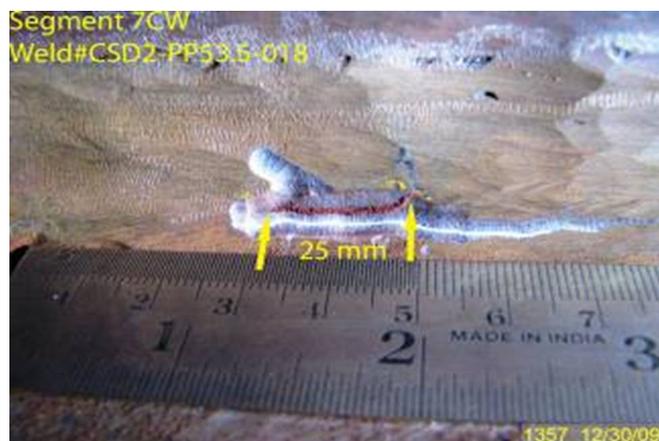
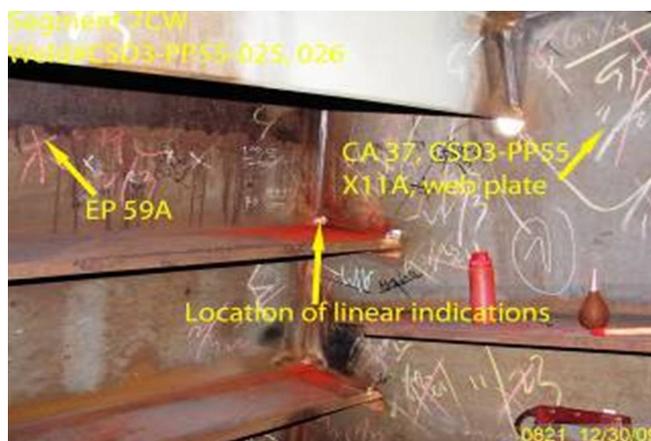
During the Quality Assurance Magnetic Particle Testing (MT) review of welds located on Segment 7CW, this Quality Assurance Inspector (QA) discovered the following issues:

- Two (2) Longitudinal linear indication measuring approximately 20mm and 25mm in length.
- The welds are identified as: CSD3-PP55-025, 026 (30 mm) and CSD2-PP53.5-018 (25 mm).
- The welds are a Fillet Weld type joining the Edge Plate (EP59A) stiffeners to Corner Assembly (CA37A) web plates.
- The OBG 7CW segment is located at in front of Blast Shop.

The Notice of Witness Inspection Number (NWIT) is 004947. The indication is located inside the area that has been previously tested and accepted by ZPMC Quality Control (QC) personnel. ZPMC's QC personnel are required to perform twenty five (25%) percent MT inspection of this weld.

AWS D1.5 (02) Section 6.26.2 – “Welds that are subject to MT in addition to visual inspection shall have no cracks.

Submit a repair procedure to the engineer for approval. Provide the ZPMC MT technician additional training and equipment to ensure these types of indications are identified in the future.

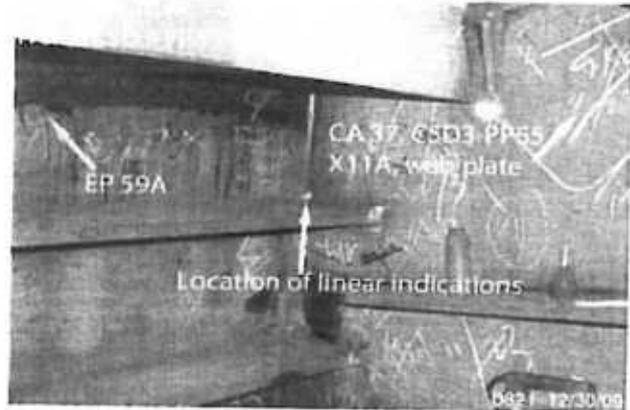
During the Quality Assurance Magnetic Particle Testing (MT) review of welds located on Segment 7CW, this Quality Assurance Inspector (QA) discovered the following issues:

- Two (2) Longitudinal linear indication measuring approximately 20mm and 25mm in length.
- The welds are identified as: CSD3-PP55-025, 026 (30 mm) and CSD2-PP53.5-018 (25 mm).
- The welds are a Fillet Weld type joining the Edge Plate (EP59A) stiffeners to Corner Assembly (CA37A) web plates.
- The OBG 7CW segment is located at in front of Blast Shop.

The Notice of Witness Inspection Number (NWIT) is 004947. The indication is located inside the area that has been previously tested and accepted by ZPMC Quality Control (QC) personnel. ZPMC's QC personnel are required to perform twenty five (25%) percent MT inspection of this weld.

AWS D1.5 (02) Section 6.26.2 – “Welds that are subject to MT in addition to visual inspection shall have no cracks.

Submit a repair procedure to the engineer for approval. Provide the ZPMC MT technician additional training and equipment to ensure these types of indications are identified in the future.

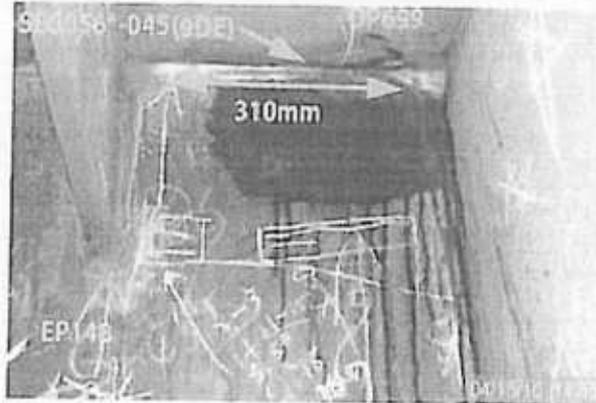
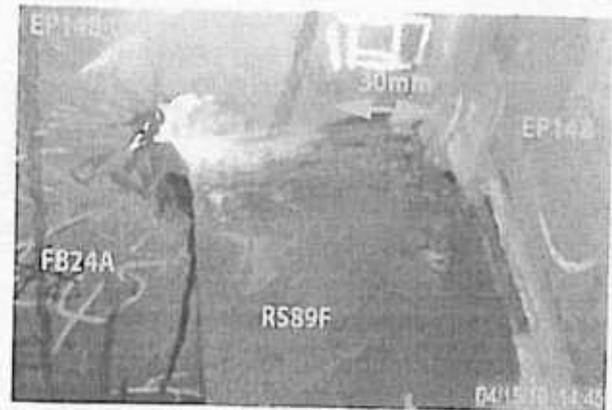
During the Quality Assurance (QA) Ultrasonic Testing (UT) review of welds located on Orthotropic Box Girder (OBG) Segment 9DE, this QA Inspector discovered the following issues:

- Two (2) longitudinal linear indications measuring approximately 310mm and 30mm in length.
- The indications dBs rating are +6 and +4.
- Material thickness is 18mm.
- The depth of the indications is approximately 11mm and 13mm.
- The welds are identified as SEG056*-045 at Panel Point (PP) PP81.5 and EP148-022 at PP 81.
- The welds are designated as Seismic Performance Critical Material (SPCM).
- The indications are clearly marked on or near the weld.
- The Y distance for the indications are 50 mm from PP81.5 and 0 mm from EP148A.
- Weld SEG056*-045 is a Complete Joint Penetration (CJP) Corner joint, joining the Edge Plate PL1336C(SPCM) to Deck Plate PL1314A (Non SPCM).
- Weld EP148-022 is a Complete Joint Penetration (CJP) "T" joint, joining the Edge Plate stiffener RS89F (Non SPCM) to FB24A plate PLX24D (SPCM).
- Segment 9DE is located outside of Paint shop.

AWS D1.5-02 Section 6; Table 6.3 specifies a class "A" indication as having a rating of 10dBs and under for material thicknesses 8mm through 20mm.

Propose a resolution for the identified non-conformance to prevent future occurrences. A response for the resolution of this issue is expected within 7 days.

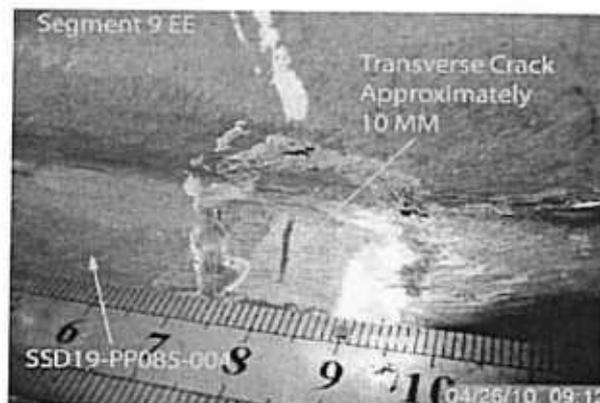
During the Quality Assurance (QA) Magnetic Particle Testing (MT) review of welds located on Segment 9EE, this QA Inspector discovered the following issues:

- One (1) transverse crack measuring approximately 10mm in length in the fillet weld joining the Deck Panel Diaphragm (X1D) to Floor Beam Web Flange (X6F) at panel point 85.
- The Y location is 10800mm from the termination of the weld on the crossbeam side.
- The indication is clearly marked near the weld.
- The weld is identified as: SSD19-PP085-004.
- OBG segment 9EE is located north of the blast shop.
- The Notice of Witness Inspection Number (NWIT) is 005583. The indication is located within the area that has been previously tested and accepted by ZPMC Quality Control (QC) personnel.

AWS D1.5 (02) Section 6.26.2 – “Welds that are subject to MT in addition to visual inspection shall have no cracks.
