QUALITY ASSURANCE -- NON-CONFORMANCE REPORT

Location: Changxing Island, Shanghai, P.R. China **Report No:** NCR-000575
Prime Contractor: American Bridge/Fluor Enterprises, a JV **Date:** 01-Jan-2010
Submitting Contractor: Zhenhua Port Machinery Company, Ltd (ZPMC), Changxing Island **NCR #:** ZPMC-0548

Reference Description: Base Metal Repair without Engineer's Approval, East Shaft, Lift 1, Skin A Stiffener

Job Name: SAS Superstructure
Document No: 05.03.06-000538

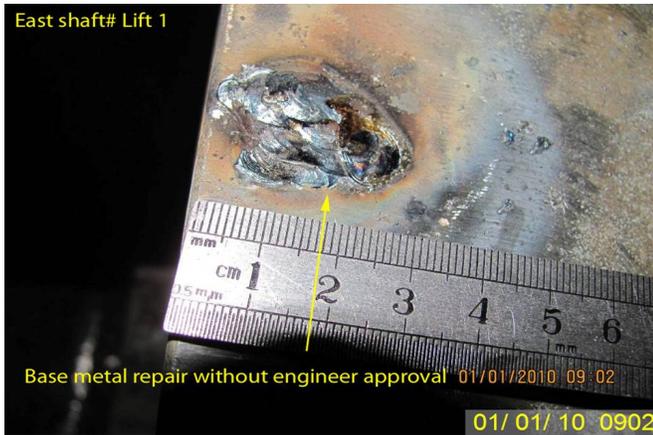
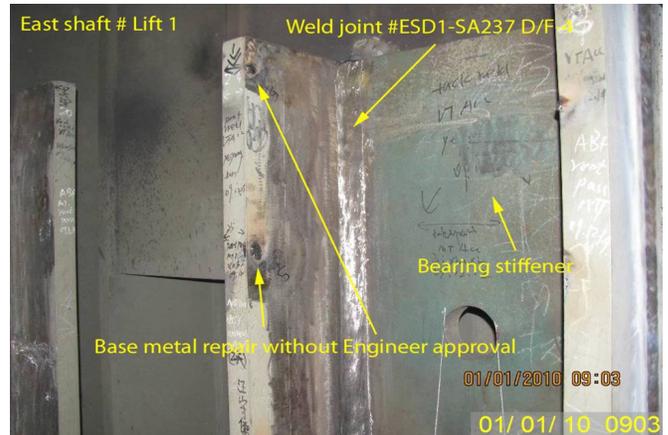
- Base metal repairs of Skin A stiffener without the Engineer's approval.
- The length of the base metal repairs were approximately 15mm and 25mm in length.
- The member is identified as Skin A stiffener, inside East Shaft – Lift 1.
- The member is located at the heavy dock jetty outside.
- The nearby weld joint is identified as: ESD1-SA 237 D/F-4
- The repair was performed utilizing the Shielded Metal Arc Welding (SMAW) process.
- The material is classified as A709 Grade 345 (Non SPCM).

Standard Specifications (99) section 8-3.01: "The Engineer shall be notified immediately in writing when welding problems, deficiencies, base metal repairs, or any other type of repairs not submitted in the WQCP are discovered and also of the proposed repair procedures to correct them. For requests to perform repairs, The contractor shall include an engineering evaluation of the proposed repair."

AWS D1.5/2002, Section 3.7.4: "Prior approval of the Engineer shall be obtained for repairs to base metal."

Propose a resolution for the identified non-conformance, documenting that the repaired base metal / welding repair is in compliance with the contract requirements. Documentation provided for the Engineer’s review of the acceptability of the weld repair shall at a minimum include the procedure utilized/WRR and the NDT results.

In addition to the material/workmanship non-conformance, address the failure by both Production and Quality Control in proceeding with base metal repair without prior approval from the Engineer. Provide documentation of the steps/actions taken by Production and Quality Control to prevent future occurrences.

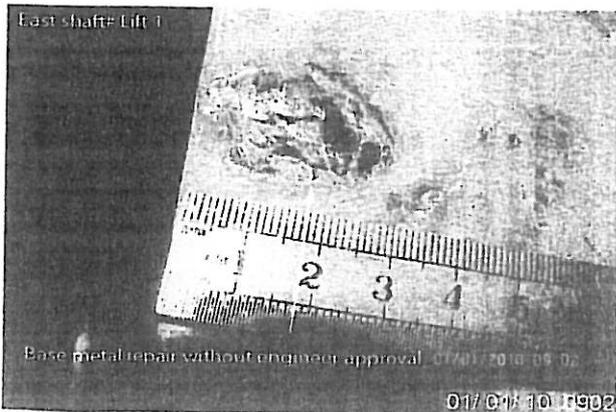
- Base metal repairs of Skin A stiffener without the Engineer's approval.
- The length of the base metal repairs were approximately 15mm and 25mm in length.
- The member is identified as Skin A stiffener, inside East Shaft – Lift 1.
- The member is located at the heavy dock jetty outside.
- The nearby weld joint is identified as: ESD1-SA 237 D/F-4
- The repair was performed utilizing the Shielded Metal Arc Welding (SMAW) process.
- The material is classified as A709 Grade 345 (Non SPCM).

Standard Specifications (99) section 8-3.01: "The Engineer shall be notified immediately in writing when welding problems, deficiencies, base metal repairs, or any other type of repairs not submitted in the WQCP are discovered and also of the proposed repair procedures to correct them. For requests to perform repairs, The contractor shall include an engineering evaluation of the proposed repair."

AWS D1.5/2002, Section 3.7.4: "Prior approval of the Engineer shall be obtained for repairs to base metal."

Documentation for the base metal repair and MT verification was provided (T-WR3002 and T787-MT-7840).

The ABF QCM informed ZPMC QA of the CWR requirements pertaining to base metal repairs.
