Contract #: 04-0120F4
 Cty: SF/ALA Rte: 80 PM: 13.2/13.9
 File #: 69.25B

QUALITY ASSURANCE -- NON-CONFORMANCE REPORT

Report No: NCR-000582

Reference Description: Perform of heat straightening in Segment 10CE without Engineer's approval

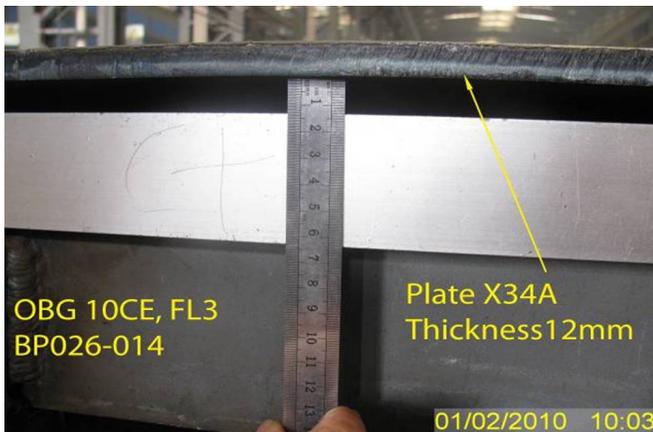
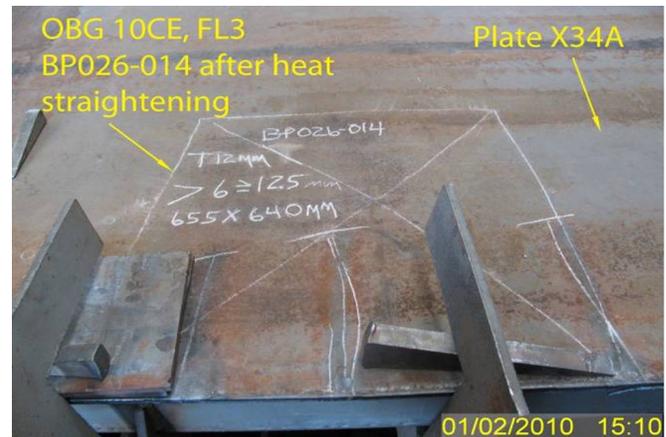
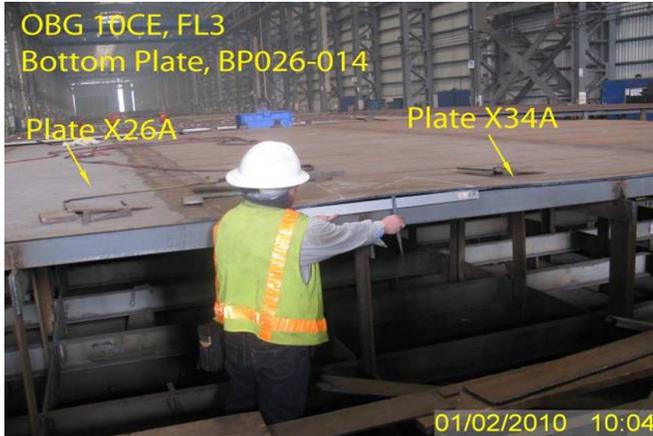
- ZPMC personnel performed heat straightening on OBG segment 10CE, FL3 Bottom Plate without the prior approval of the engineer.

-The Bottom Plate assembly is identified as BP026-014 and the plate is identified as X34A, which measured to be a total of 12.5mm out of straightness in 1000mm.

-ZPMC QC or CWI were not present during the time of the heat straightening process.

AWS D1.5/2002 Section 3.7.3; Members distorted by welding shall be heat straightened by mechanical means or by carefully supervised application of a limited amount of localized heat as approved by the engineer.

Caltrans Special Provisions Section 8-3: "For material less than or equal to 16 mm thick, the Contractor shall not heat straighten members more than 6 in 1000 without prior approval of the Engineer.

Propose a resolution for the identified non-conformance with revised procedures to prevent future occurrences. After the HS plan is reviewed and approved notify the engineer prior to starting HS activities. A response for the resolution of this issue is expected within 7 days.

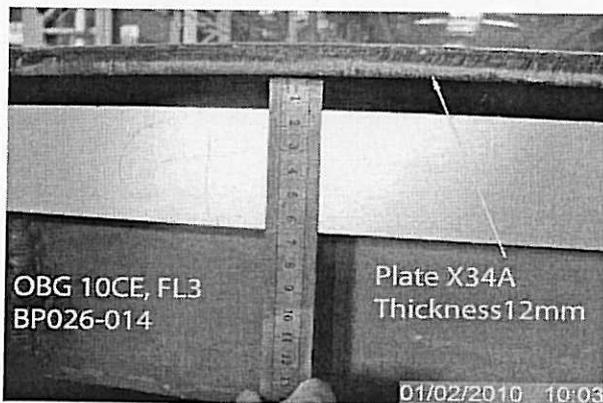
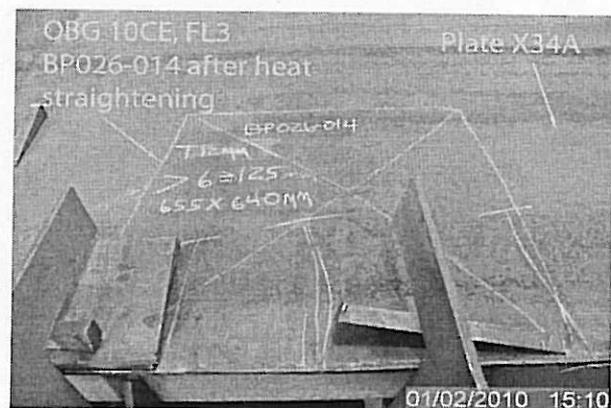
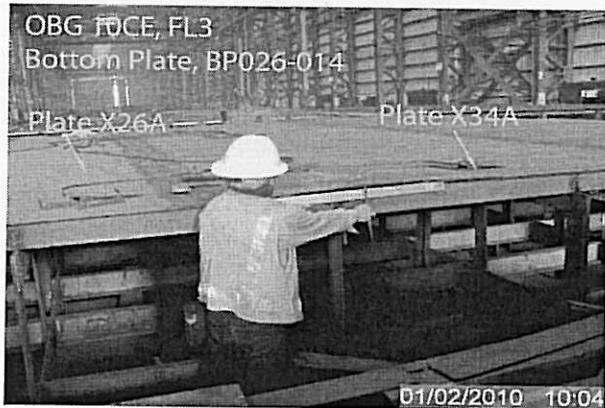
- ZPMC personnel performed heat straightening on OBG segment 10CE, FL3 Bottom Plate without the prior approval of the engineer.

-The Bottom Plate assembly is identified as BP026-014 and the plate is identified as X34A, which measured to be a total of 12.5mm out of straightness in 1000mm.

-ZPMC QC or CWI were not present during the time of the heat straightening process.

AWS D1.5/2002 Section 3.7.3; Members distorted by welding shall be heat straightened by mechanical means or by carefully supervised application of a limited amount of localized heat as approved by the engineer.

Caltrans Special Provisions Section 8-3: "For material less than or equal to 16 mm thick, the Contractor shall not heat straighten members more than 6 in 1000 without prior approval of the Engineer.

Meet with ZPMC's QA manager to reinforce the importance of following procedures in accordance with the Contract requirements.

ZPMC issued an internal NCR in regards to this matter and meetings are scheduled between ABF and ZPMC's QA department to ensure that they are aware of this issue and the Contract requirements pertaining to heat straightening.

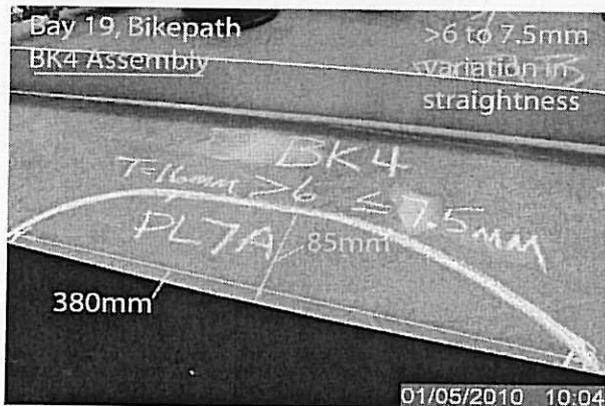
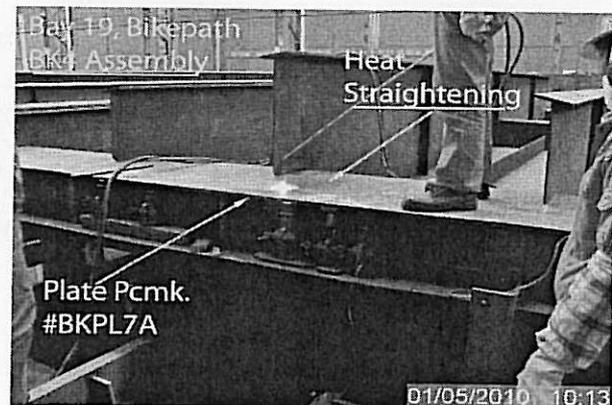
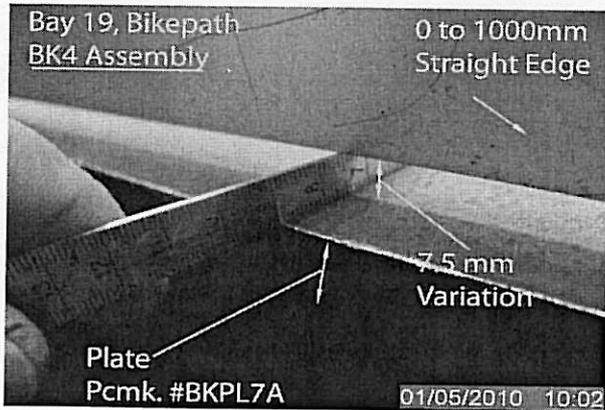
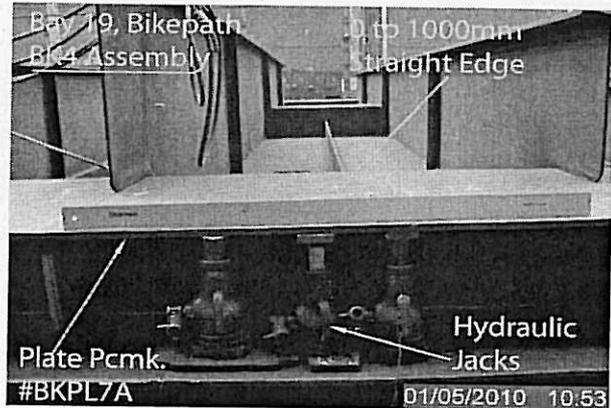
- ZPMC heat straightening an area of material distorted by welding without the Engineers approval.
- The bike path segment is identified as BK4.
- The part is identified as BKPL7A.
- The deviation from flat as measured by this QA was 7.5mm per 1000mm.
- Material thickness is 16mm.
- ZPMC QC was not present during the time of the heat straightening process.

AWS D1.5/2002 Section 3.7.3: Members distorted by welding shall be heat straightened by mechanical means or by carefully supervised application of a limited amount of localized heat as approved by the engineer.

Caltrans Special Provisions Section 8-3: For material less than or equal to 16 mm thick, the Contractor shall not heat straighten members more than 6 in 1000 without prior approval of the Engineer.

Propose a resolution for the identified non-conformance with revised procedures to prevent future occurrences. Do not perform HS without prior notification of the engineer. A response for the resolution of this issue is expected within 7 days.
