DEPARTMENT OF TRANSPORTATION
 DIVISION OF ENGINEERING SERVICES
 Office of Structural Materials
 Quality Assurance and Source Inspection

QUALITY ASSURANCE -- NON-CONFORMANCE REPORT

Report No: NCR-000589

Reference Description: Base Metal linear indication discovered with MT after ZPMC had tested and accepted this Temporary Attachment removal area in Segment 8BE Side Panel

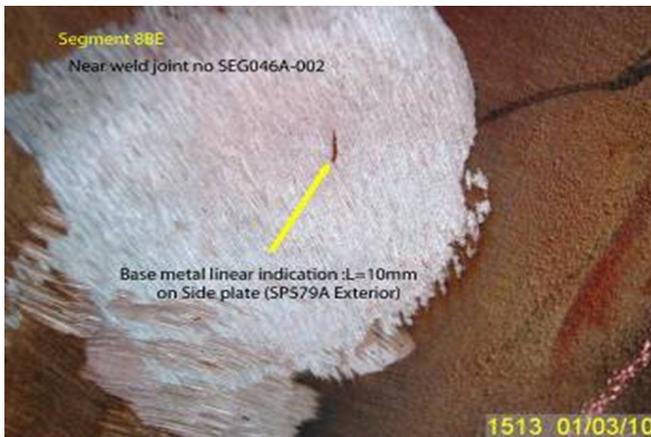
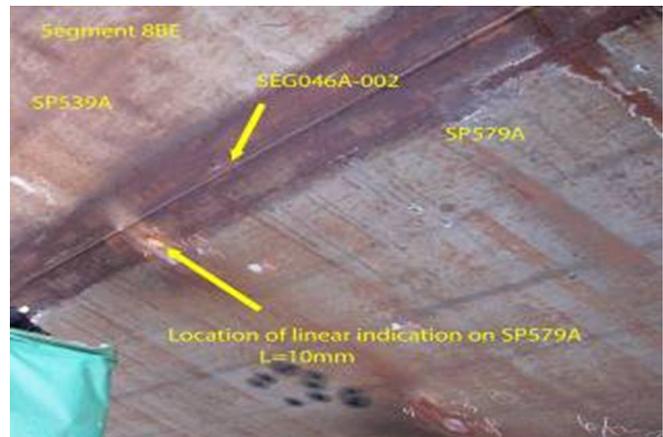
- One (1) linear indication that measured approximately 10mm in length.
- The linear indication was discovered in the base metal at SP579A (PL1043A Exterior).
- The adjacent weld is identified as: SEG046A-002
- This weld joins SP579A (PL1043A) to SP539A (PL1042A).
- This base metal linear indication was located in a temporary attachment removal area.
- The OBG Segment 8BE is located in the outside yard, south side of the Bay14.

The Notice of Witness Inspection Number (NWIT) is 004978. The indication is located inside the area that has been previously tested and accepted by ZPMC Quality Control (QC) personnel. As per the contract documents, ZPMCs QC personnel are required to perform 100% Magnetic particle inspection of this weld.

Propose a resolution for the identified non-conformance with revised procedures to prevent future occurrences. Missed MT indications are a chronic issue. Provide the required training and equipment necessary so the ZPMC MT technician does not miss this type of indication in the future. A response for the resolution of this issue is expected within 7 days.

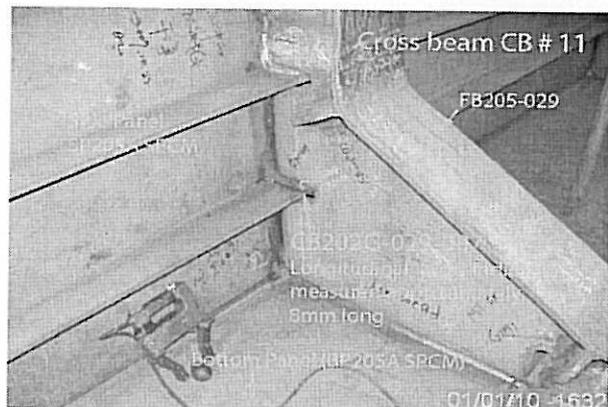
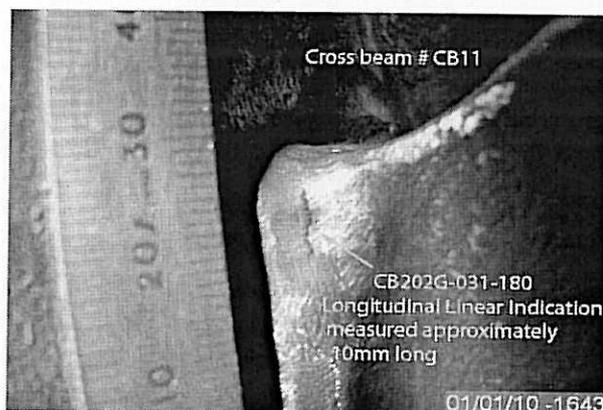
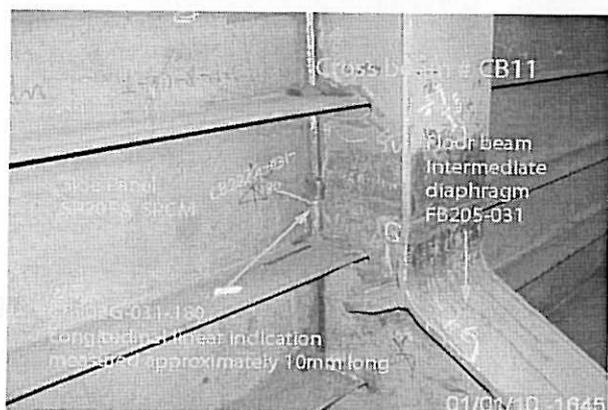
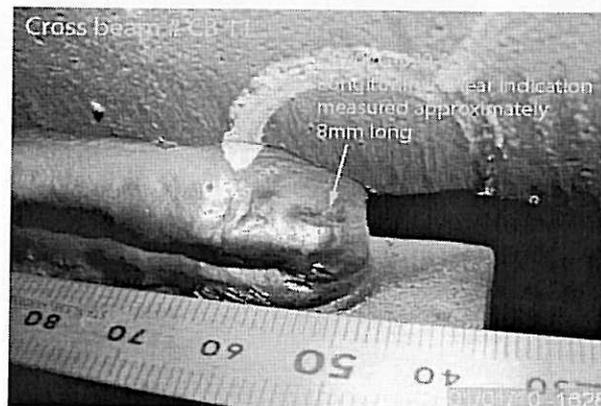
During the Quality Assurance Magnetic Particle Testing (MT) review of welds located on Orthotropic Box Girder (OBG) Crossbeam CB11, the Quality Assurance Inspector (QA) discovered the following issue:

-Two (2) longitudinal linear indications measuring approximately 10mm and 8mm in length.

-The welds are identified as: CB202G-029-087 (8 mm) and CB202G-031-180 (10 mm).

-Weld CB202G-029-087 is a horizontal Fillet Weld joining the Side Panel (SP205A) Seismic Performance Critical Member (SPCM) stiffener connecting to the Floor Beam Intermediate Diaphragm (FB205-029).

-Weld CB202G-031-180 is a vertical Fillet Weld joining the Side Panel (SP205A) SPCM stiffener connecting to the Floor Beam Intermediate Diaphragm (FB205-031).

-The Notice of Witness Inspection Number (NWIT) is 004973. The indications are located inside the area that has been previously tested and accepted by ZPMC Quality Control (QC) personnel. ZPMC's QC personnel are required to perform hundred (100%) percent MT inspection of these welds.

AWS D1.5 (02) Section 6.26.2 – “Welds that are subject to MT in addition to visual inspection shall have no cracks.”

Submit a repair procedure to the engineer for approval. Ensure the MT technician that missed these indications is trained and equipped in a manner so these indications are not missed in the future. A response for the resolution of this issue is expected within 7 days.

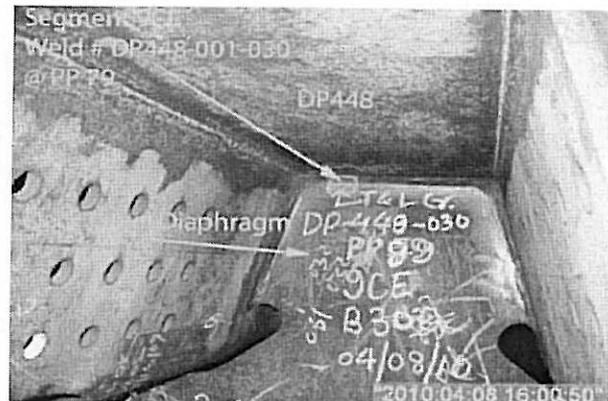
- One (1) Transverse linear indication (crack) measuring approximately 12 mm in length.
- One (1) Longitudinal linear indication (crack) measuring approximately 20 mm in length.
- The weld is identified as: DP448-001-030 @ Panel Point-079.
- The weld is a Fillet Weld type joining DP448 to Deck Panel Diaphragm plate X1C.
- The OBG 9CE segment is located at the back side of Bay # 13.

The Notice of Witness Inspection Number (NWIT) is 005476. The indication is located inside the area that has been previously tested and accepted by ZPMC Quality Control (QC) personnel. ZPMC's QC personnel are required to perform twenty five (25%) percent MT inspection of this weld.

-AWS D1.5 (02) Section 6.26.2 – “Welds that are subject to MT in addition to visual inspection shall have no cracks.
