Contract #: 04-0120F4  
 Cty: SF/ALA Rte: 80 PM: 13.2/13.9  
 File #: 69.25B

**QUALITY ASSURANCE -- NON-CONFORMANCE REPORT**

**Location:** Changxing Island, Shanghai, P.R. China **Report No:** NCR-000604  
**Prime Contractor:** American Bridge/Fluor Enterprises, a JV **Date:** 05-Jan-2010  
**Submitting Contractor:** Zhenhua Port Machinery Company, Ltd (ZPMC), Changxing Island **NCR #:** ZPMC-0577

**Reference Description:** Excessive root gap at weld joint of FL3 to I- Rib Stiffener was welded with fillet weld in Segment 7DW

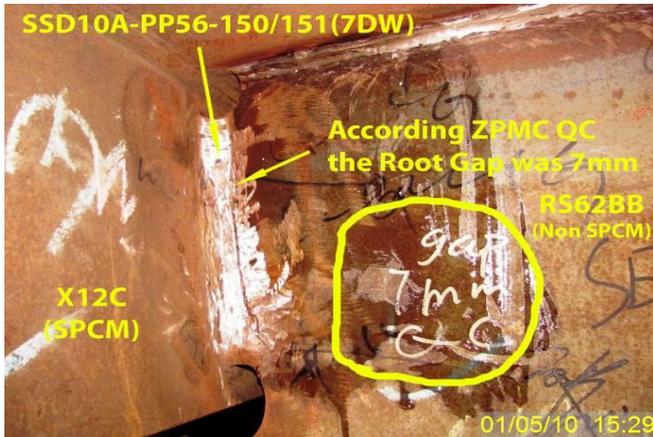
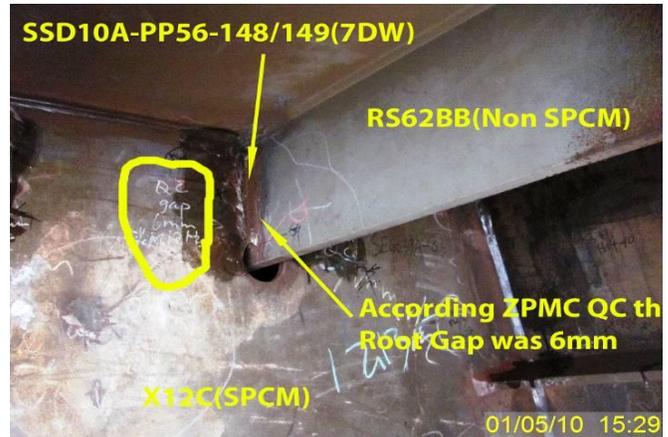
During the Quality Assurance Ultrasonic Testing (UT) review of welds located on Orthotropic Box Girder (OBG) segment 7DW, this Quality Assurance Inspector (QA) discovered the following issues:

- The original welds per the approved drawing (SEGSD10A) are designated as Fillet Welds. ZPMC performed fillet weld welding knowing that the root gap exceeded the specified tolerance.
- The welds are identified as: SSD10A-PP56-148/149 and SSD10A-PP56-150/151.
- The excessive root gaps confirmed by ZPMC QC were 6mm and 7mm.
- Located at Panel Point 56 at Cross Beam side.
- The weld is designated as Seismic Performance Critical Material (SPCM).
- The welds are joining the Plate X12C (SPCM) to Stiffener RS62BB (Non SPCM).
- This Green Tag inspection was identified as: Green Tag # 004993
- OBG Segment 7DW is located in the outside yard west of Bay 13.

Change weld type from fillet to CJP and perform required NDT.

Contractor submitted Notification for Engineer's Review and Approval form to change the weld type and CJP welds were administered at the locations noted in the NCR. After welding, Quality Control (QC) personnel performed Ultrasonic Testing (UT) at the weld locations to verify the welds are in compliance with Contract specifications. QA verified these results after receiving notification that the welds were found to be acceptable.

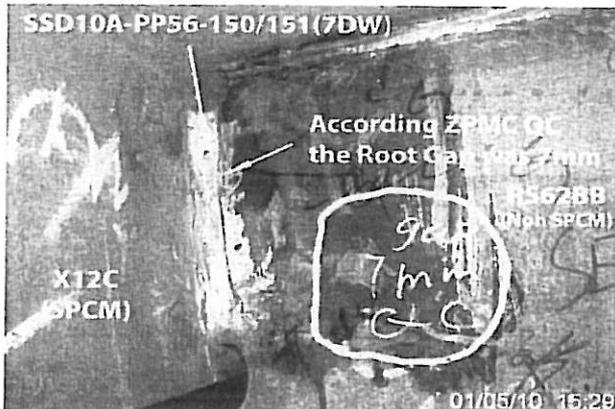
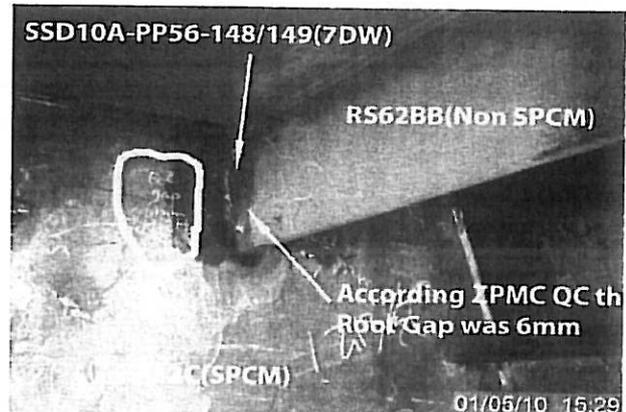
- During the Quality Assurance Ultrasonic Testing (UT) review of welds located on Orthotropic Box Girder (OBG) segment 7DW, this Quality Assurance Inspector (QA) discovered the following issues:
- The original welds per the approved drawing (SEGSD10A) are designated as Fillet Welds. ZPMC performed fillet weld welding knowing that the root gap exceeded the specified tolerance.
  - The welds are identified as: SSD10A-PP56-148/149 and SSD10A-PP56-150/151.
  - The excessive root gaps confirmed by ZPMC QC were 6mm and 7mm.
  - Located at Panel Point 56 at Cross Beam side.
  - The weld is designated as Seismic Performance Critical Material (SPCM).
  - The welds are joining the Plate X12C (SPCM) to Stiffener RS62BB (Non SPCM).
  - This Green Tag inspection was identified as: Green Tag # 004993
  - OBG Segment 7DW is located in the outside yard west of Bay 13.

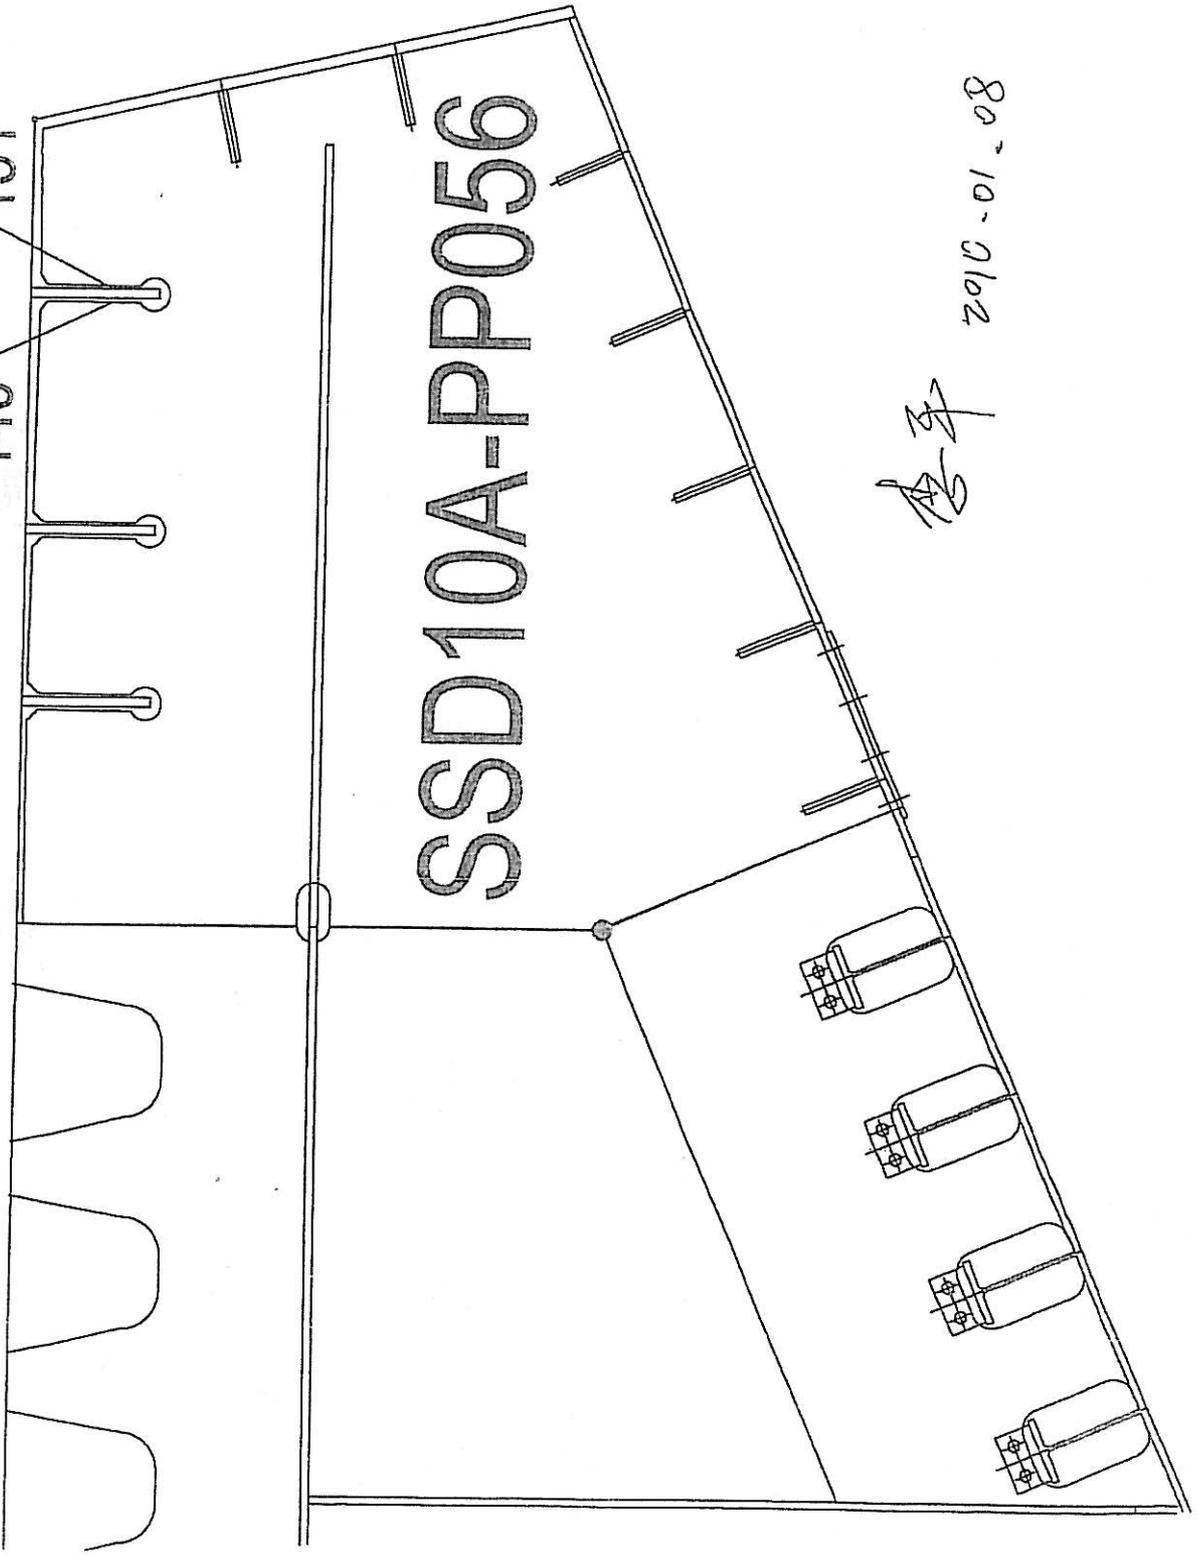
Lift/Segment: 70W Measured Gap Size (mm): Gap max = 7mm

Weld ID#: SS010A - PP56 - 148/149, 150/151

gap=6mm  $\frac{148}{149}$   $\frac{150}{151}$  gap=7mm

Out-of-tolerance Repair: Excessive Root Gap Turning Fillet Weld to CJP per Submittal 200R2
