Contract #: 04-0120F4Cty: SF/ALA Rte: 80 PM: 13.2/13.9File #: 69.25B

**QUALITY ASSURANCE -- NON-CONFORMANCE REPORT**

**Location:** Changxing Island, Shanghai, P.R. China**Report No:** NCR-000622**Prime Contractor:** American Bridge/Fluor Enterprises, a JV**Date:** 11-Jan-2010**Submitting Contractor:** Zhenhua Port Machinery Company, Ltd (ZPMC), Changxing Island**NCR #:** ZPMC-0595**Type of problem:**

**Reference Description:** Weld repair of transverse cracks without the Engineer's approval on Segment 5AE Deck to Side Panel

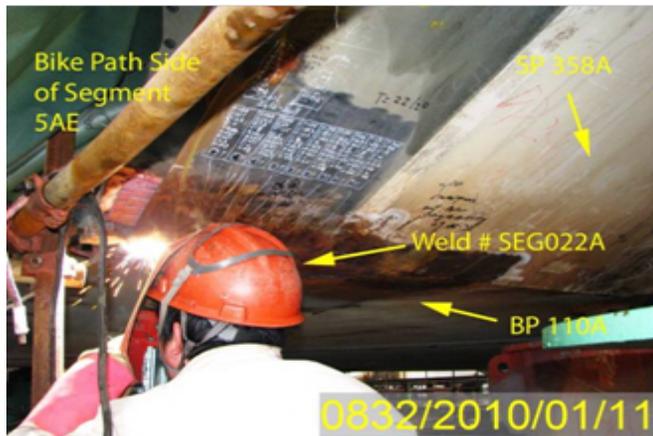
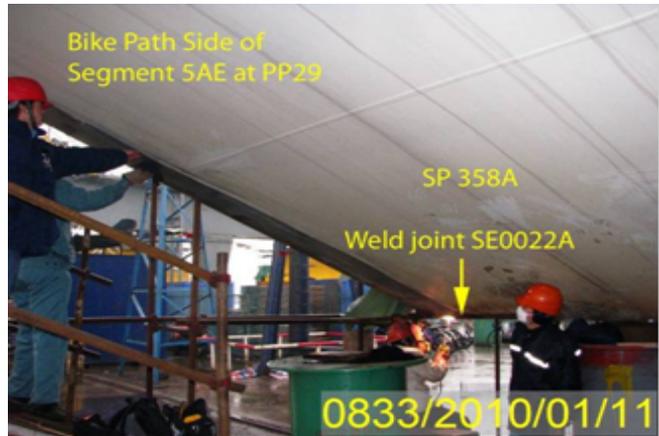
During the Quality Assurance in-process observations of the fabrication of lift 5 East, the QA inspector discovered the following issues:

- Weld repair of transverse cracks without the Engineer's approval.
  - No approved welding procedure specification (WPS) was onsite during the welding repair process.

- The weld is identified as "Hold Back" weld #SEG022A-007
  - The weld is a Complete Joint Penetration (CJP) weld.
  - The weld is joining bottom panel identified as BP110A to the side panel identified as SP558A

- Location is nearest to panel point 032 on the bike path side of segment (@ E3 line).
  - Repair is being performed due to eleven (11) transverse indications being discovered in a 325mm area by the contractor using the Ultrasonic Testing (UT) method.

Propose a resolution for the identified non-conformance with revised procedures to prevent future occurrences. Notify the engineer and have WPS's onsite prior to the start of the repair.

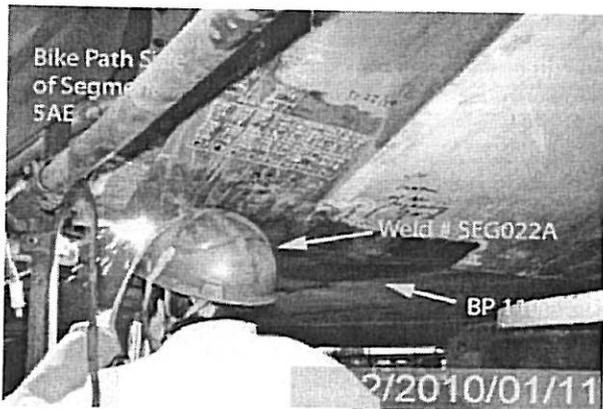
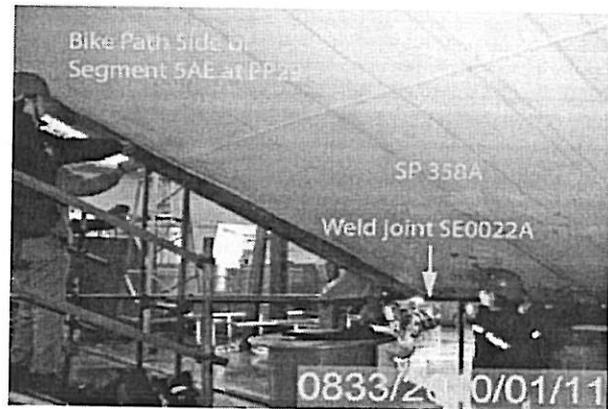
During the Quality Assurance in-process observations of the fabrication of lift 5 East, the QA inspector discovered the following issues:

- Weld repair of transverse cracks without the Engineer's approval.
- No approved welding procedure specification (WPS) was onsite during the welding repair process.
- The weld is identified as "Hold Back" weld #SEG022A-007
- The weld is a Complete Joint Penetration (CJP) weld.
- The weld is joining bottom panel identified as BP110A to the side panel identified as SP558A
- Location is nearest to panel point 032 on the bike path side of segment (@ E3 line).
- Repair is being performed due to eleven (11) transverse indications being discovered in a 325mm area by the contractor using the Ultrasonic Testing (UT) method.
- Y location of repair is noted to be between 20mm~345mm near the 5AE+4BE field splice.
- Lift 5 East is located in the OGB Trial Assembly Area.

- The weld is a Complete Joint Penetration (CJP) weld.
- The weld is joining bottom panel identified as BP110A to the side panel identified as SP558A
- Location is nearest to panel point 032 on the bike path side of segment (@ E3 line).
- Repair is being performed due to eleven (11) transverse indications being discovered in a 325mm area by the contractor using the Ultrasonic Testing (UT) method.
- Y location of repair is noted to be between 20mm~345mm near the 5AE+4BE field splice.
- Lift 5 East is located in the OGB Trial Assembly Area.

Propose a resolution for the identified non-conformance with revised procedures to prevent future occurrences. Notify the engineer and have WPS's onsite prior to the start of the repair.
