Contract #: 04-0120F4Cty: SF/ALA Rte: 80 PM: 13.2/13.9File #: 69.25B**QUALITY ASSURANCE -- NON-CONFORMANCE REPORT****Location:** Changxing Island, Shanghai, P.R. China**Report No:** NCR-000628**Prime Contractor:** American Bridge/Fluor Enterprises, a JV**Date:** 12-Jan-2010**Submitting Contractor:** Zhenhua Port Machinery Company, Ltd (ZPMC), Changxing Island**NCR #:** ZPMC-0601**Type of problem:**

Reference Description: One Longitudinal Linear Indication discovered in Segment 8CW after ZPMC NDT testing and acceptance

Subject: NCR No. ZPMC-0601

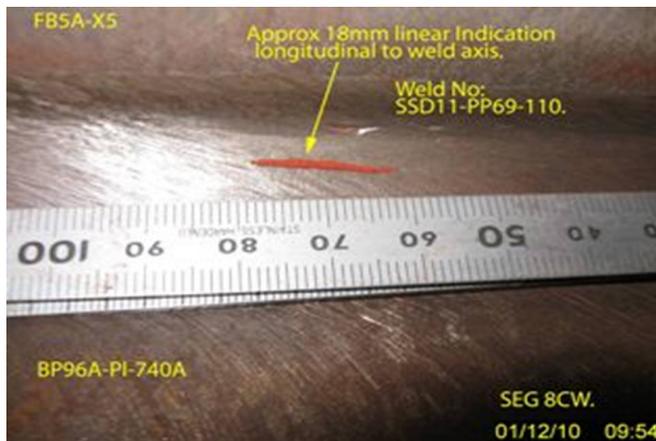
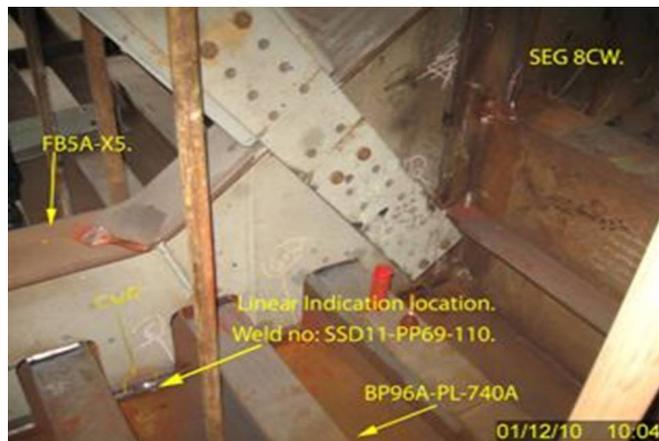
During the Quality Assurance(QA) Magnetic Particle Testing (MT) review of welds on OBG Segment 8CW, this QA Inspector discovered the following issue:

- One (1) linear indication longitudinal to the weld axis measuring approximately 18mm in length.
- The Y location is approximately 120mm from the left end of the weld.
- The indication is clearly marked on the material near the weld.
- The weld is identified as: SSD11-PP69-110.
- The weld is a fillet weld joining the Bottom Panel BP96A-PL-740A & Floor Beam FB5A-X5.
- This material is designated as Seismic Performance Critical Member (SPCM).
- Segment 8CW is located in Outside Yard.

The Notice of Witness Inspection Number (NWIT) is 005037. The indication is located outside the area that has been previously tested and accepted by ZPMC Quality Control (QC) personnel. As per the contract documents, ZPMC's QC personnel are required to perform Twenty Five (25) percent MT inspection of this weld.

AWS D1.5 (02) Section 6.26.2 – “Welds that are subject to MT in addition to visual inspection shall have no cracks.”

Propose a resolution for the identified non-conformance with revised procedures to prevent future occurrences. Provide training and equipment to the ZPMC MT technician so that these indications are found and provide evidence of such training to the engineer. A response for the resolution of this issue is expected within 7 days.

Repair indication and perform required NDT.

ABF submitted internal NDT documentation verifying the weld is now in conformance with Contract specifications. Per Team China discussions, documentation from ZPMC verifying the repairs were made and NDT was performed by ZPMC technicians will be submitted at a later date and added to the Data Base.
