Contract #: 04-0120F4Cty: SF/ALA Rte: 80 PM: 13.2/13.9File #: 69.25B**QUALITY ASSURANCE -- NON-CONFORMANCE REPORT****Location:** Changxing Island, Shanghai, P.R. China**Report No:** NCR-000635**Prime Contractor:** American Bridge/Fluor Enterprises, a JV**Date:** 16-Jan-2010**Submitting Contractor:** Zhenhua Port Machinery Company, Ltd (ZPMC), Changxing Island**NCR #:** ZPMC-0608**Type of problem:**

Reference Description: Free hand thermal cutting on tower strut without Engineer's approval, South Tower Side

Job Name: SAS Superstructure
Document No: 05.03.06-000595

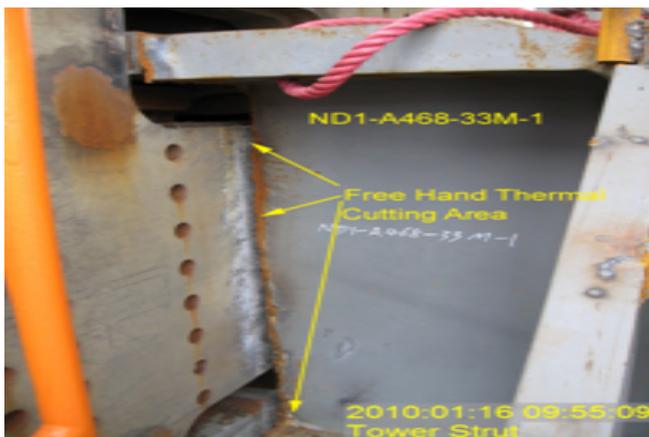
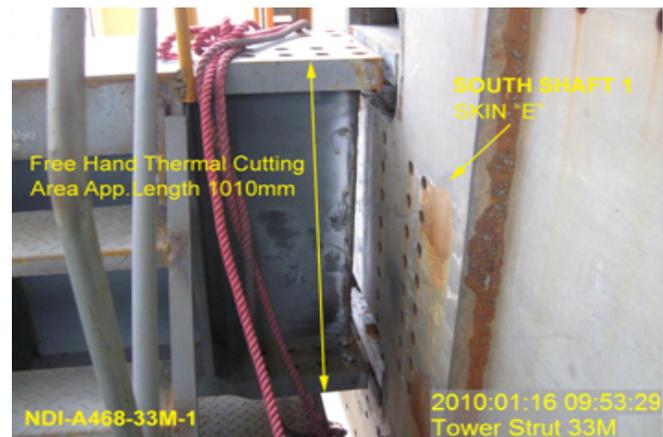
- Free hand thermal cutting were carried out on edges of the strut plate towards South Tower side without Engineer's approval.
- The strut is identified as ND1-A468-33M-1 at elevation level 33M.
- The thermal cut area is measured approximately 1010 mm.
- The material is designated as Seismic Performance Critical Member (SPCM).
- The member is located at Tower assembly area (Jetty Area).

AWS D1.5 (02) Section 3.2.3: "Steel and weld metal may be thermally cut, provided a smooth and regular surface free from cracks and notches is secured, and provided that an accurate profile is secured by the use of a mechanical guide. Freehand thermal cutting shall be done only where approved by the Engineer."

Propose a resolution for the identified non-conformance, documenting that the affected plate edges have been brought in compliance with the contract requirements.

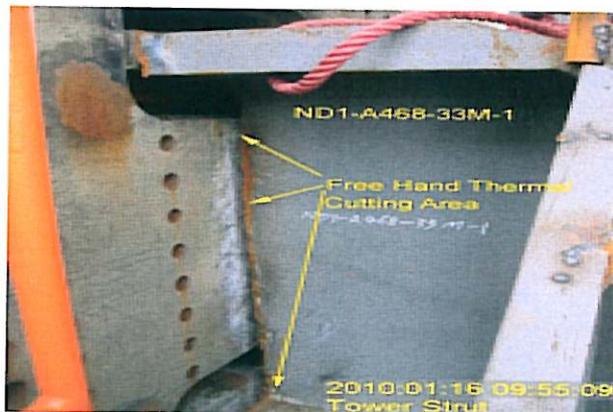
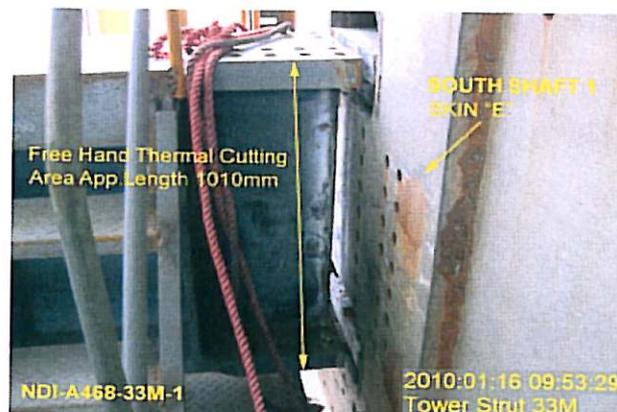
- Free hand thermal cutting were carried out on edges of the strut plate towards South Tower side without Engineer's approval.
- The strut is identified as ND1-A468-33M-1 at elevation level 33M.
- The thermal cut area is measured approximately 1010 mm.
- The material is designated as Seismic Performance Critical Member (SPCM).
- The member is located at Tower assembly area (Jetty Area).

AWS D1.5 (02) Section 3.2.3: "Steel and weld metal may be thermally cut, provided a smooth and regular surface free from cracks and notches is secured, and provided that an accurate profile is secured by the use of a mechanical guide. Freehand thermal cutting shall be done only where approved by the Engineer."

ZPMC has taken action to repair these areas by buttering, and hole edge distance can also be satisfied. Now this strut has been green tagged.
