Contract #: 04-0120F4Cty: SF/ALA Rte: 80 PM: 13.2/13.9File #: 69.25B**QUALITY ASSURANCE -- NON-CONFORMANCE REPORT****Location:** Changxing Island, Shanghai, P.R. China**Report No:** NCR-000645**Prime Contractor:** American Bridge/Fluor Enterprises, a JV**Date:** 20-Jan-2010**Submitting Contractor:** Zhenhua Port Machinery Company, Ltd (ZPMC), Changxing Island**NCR #:** ZPMC-0616**Type of problem:**

Reference Description: ZPMC performed Base Metal Repair on 6AW Edge Panel (SPCM material) without prior Engineer's approval

Dear: Mr. Charles Kanapicki
Job Name: SAS Superstructure

Subject: NCR No. ZPMC-0616

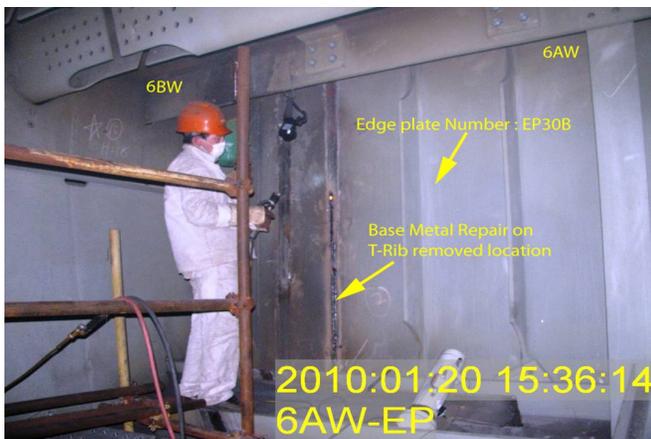
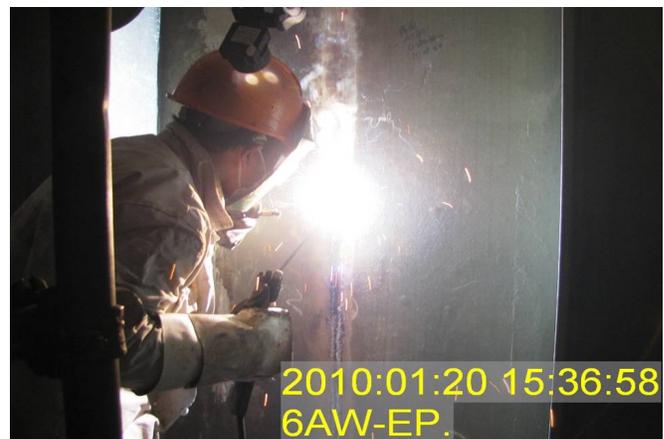
During the Quality Assurance (QA) random in-process visual inspection of the OBG segments in the Trial Assembly area, this QA inspector discovered the following issue:

- Base metal repairs (BMR) were being performed without Engineer's approval or Critical Weld Report (CWR) at a location where a T-Rib stiffener had been removed.
- These BMR's were located along the 6AW Edge Panel at panel point (PP) 40.75 Cross Beam side.
- Y location measured from PP 41 is: 1 meter
- The removed T-Rib stiffener is identified as: X106M(FS)
- The Edge Plate located at 6AW is identified as: EP30B
- The material is identified as: A709M Grade 345 Seismic Performance Critical Member (SPCM).
- The approved drawing sheet reference is: EP30

ZPMC acknowledged this problem and has issued internal NCR. ZPMC QA has emphasized the requirement to site QC/CWI that there should be a copy of WRR/CWR before start welding for base metal repair. After grinding these repair areas was tested by MT and was found to be acceptable. T stiffeners have been rewelded and the fillet welds were tested to be acceptable. After NDT verification this issue has been removed from punchlist by CT's representative and green tag has been achieved by three parties. Based on this, ZPMC is requesting this NCR to be closed.

Contractor issued an internal NCR regarding this issue. NDT documentation was not submitted with the NPR. However, the department performed MT at this location before removing the item from the Voyage 2 Punchlist and confirmed that the repairs are in conformance with Contract specifications.

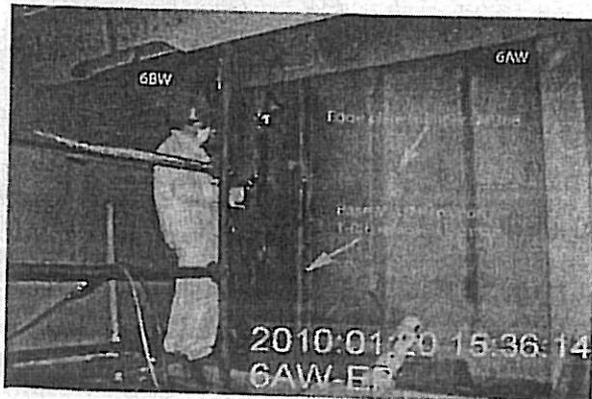
During the Quality Assurance (QA) random in-process visual inspection of the OBG segments in the Trial Assembly area, this QA inspector discovered the following issue:

- Base metal repairs (BMR) were being performed without Engineer's approval or Critical Weld Report (CWR) at a location where a T-Rib stiffener had been removed.
- These BMR's were located along the 6AW Edge Panel at panel point (PP) 40.75 Cross Beam side.
- Y location measured from PP 41 is: 1 meter
- The removed T-Rib stiffener is identified as: X106M(FS)
- The Edge Plate located at 6AW is identified as: EP30B
- The material is identified as: A709M Grade 345 Seismic Performance Critical Member (SPCM).
- The approved drawing sheet reference is: EP30
