QUALITY ASSURANCE -- NON-CONFORMANCE REPORT

Report No: NCR-000647

Component: OBG Segment 6CW

Reference Description: ZPMC cut WT stiffener in Partial Height Crossbeam Diaphragm located at PP 46

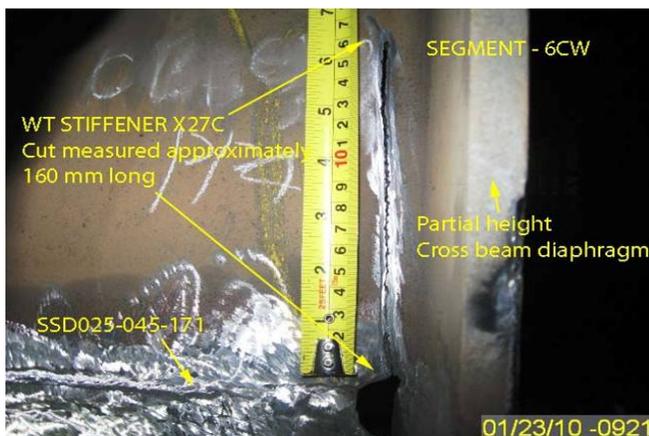
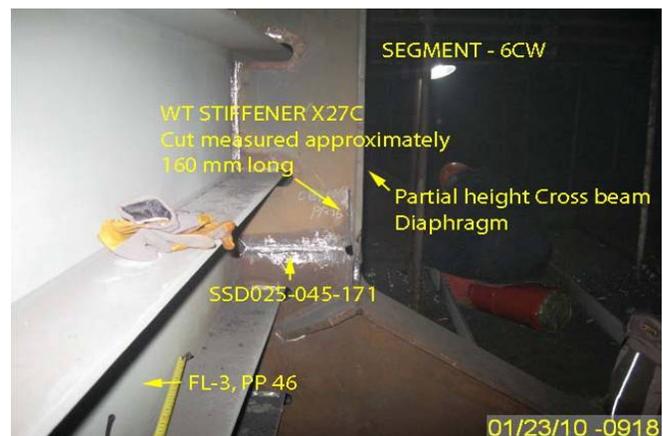
-ZPMC has cut the flange from the web of WT stiffener identified as X27C.

-The stiffener is located on the FL3 floor beam at Panel Point 46.

-The cut measured approximately 160mm in length, perpendicular to Complete Joint Penetration (CJP) weld identified as SSD025-045-171.

-This area will require the addition of a weld that is not designated on the approved shop drawings.

ZPMC acknowledged this problem and has issued internal NCR. The flange was cut to adjust the misalignment with the lower floor beam. ZPMC has repaired the base metal and is providing the NDT records show the repaired area is acceptable. After verification by CT's representative, this issue has been removed from punchlist. ZPMC QA has instructed production department to notify Engineer prior to perform any cutting to base metal. Based on this, ZPMC is requesting this NCR to be closed.

Reference Resolution: ZPMC is providing the NDT records which show that the base metal is acceptable after repair. Based on this ZPMC requests closure of this NCR.

对开孔焊缝进行NDT检测(UT, MT, VT), 合格回用, 加强
现场监控和检查, 确保质量
Perform NDT inspection (UT, MT, VT) to the welds which have been cutted
away, use-as-is can be done. Enhance supervision on site and ensure the
quality of product.

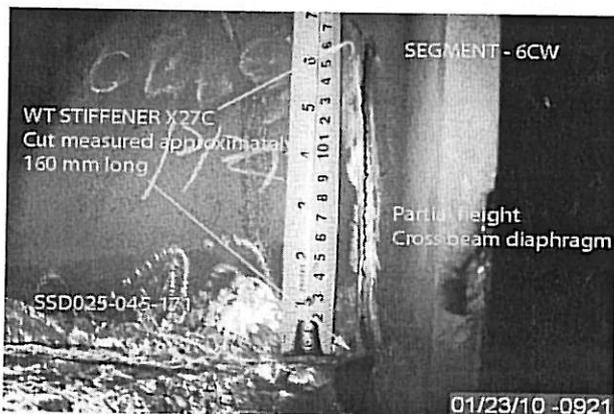
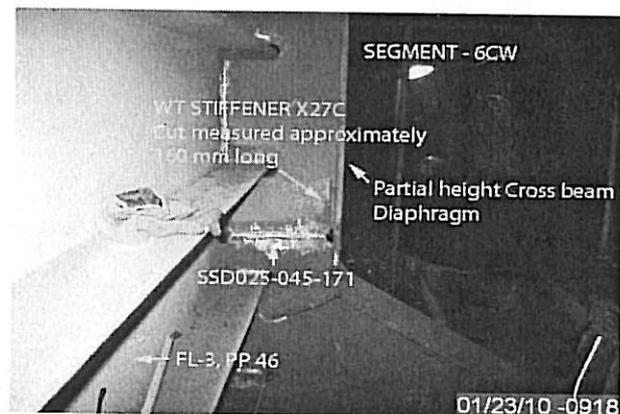
-ZPMC has cut the flange from the web of WT stiffener identified as X27C.

-The stiffener is located on the FL3 floor beam at Panel Point 46.

-The cut measured approximately 160mm in length, perpendicular to Complete Joint Penetration (CJP) weld identified as SSD025-045-171.

-This area will require the addition of a weld that is not designated on the approved shop drawings.

Perform NDT required to verify weld quality.

Contractor issued an internal NCR in regards to this issue. NDT documentation was submitted verifying the quality of the weld complies with Contract specifications.
