## QUALITY ASSURANCE -- NON-CONFORMANCE REPORT

**Report No:** NCR-000659

**Reference Description:** Noted deflection exceeding contract requirement on 5CW Longitudinal Diaphragm Side Stiffener

**Job Name:** SAS Superstructure

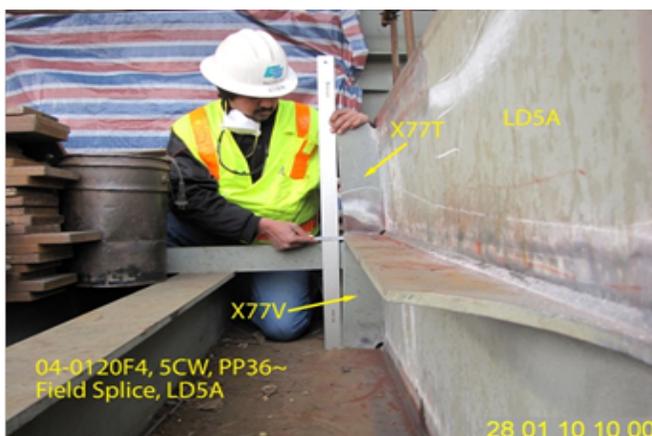
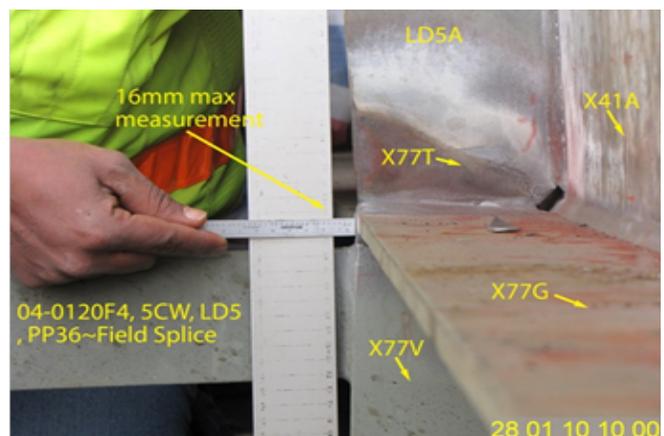
-Two (2) longitudinal diaphragm (LD) stiffeners were found to be out of tolerance over the length of both stiffeners measured vertically.

-16mm max deflection was measured with a straight edge in contact with the bottom of X77V and the top of X77T.

-Stiffeners X77T and X77V are attached to the intermediate stiffener X77G.

-The LD deflection was measured horizontally across the web and is 11mm in 4000mm on LD5A.

-These measurements were taken at Segment 5CW panel point (PP) 36 Counter Weight side.

Allowable lateral variations between the centerline of the web and the centerline of the flange of built-up H or I members at contact surface shall not exceed 6mm (1/4).

Propose a resolution for the identified non-conformance with revised procedures to prevent future occurrences and also provide documentation to show that the deflection has been properly corrected to meet contract requirements.

ZPMC acknowledged this problem and the rectification has been performed. The stiffeners on LD was cut off and rewelded to fix the deflection. After NDT verification and dimension checking, this issue has been removed from punchlist by CT's representative. Based on this, ZPMC is requesting closure of this NCR.

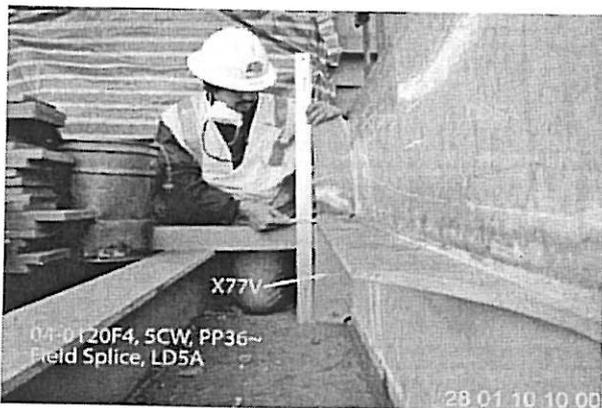
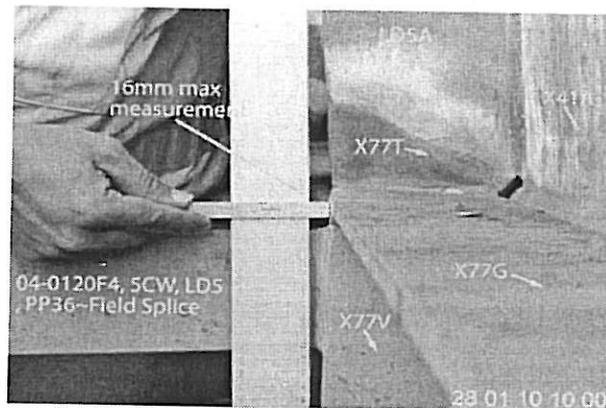
- During random Quality Assurance In-Process Visual inspection on segment 5CW, this Quality Assurance Inspector (QA) discovered the following issues:
- Two (2) longitudinal diaphragm (LD) stiffeners were found to be out of tolerance over the length of both stiffeners measured vertically.
- 16mm max deflection was measured with a straight edge in contact with the bottom of X77V and the top of X77T.
- Stiffeners X77T and X77V are attached to the intermediate stiffener X77G.
- The LD deflection was measured horizontally across the web and is 11mm in 4000mm on LD5A.
- The full length of LD5A is 4260mm.
- The field splice connecting LD5A is between 5CW to 6AW.
- These measurements were taken at Segment 5CW panel point (PP) 36 Counter Weight side.
- Segment 5CW is located outside in the OBG Trail Assembly area.

Allowable lateral variations between the centerline of the web and the centerline of the flange of built-up H or I members at contact surface shall not exceed 6mm (1/4).

Propose a resolution for the identified non-conformance with revised procedures to prevent future occurrences and also provide documentation to show that the deflection has been properly corrected to meet contract requirements.

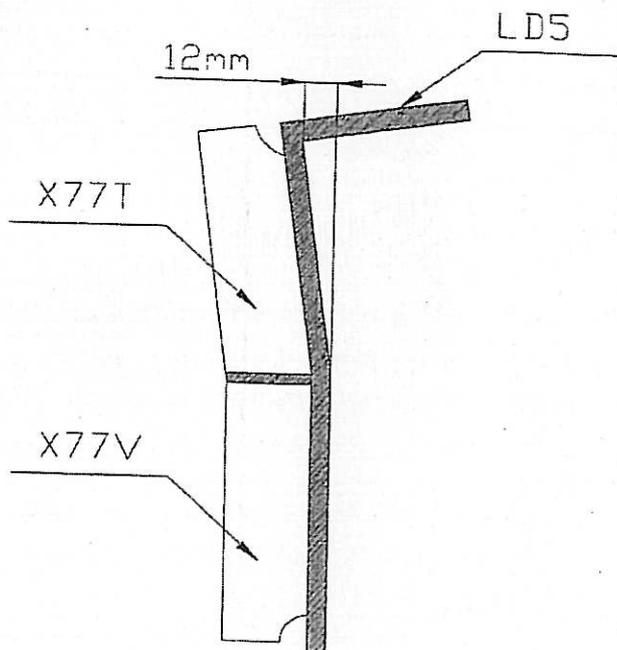
Draft of welding discontinuity:

5CW配重块侧纵桁LD5A上的筋板X77T变形约12mm, 需要调整, 具体尺寸见下图:  
 The distortion was found at 5CW longitudinal diaphragm LD5A stiffener X77T face weight counter and needed to adjust, the detail size sees the following draft.

Weld distortion and fabricate error.

1. Remove the welds where the distortion is out of tolerance between X77TV and X77G by the way of gouging or Oxygen. Preheat according to the WPS prior to gouging.
2. Put in the heat straightening report to revise the distortion area to meet the require of the drawing.
3. Perform 100%VT inspection to the metal cutting area to ensure no defects exist ;
4. Preheat and weld according to the approved repair WPS;
5. Grind the weld flush to the adjacent weld or base metal.
6. Check the weld according to the shop drawings.

Note; during the process of heat straightening, fixture can be used to avoid deformation of LD to assure its match with relevant LD at the splice of girder.
