Contract #: 04-0120F4Cty: SF/ALA Rte: 80 PM: 13.2/13.9File #: 69.25B**QUALITY ASSURANCE -- NON-CONFORMANCE REPORT****Location:** Changxing Island, Shanghai, P.R. China**Report No:** NCR-000672**Prime Contractor:** American Bridge/Fluor Enterprises, a JV**Date:** 03-Feb-2010**Submitting Contractor:** Zhenhua Port Machinery Company, Ltd (ZPMC), Changxing Island**NCR #:** ZPMC-0640**Type of problem:**

Reference Description: Missed MT and UT indications by QC on welded members in Segment 9AE**Description of Non-Conformance:**

Dear: Mr. Charles Kanapicki
Attention: Mr. Thomas Nilsson Project/Fabrication Manager
Subject: NCR No. ZPMC-0640

Job Name: SAS Superstructure
Document No: 05.03.06-000631

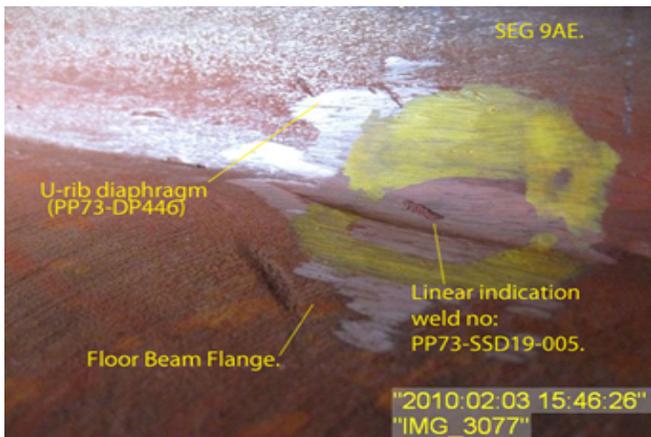
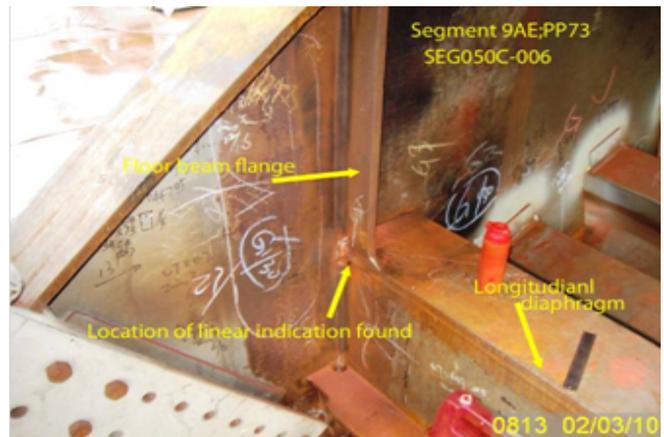
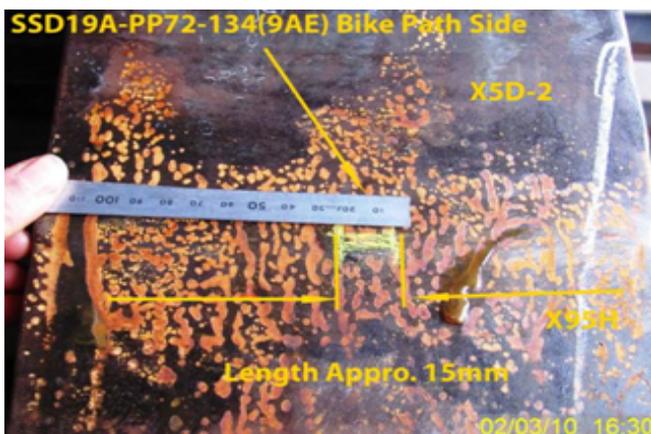
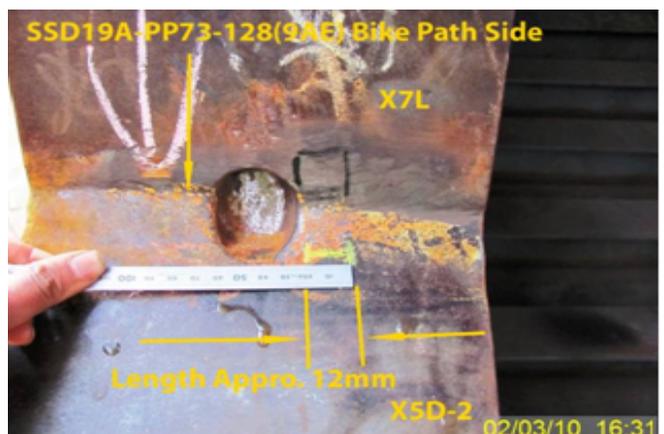
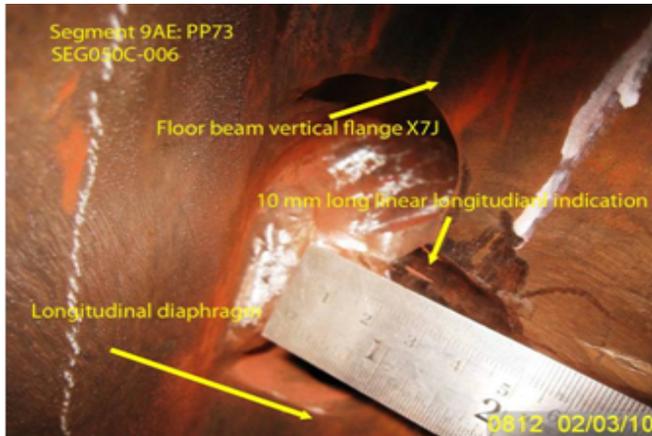
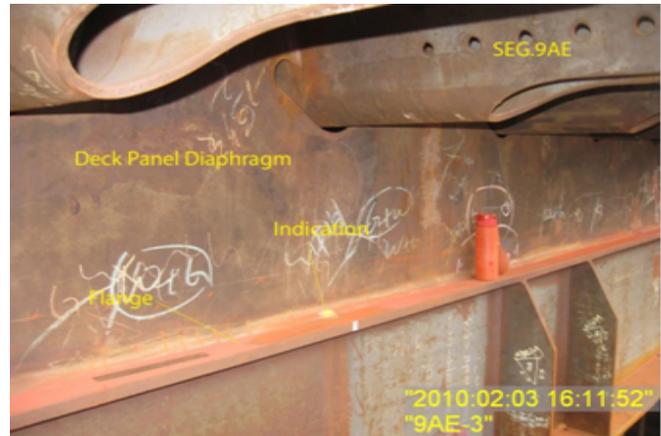
During the Quality Assurance Ultrasonic Testing (UT) review of welds located on Orthotropic Box Girder (OBG) segment 9AE, this Quality Assurance Inspector (QA) discovered the following issues:

- Location #1: Two (2) longitudinal Class "A" indications.
- Indication #1 measures approximately 15mm.
- The indication dBs rating is +6.
- Material thickness is 20mm.
- The depth of the indication is approximately 16.5mm.
- The weld is identified as SSD19A-PP72-134.
- The indication is clearly marked on or near the weld.
- The Y location is approximately 70mm from edge of the flange plate.
- The weld is a Complete Joint Penetration (CJP) Butt joint joining Flange Plate X5D-2 to Floor Beam X5D.

- Location #2: One Indication measures approximately 12mm.
- The indication dBs rating is +7.
- Material thickness is 20mm.
- The depth of the indication is approximately 17mm.
- The weld is identified as SSD19A-PP73-128.
- The indication is clearly marked on or near the weld.
- The Y location is approximately 55mm from edge of the flange plate.
- The weld is a Complete Joint Penetration (CJP) "T" joint joining Flange Plate X5D-2 to Floor Beam X7L.
- These indications (location #1 and #2) are located in an area previously tested and accepted by ZPMC Quality Control (QC) personnel. As per the contract documents, ZPMCs QC personnel are required to perform 25% UT inspection of this weld.

During the Quality Assurance Magnetic particle Testing (MT) review of welds located on OBG Segment 9AE, this Quality Assurance Inspector (QA) discovered the following issue:

- One (1) longitudinal linear crack that measured approximately 10mm in length.
 - The weld is identified as SEG050C-006 at panel point (PP) 73.
 - This weld is a partial joint penetration (PJP) weld joining the Floor Beam (FB10A) to the vertical Flange (X7J) that attaches to the Longitudinal Diaphragm (LD2A).

- This weld joint is designated as Non-Seismic Performance Critical Member (Non-SPCM).
-
- One (1) longitudinal linear indication measuring approximately 8 mm.

- The weld is identified as SSD19-PP73-005.
 - The weld is an 8mm fillet T-joint joining the deck panel diaphragm to the top flange of the FL2-1 floor beam at PP 73.

- The Y location is approximately 9800mm from the bike path end of this floor beam.
 - The indication is clearly marked on the material on/near the weld.
-

- These indications are located within the area that has been previously tested and accepted by ZPMC Quality Control (QC) personnel. ZPMC's QC personnel are required to perform 100% MT inspection of this weld.

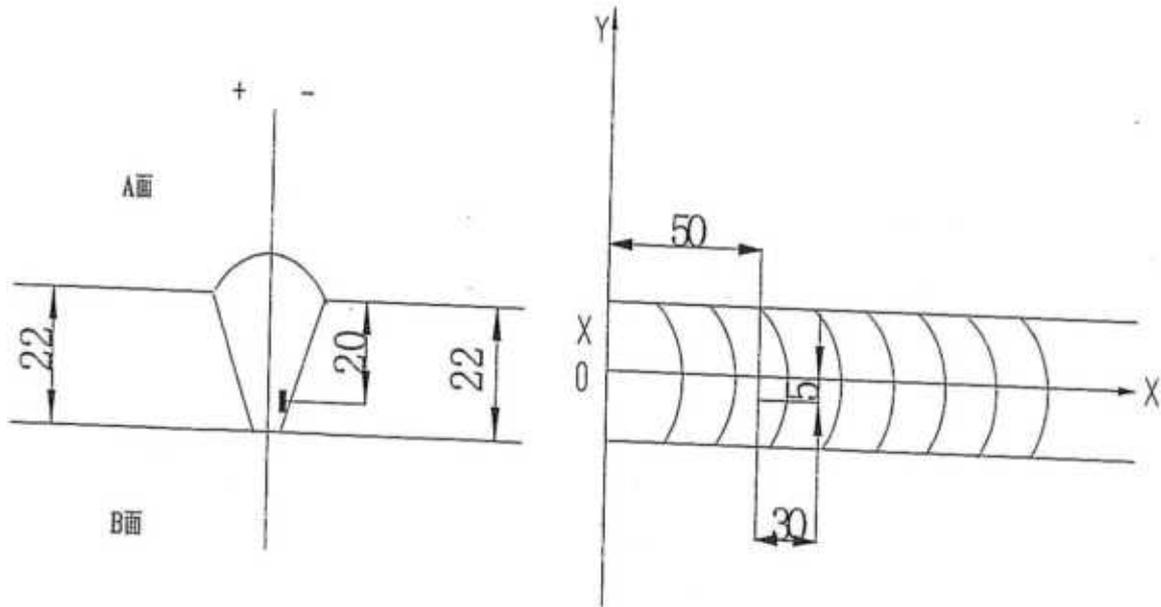
WELD NUMBER: SSD19A-PP072-134

Rejected indication found by ultrasonic inspection is less than the maximum allowance aggregate length.

(UT探伤发现的缺陷总长度小于最大允许长度。) SSD19A-PP072-134

1. Gouge or grind from nearer side from metal edge ($D \leq 0.65T$, "D" is depth of defects, "T" is thickness of metal) to remove all defects;

2. Follow repair WPS for joint preparation, preheat, and weld deposit;

3. Verify with VT no defects remain in the weld joint prior to welding;

4. Grind the repaired area flush with base metal or the adjacent weld;

5. Perform UT inspection to the weld along with 50mm on each end of the repair area;

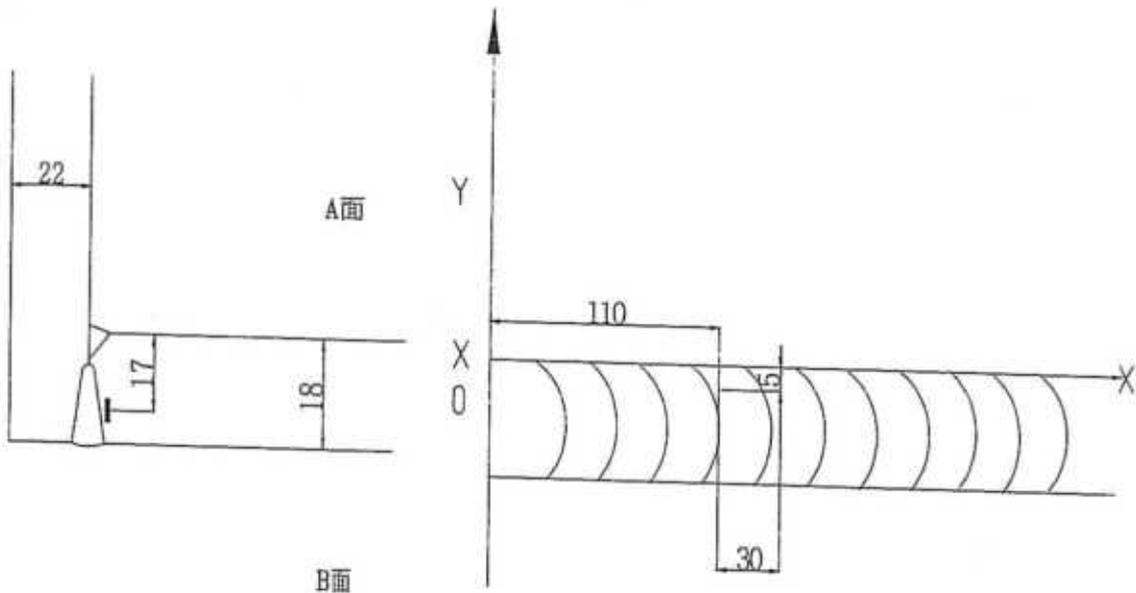
WELD NUMBER: SSD19A-PP073-128

Rejected indication found by ultrasonic inspection is less than the maximum allowance aggregate length.

(UT探伤发现的缺陷总长度小于最大允许长度。) SSD19A-PP073-128

1. 从缺陷距离端面较近一侧 ($D \leq 0.65T$, D为缺陷深度, T为板厚) 采用碳刨或打磨的方法去除焊缝缺陷;
 2. 参照返修焊接工艺规程 (WPS) 准备正确的接头型式, 预热和焊接;
 3. 焊前对修补区域进行VT检测保证缺陷完全被清除;
 4. 将修补区域打磨到与母材或邻近焊缝平齐;
 5. 对焊缝进行UT检测, 检测范围为返修区域以及其两端各延长50mm.
-
1. Gouge or grind from nearer side from metal edge ($D \leq 0.65T$, "D" is depth of defects, "T" is thickness of metal) to remove all defects;
 2. Follow repair WPS for joint preparation, preheat, and weld deposit;
 3. Verify with VT no defects remain in the weld joint prior to welding;
 4. Grind the repaired area flush with base metal or the adjacent weld;
 5. Perform UT inspection to the weld along with 50mm on each end of the repair area;

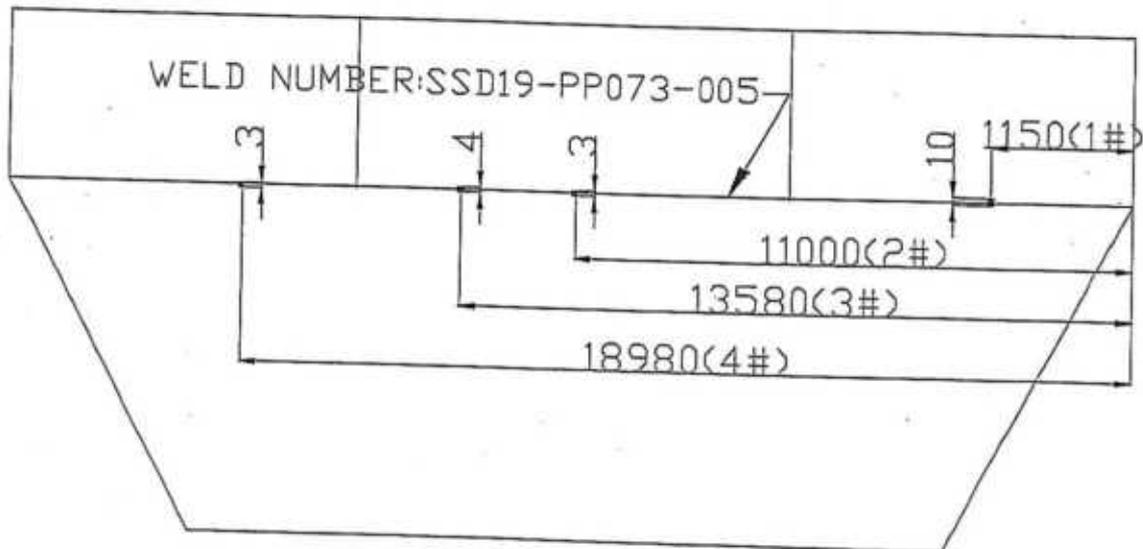
在对SSD19-PP073-005检测时,发现4处横向裂纹。L1=10mm;L2=3mm;L3=4mm;L4=3mm

Four transverse cracks were found by use of MT on SSD19-PP073-005.

1. 火焰加热时, 水汽没有完全的去掉或者这个区域预热不够;
1. Moisture wasn't completely removed during drying operation (preheating) or the area wasn't preheated sufficiently.

1. QC and a Lead CWI shall be present, direct and supervise all grinding and welding operations during this repair to ensure the repair is per the disposition requirements

2. QC and a Lead CWI shall have an approved copy of the CWR in hand prior to the repair.
3. Remove paint ≥ 25 mm in all direction of HAZ prior to MT.
4. Clean the excavation area of all loose debris including MT powder. Preheat to 65° C before removing cracks by grinding, repair area shall extend a minimum of 50mm beyond each end of single crack repairs and 50mm beyond the outermost cracks for multiple crack repairs.

5. If base metal is damaged by grinding, the damaged area shall be ground clean prior to performing weld repair. If gap > 5 mm is found during or after grinding, comply with the notification on changing fillet weld to CJP which is submitted for Engineer's review and approval form.

6. Prepare excavation in accordance with the New Repair Procedure prior to welding.
7. Before this repair, Verify with VT and MT repair areas are defects free, and also MT shall be performed on the base metal laying abroad cracks to ensure that no cracks were propagated to the base metal. Separate CWR approval is needed if cracks are found in the base metal, and only after this new CWR's approval can continue the repair.

8. Clean excavation area of all loose debris including MT powder after excavation. Preheat and weld according to repair WPS, the preheat shall between 160° C-230° C

9. Perform post weld heating according to repair WPS, the postheat shall between 230° C-315° C and for one hour minimum.
10. Allow the weld to cool to ambient temperature gradually. Control cooling rate after PWHT to no more than 50° C per hour.

11. Grind the repaired area flush with base metal or the adjacent weld after post weld heating.
12. Wait 48 hours at least after the repair area has cooled to ambient temperature before performing NDT.

13. Perform MT inspection to all repair area according to Contract Drawings along with all additional NDT required by the applicable notes Special Provision Section 10-1.59 'Steel Structure', subsection 'inspection testing'. NDT include VT, MT and UT if it is a CJP weld.

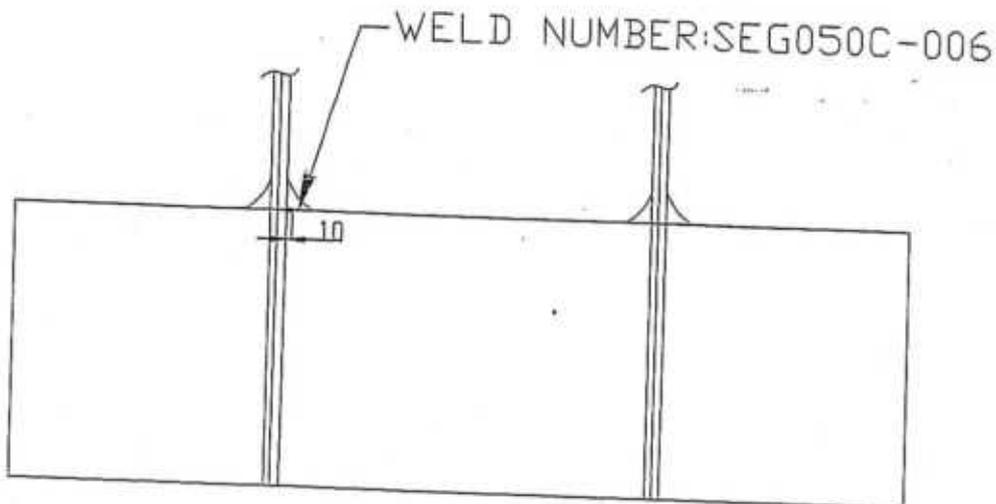
在对SEG050C-006检测时, 发现1处纵向裂纹。1、L=10mm

One longitudinal crack was found by use of MT on SEG050C-006

1. Moisture wasn't completely removed during drying operation (preheating) or the area wasn't preheated sufficiently.

1. QC and a Lead CWI shall be present, direct and supervise all grinding and welding operations during this repair to ensure the repair is per the disposition requirements.

2. QC and a Lead CWI shall have an approved copy of the CWR in hand prior to the repair.
3. Remove paint ≥25mm in all direction of HAZ prior to MT.
4. Clean the excavation area of all loose debris including MT powder. Preheat to 65° C before removing cracks by grinding and it applied to all the repair process. Repair area shall extend a minimum of 50mm beyond each end of single crack repairs.

5. If base metal is damaged by grinding, the damaged area shall be ground clean prior to performing weld repair.
6. Prepare excavation in accordance with the New Repair Procedure prior to welding.

7. Before this repair, Verify with VT and MT repair areas are defects free, and also MT shall be performed on the base metal laying abroad cracks to ensure that no cracks were propagated to the base metal. Separate CWI approval is needed if cracks are found in the base metal, and only after this new CWR's approval can continue the repair.

8. Clean excavation area of all loose debris including MT powder after excavation. Preheat and weld according to repair WPS, the preheat shall between 160° C—230° C.

9. If a crack still present and excavation have reached (2/3T+2)mm maximum, the grinding work shall be ceased. Prepare excavation that all metal is ground clean to a smooth, shiny metal finish and starts and stops are tapered to a 1:1 slope. Weld first side of repair according to approved WPS, and the preheat temperature be 160° C at least. Grind from the opposite side until sound weld metal is reached and perform 100% MT of excavation to ensure no crack exists. Prepare excavation that all metal is ground clean to a smooth, shiny metal finish and starts and stops are tapered to a 1:1 slope. Weld opposite side of repair according to approved WPS.

10. Perform post weld heating according to repair WPS, the postheat shall between 230° C—315° C and for one hour minimum.
11. Allow the weld to cool to ambient temperature gradually. Control cooling rate after PWHT to no more than 50° C per hour.

12. Grind the repaired area flush with base metal or the adjacent weld after post weld heating.
13. Wait 48 hours at least after the repair area has cooled to ambient temperature before performing NDT.

Perform VT, UT and MT inspection to all repair area according to Contract Drawings along with all additional NDT required by the applicable notes Special Provision Section 10-1.59 'Steel Structure', subsection 'inspection testing'.
