Contract #: 04-0120F4Cty: SF/ALA Rte: 80 PM: 13.2/13.9File #: 69.25B**QUALITY ASSURANCE -- NON-CONFORMANCE REPORT****Location:** Changxing Island, Shanghai, P.R. China**Report No:** NCR-000683**Prime Contractor:** American Bridge/Fluor Enterprises, a JV**Date:** 21-Feb-2010**Submitting Contractor:** Zhenhua Port Machinery Company, Ltd (ZPMC), Changxing Island**NCR #:** ZPMC-0650**Type of problem:**

**Reference Description:** Missed MT Indications by QC on OBG Segment 6AE and 6BE Edge Panel Stiffeners

**Subject:** NCR No. ZPMC-0650

**QUALITY ASSURANCE -- NON-CONFORMANCE RESOLUTION**

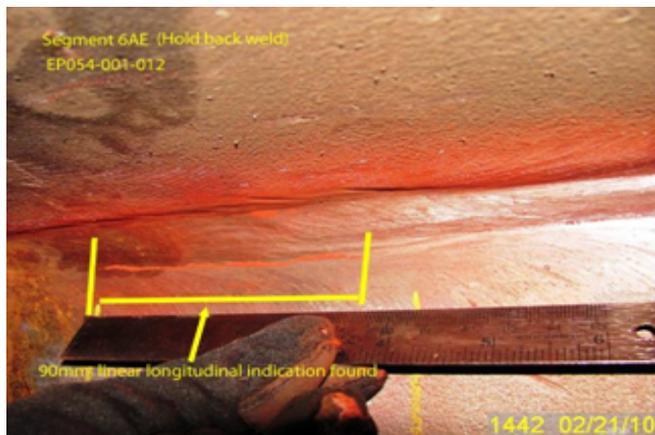
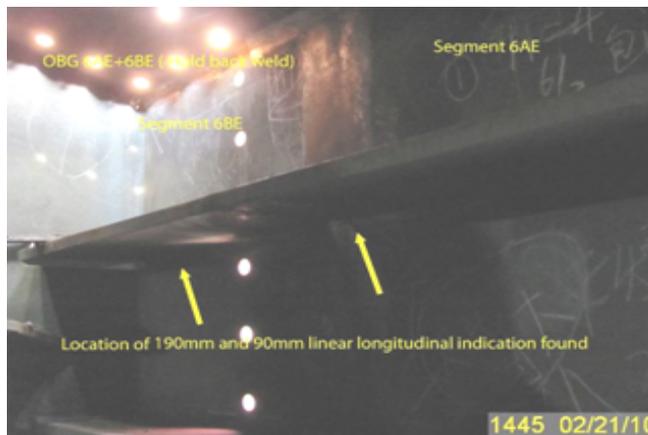
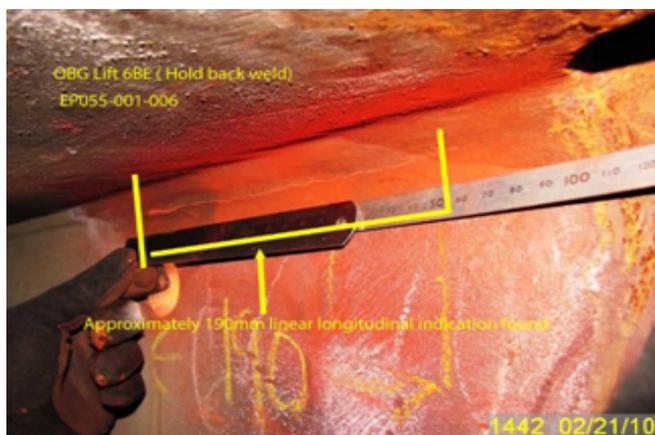
During the Quality Assurance (QA) Magnetic particle Testing (MT) review of welds located on OBG Segment 6AE and 6BE, this QA Inspector discovered the following issue:

- Two (2) longitudinal linear indications that measured approximately 90mm and 190mm in length.
- The welds are identified as:
  - EP054-001-012 in segment 6AE @ in between panel point PP40.5 to PP41 (90mm).
  - EP055-001-006 in segment 6BE @ in between panel point PP40.5 to PP41 (190mm).
- These weld joints are designated as Seismic Performance Critical Members (SPCM).
- The welds are fillet welds joining:
  - The stiffener identified as RS88HA to the edge plate (EP054) identified as PL1157B (SPCM) in segment 6AE.

The stiffener identified as RS88EA to the edge plate (EP055) identified as PL1162A (SPCM) in segment 6BE.

- The indications are clearly marked on the material on/near the weld.
  - The OBG segment is located in the trial assembly.
- The Notice of Witness Inspection Number (NWIT) is 005218. The indication is located inside the area that has been previously tested and accepted by ZPMC Quality Control (QC) personnel. As per the contract documents, ZPMC QC personnel are required to perform 100% Magnetic particle inspection of these welds.

AWS D1.5 (02) Section 6.26.2 – “Welds that are subject to MT in addition to visual inspection shall have no cracks.

**Reference Resolution:** ZPMC has repaired the missed indications and is attaching NDT documentation to show that the welds are acceptable. Based on this ZPMC requests closure of this NCR.

ZPMC has repaired the missed indications and is attaching NDT documentation to show that the welds are acceptable. In addition, ZPMC has conducted training with its inspectors to reduce the number of missed indications. Also ZPMC has written and internal NCR to address this problem. Based on this ZPMC requests closure of this NCR.

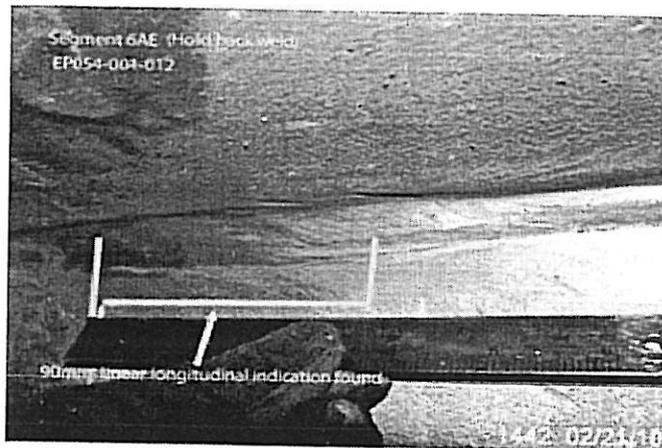
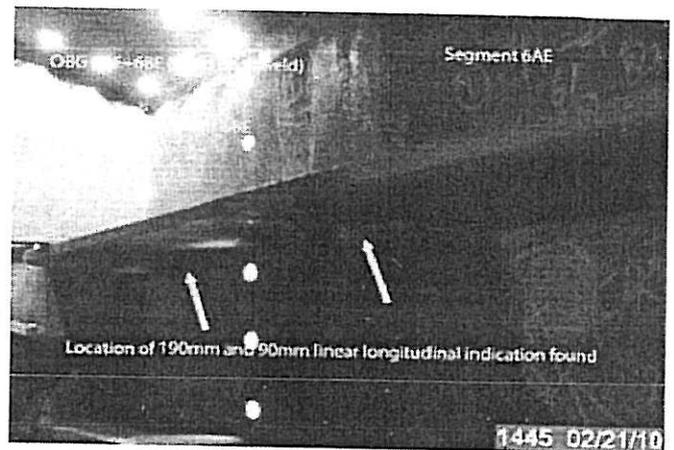
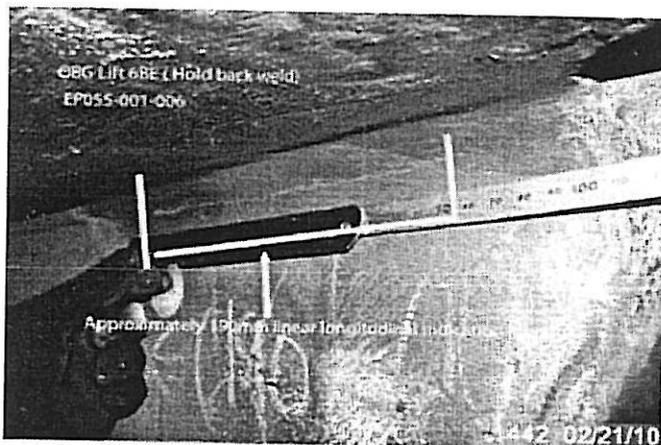
During the Quality Assurance (QA) Magnetic particle Testing (MT) review of welds located on OBG Segment 6AE and 6BE, this QA Inspector discovered the following issue:

- Two (2) longitudinal linear indications that measured approximately 90mm and 190mm in length.
  - The welds are identified as:  
EP054-001-012 in segment 6AE @ in between panel point PP40.5 to PP41 (90mm).  
EP055-001-006 in segment 6BE @ in between panel point PP40.5 to PP41 (190mm).

- These weld joints are designated as Seismic Performance Critical Members (SPCM).
  - The welds are fillet welds joining:  
The stiffener identified as RS88HA to the edge plate (EP054) identified as PL1157B (SPCM) in segment 6AE.  
The stiffener identified as RS88EA to the edge plate (EP055) identified as PL1162A (SPCM) in segment 6BE.

- The indications are clearly marked on the material on/near the weld.
  - The OBG segment is located in the trial assembly.
- The Notice of Witness Inspection Number (NWIT) is 005218. The indication is located inside the area that has been previously tested and accepted by ZPMC Quality Control (QC) personnel. As per the contract documents, ZPMC QC personnel are required to perform 100% Magnetic particle inspection of these welds.

AWS D1.5 (02) Section 6.26.2 – “Welds that are subject to MT in addition to visual inspection shall have no cracks.

Repair said indications and perform NDT required to verify weld quality.

Contractor submitted NDT reports verifying the welds were repaired in conformance with approved CWRs and are now in conformance with Contract specifications. An internal NCR was also issued by the Contractor in regards to this issue.
