Contract #: 04-0120F4Cty: SF/ALA Rte: 80 PM: 13.2/13.9File #: 69.25B**QUALITY ASSURANCE -- NON-CONFORMANCE REPORT****Location:** Changxing Island, Shanghai, P.R. China**Report No:** NCR-000684**Prime Contractor:** American Bridge/Fluor Enterprises, a JV**Date:** 21-Feb-2010**Submitting Contractor:** Zhenhua Port Machinery Company, Ltd (ZPMC), Changxing Island**NCR #:** ZPMC-0651**Type of problem:**

Reference Description: Missed MT Transverse Indication by QC on Segment 6BW Edge Panel Stiffener**Description of Non-Conformance:**

Job Name: SAS Superstructure

Subject: NCR No. ZPMC-0651

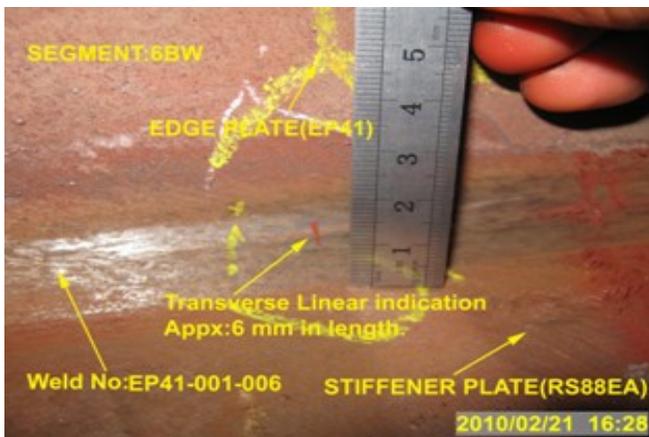
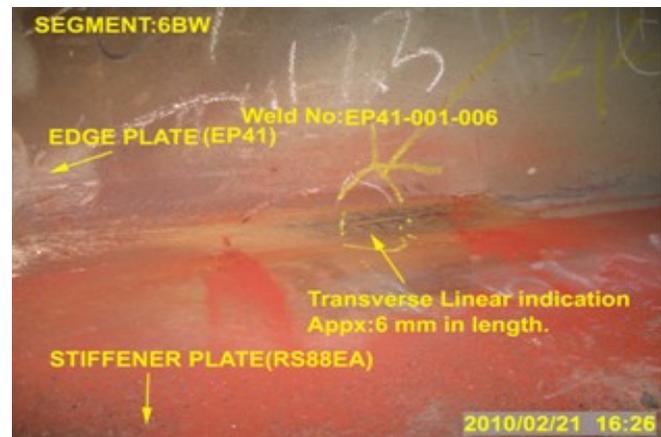
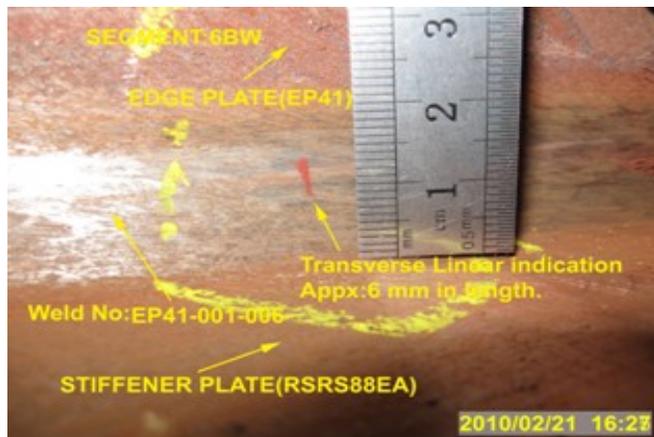
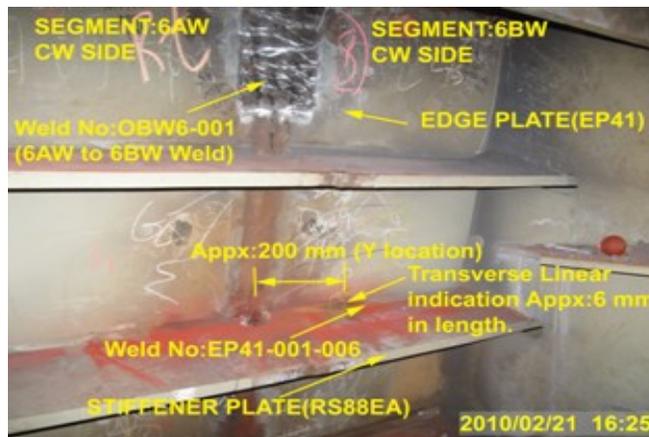
During Quality Assurance (QA) Magnetic Particle Testing (MT) review of welds located on Orthotropic Box Girder (OBG) Segment 6BW, this QA Inspector discovered the following issue:

- One (1) Transverse Linear indication measuring approximately 6 mm in length.
- The weld is identified as: EP41-001-006.
- The weld is a fillet weld joining stiffener plate RS88EA to edge plate EP41.
- The Y location is approximately 200mm from segment splice weld identified as OBW6-001.
- Segment 6BW is located in the OBG trial assembly yard.

The Notice of Witness Inspection Number (NWIT) is 005218. The indication is located inside the area that has been previously tested and accepted by ZPMC Quality Control (QC) personnel. As per the contract documents, ZPMC QC personnel are required to perform 100% MT inspection of these welds.

AWS D1.5 2002, Figure 6.8: – specifies for fillet weld sizes between 6mm and 13mm the maximum discontinuity length is approximately 2mm to 4mm.

Provide CWR and perform weld repair and subsequent NDT to ensure that the weld is acceptable to the contract requirement.

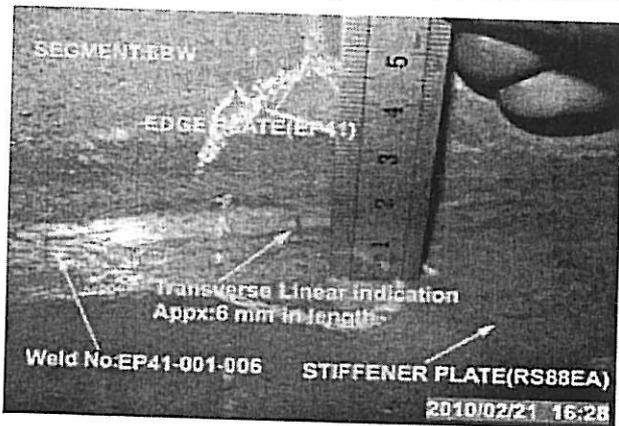
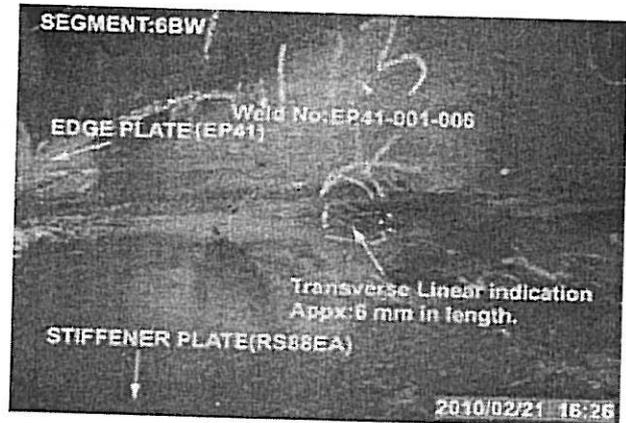
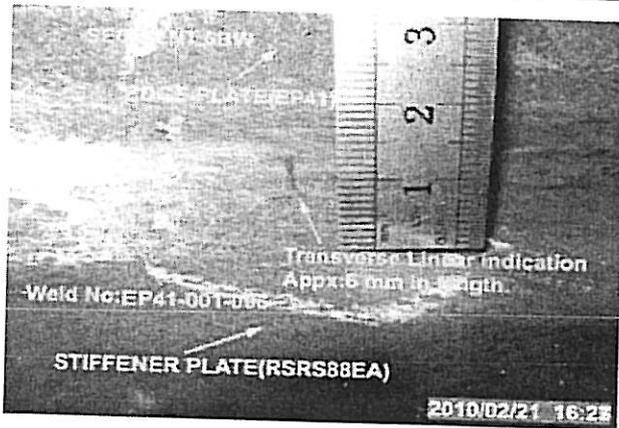
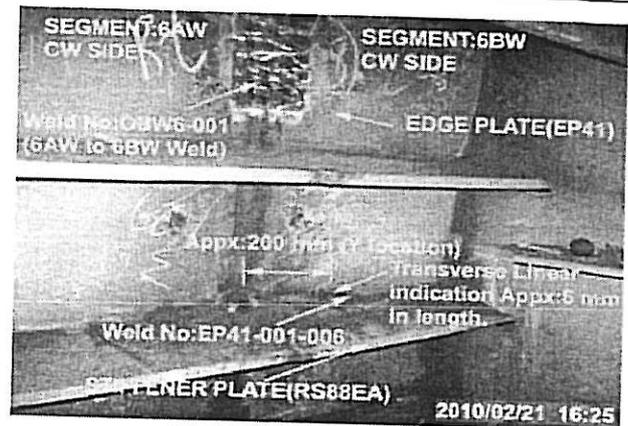
During Quality Assurance (QA) Magnetic Particle Testing (MT) review of welds located on Orthotropic Box Girder (OBG) Segment 6BW, this QA Inspector discovered the following issue:

- One (1) Transverse Linear indication measuring approximately 6 mm in length.
- The weld is identified as: EP41-001-006.
- The weld is a fillet weld joining stiffener plate RS88EA to edge plate EP41.
- The Y location is approximately 200mm from segment splice weld identified as OBW6-001.
- Segment 6BW is located in the OBG trial assembly yard.

The Notice of Witness Inspection Number (NWIT) is 005218. The indication is located inside the area that has been previously tested and accepted by ZPMC Quality Control (QC) personnel. As per the contract documents, ZPMC QC personnel are required to perform 100% MT inspection of these welds.

AWS D1.5 2002, Figure 6.8: – specifies for fillet weld sizes between 6mm and 13mm the maximum discontinuity length is approximately 2mm to 4mm.

Provide CWR and perform weld repair and subsequent NDT to ensure that the weld is acceptable to the contract requirement.
