Contract #: 04-0120F4Cty: SF/ALA Rte: 80 PM: 13.2/13.9File #: 69.25B**QUALITY ASSURANCE -- NON-CONFORMANCE REPORT****Location:** Changxing Island, Shanghai, P.R. China**Report No:** NCR-000687**Prime Contractor:** American Bridge/Fluor Enterprises, a JV**Date:** 26-Feb-2010**Submitting Contractor:** Zhenhua Port Machinery Company, Ltd (ZPMC), Changxing Island**NCR #:** ZPMC-0654**Type of problem:**

Reference Description: Missed UT indications by QC on Segment 5BW on Side to Edge Panel Welds**Description of Non-Conformance:**

Job Name: SAS Superstructure
Document No: 05.03.06-000644

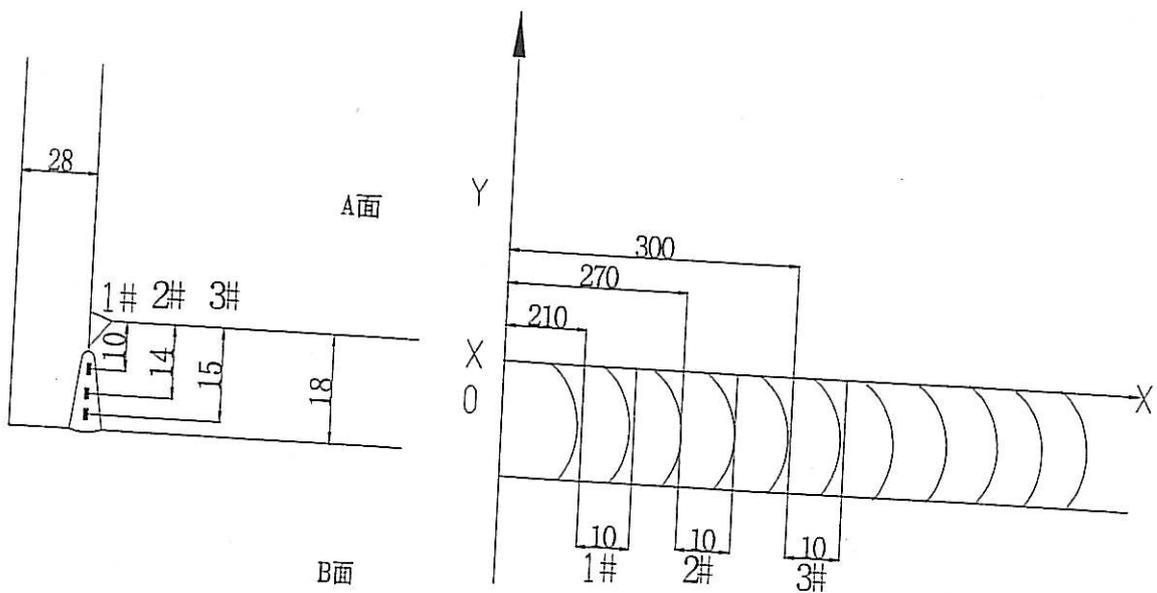
WELD NUMBER: CA019-001

Rejected indication found by ultrasonic inspection is less than the maximum allowance aggregate length.
(UT探伤发现的缺陷总长度小于最大允许长度。) CA019-001

1. Did not clear the weld pass completely in time.

1. Gouge or grind from nearer side from metal edge ($D \leq 0.65T$, "D" is depth of defects, "T" is thickness of metal) to remove all defects;

2. Follow repair WPS for joint preparation, preheat, and weld deposit;

3. Verify with VT no defects remain in the weld joint prior to welding;

4. Grind the repaired area flush with base metal or the adjacent weld;

5. Check the welds according to the working drawings.
