QUALITY ASSURANCE -- NON-CONFORMANCE REPORT

Location: Changxing Island, Shanghai, P.R. China**Report No:** NCR-000692**Prime Contractor:** American Bridge/Fluor Enterprises, a JV**Date:** 02-Mar-2010**Submitting Contractor:** Zhenhua Port Machinery Company, Ltd (ZPMC), Changxing Island**NCR #:** ZPMC-0659**Type of problem:**

Reference Description: Unapproved Heat Straightening of Deck Plate Diaphragm**Description of Non-Conformance:**

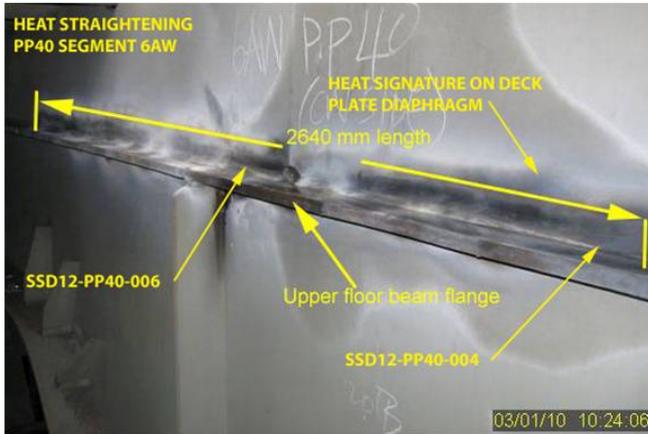
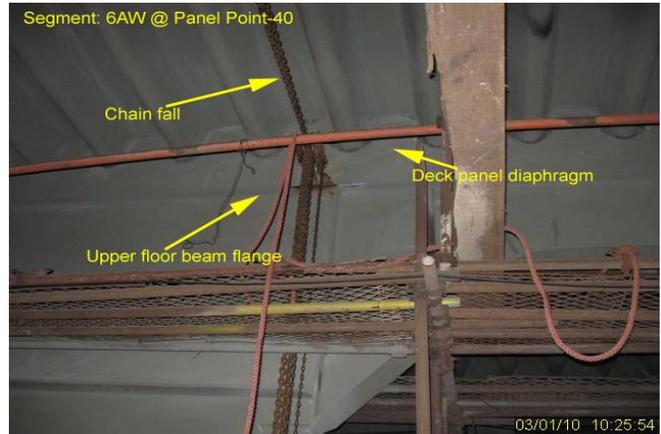
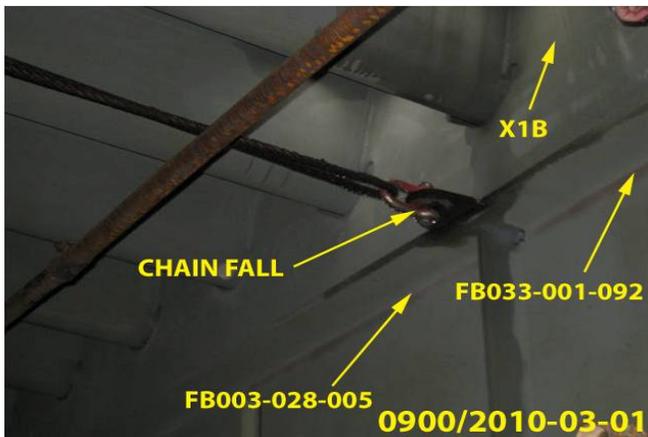
- ZPMC personnel have performed heat straightening at various locations along the top flange of the Floorbeam and the Deck Plate Diaphragm at Panel Point (PP) 40 in OBG segment 6AW.

- Heat Straightening work performed by ZPMC personnel deviated from the procedure shown on HSR1(B)-8155. Heat signatures were observed on the Deck Plate Diaphragm and the top flange of the Floorbeam. The internally approved HSR1 detailed heat straightening to be performed on the top flange of the Floorbeam only.

- HSR1(B)-8155 denotes heat straightening of up to 25mm.
- Not all locations which received heat straightening were identified in HSR1(B)-8155.
- The jack used during heat straightening was not positioned as detailed in the HSR1.

- The Deck Plate Diaphragm is 716mm tall and 14mm thick.
- The weld numbers for the affected welds at PP40 are as follows: SSD12-PP040-005, SSD12-PP040-006, SSD12B-PP040-003, FB003-028-004, FB003-028-005, FB011-003-003, FB011-003-004, FB011-003-044, FB033-001-092, FB033-001-093, and FB033-001-147.

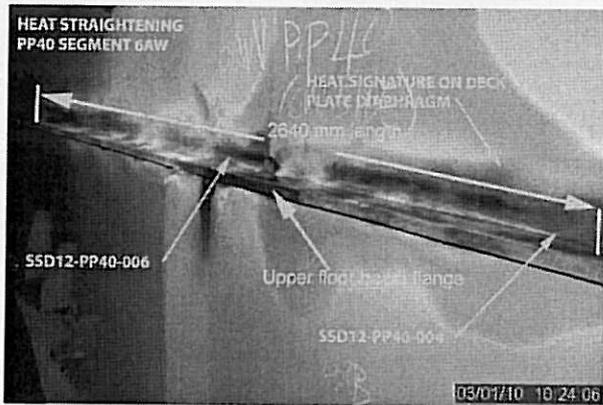
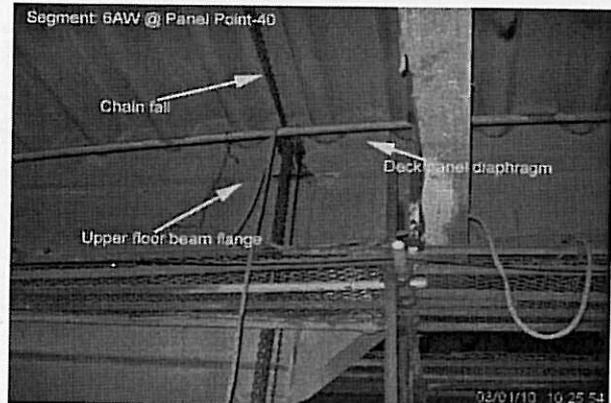
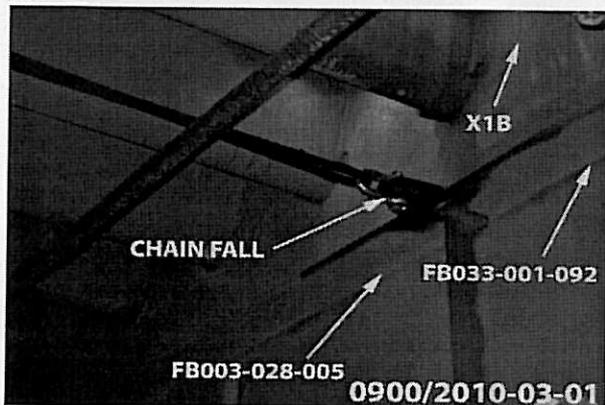
- ZPMC personnel have performed heat straightening at various locations along the top flange of the Floorbeam and the Deck Plate Diaphragm at Panel Point (PP) 40 in OBG segment 6AW.

- Heat Straightening work performed by ZPMC personnel deviated from the procedure shown on HSR1(B)-8155. Heat signatures were observed on the Deck Plate Diaphragm and the top flange of the Floorbeam. The internally approved HSR1 detailed heat straightening to be performed on the top flange of the Floorbeam only.

- HSR1(B)-8155 denotes heat straightening of up to 25mm.
- Not all locations which received heat straightening were identified in HSR1(B)-8155.
- The jack used during heat straightening was not positioned as detailed in the HSR1.

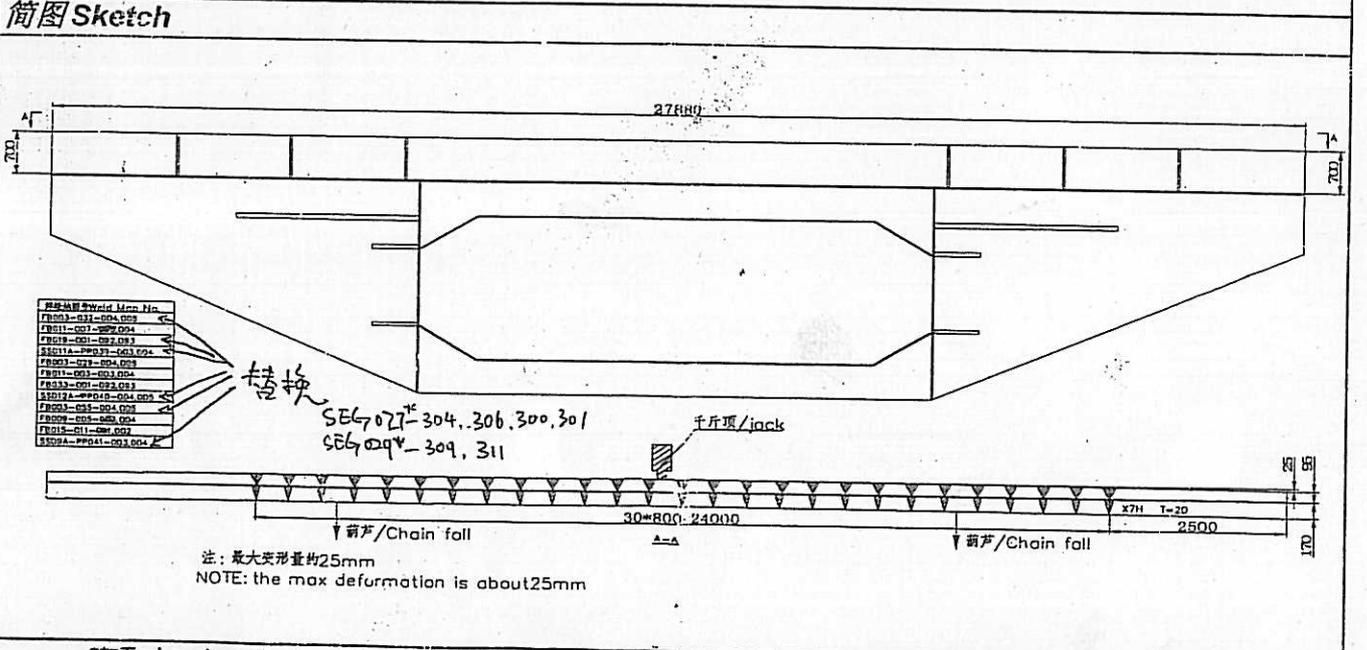
情况描述 Description of Condition
 Cause 原因: Welding distortion 焊接变形
 Type of Defect 缺陷类型: Welding distortion 焊接变形
 Inspection Method 检查方法: Visual 目检

处置方法 Disposition
 缺陷去除方法(Defect Removal Method): natural gas 天然气
 后续NDE(Post-Removal NDE): After finishing heat straightening, the weld of the heat area shall perform NDT according to the approved shop drawing 校火后, 根据图纸要求对热影响区域进行NDT检测。
 纠正措施(Corrective Action(s)): Control current, voltage and weld speed according to relevant WPS. If necessary anti-deformation or hold down device can be added. 依据相应的WPS的要求控制电流, 电压和焊接速度。如有必要, 可使用反变形设施进行校正。
 实施次数(Number of application): 1~3
 最高温度(Maximum temperature): <650°C

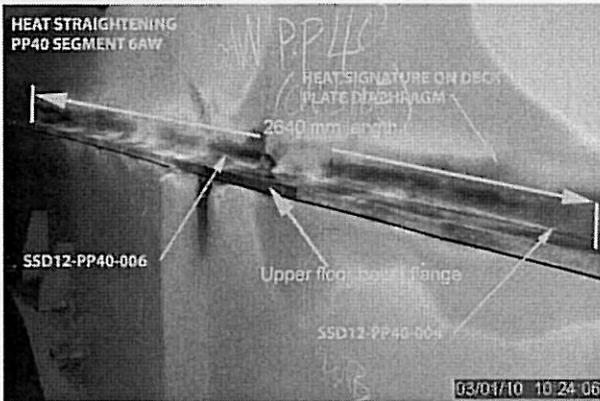
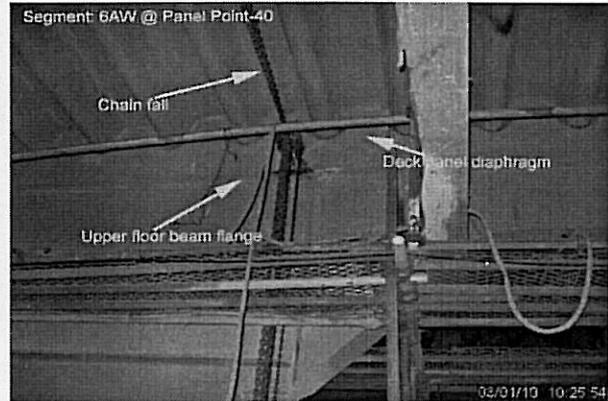
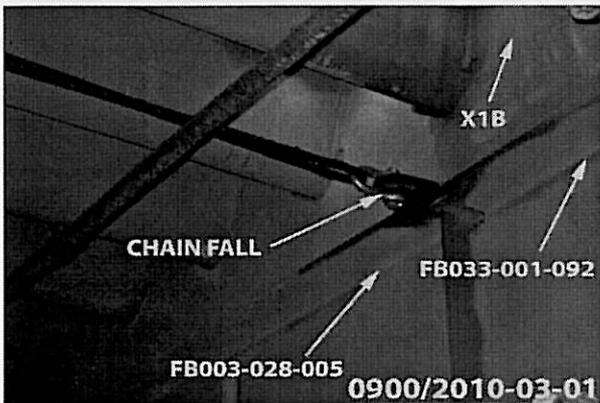
-Heat Straightening work performed by ZPMC personnel deviated from the procedure shown on HSR1(B)-8155. Heat signatures were observed on the Deck Plate Diaphragm and the top flange of the Floorbeam. The internally approved HSR1 detailed heat straightening to be performed on the top flange of the Floorbeam only.

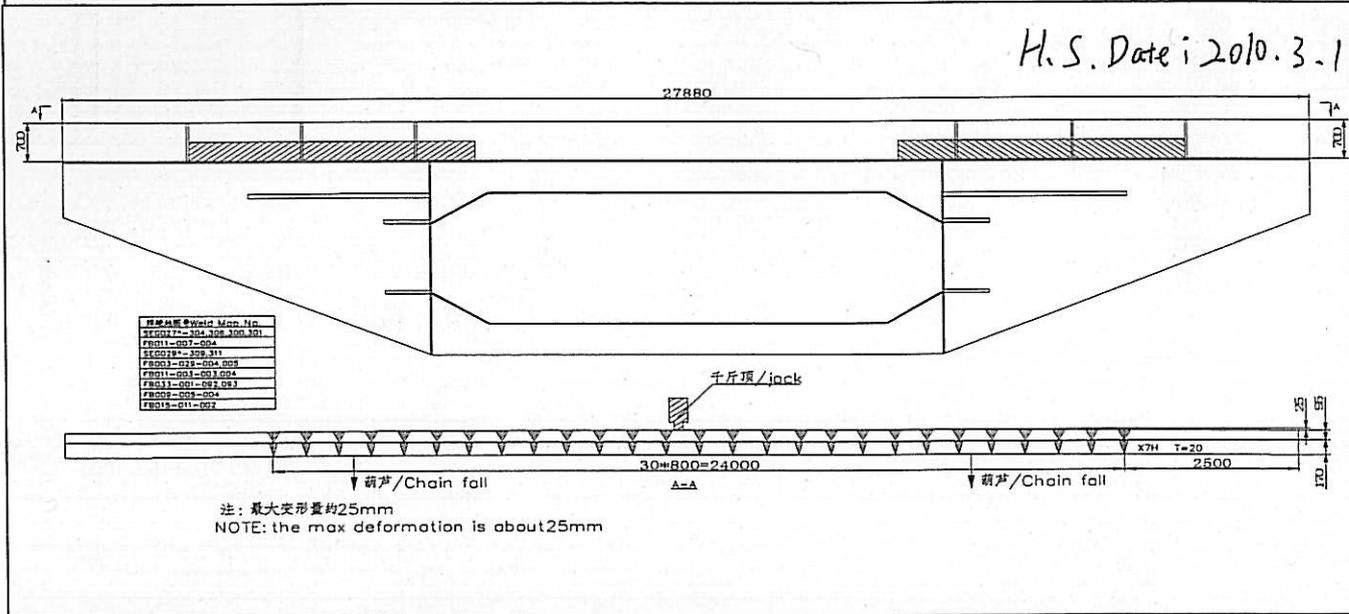
简图 Sketch

Cause原因 Welding distortion 焊接变形
 Type of Defect缺陷类型 Welding distortion 焊接变形
 Inspection Method检查方法 Visual 目检

缺陷去除方法(Defect Removal Method): natural gas 天然气

实施次数(Number of application): 1~3
 最高温度(Maximum temperature): <650°C

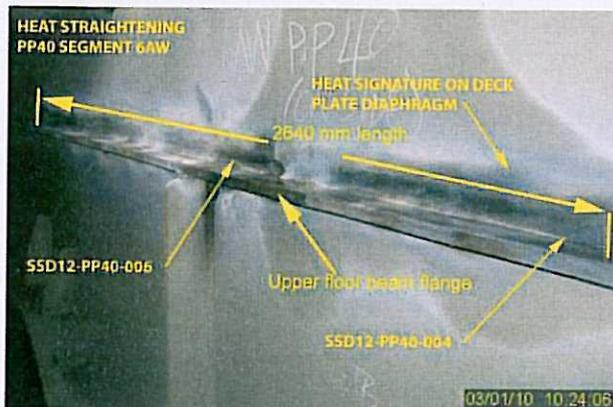
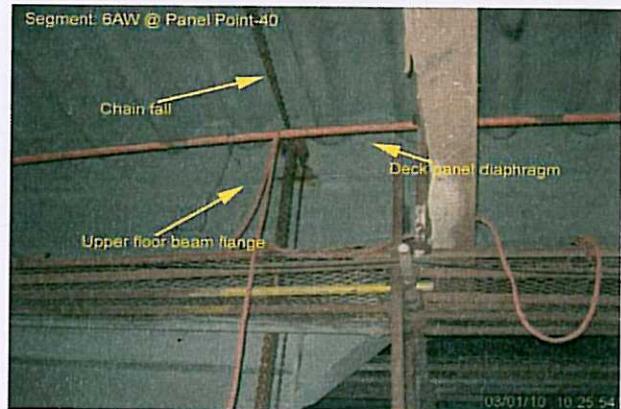
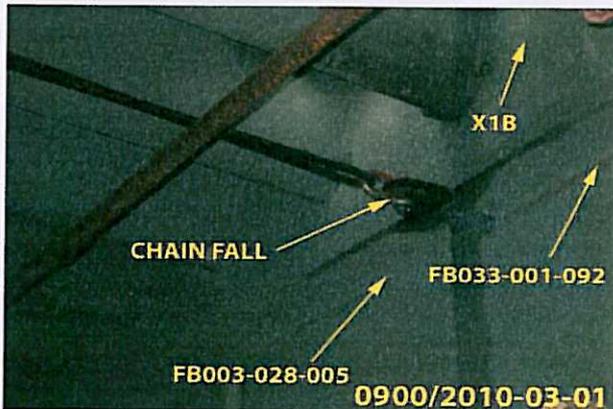
-Heat Straightening work performed by ZPMC personnel deviated from the procedure shown on HSR1(B)-8155. Heat signatures were observed on the Deck Plate Diaphragm and the top flange of the Floorbeam. The internally approved HSR1 detailed heat straightening to be performed on the top flange of the Floorbeam only.

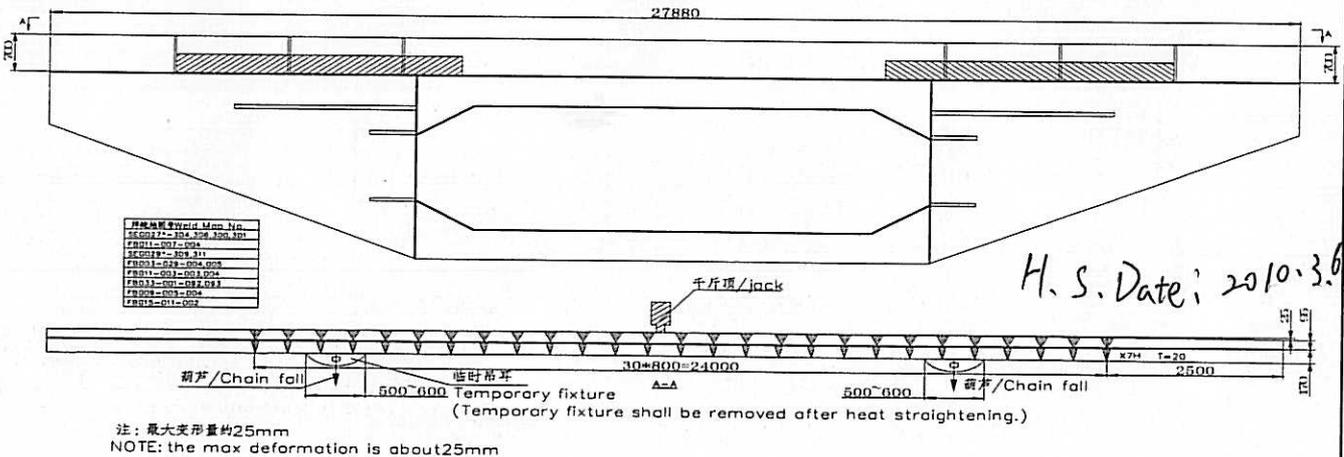
简图 Sketch

Cause 原因 Welding distortion 焊接变形

Type of Defect 缺陷类型 Welding distortion 焊接变形

缺陷去除方法(Defect Removal Method): natural gas 天然气

最高温度(Maximum temperature): <650°C
