Contract #: 04-0120F4Cty: SF/ALA Rte: 80 PM: 13.2/13.9File #: 69.25B**QUALITY ASSURANCE -- NON-CONFORMANCE REPORT****Location:** Changxing Island, Shanghai, P.R. China**Report No:** NCR-000698**Prime Contractor:** American Bridge/Fluor Enterprises, a JV**Date:** 16-Mar-2010**Submitting Contractor:** Zhenhua Port Machinery Company, Ltd (ZPMC), Changxing Island**NCR #:** ZPMC-0665**Type of problem:**

Reference Description: 16 Missed MT Transverse Indications by QC on OBG Suspender Bracket
 SB010-042-026

Report No: NCR-000698

NCR #: ZPMC-0665

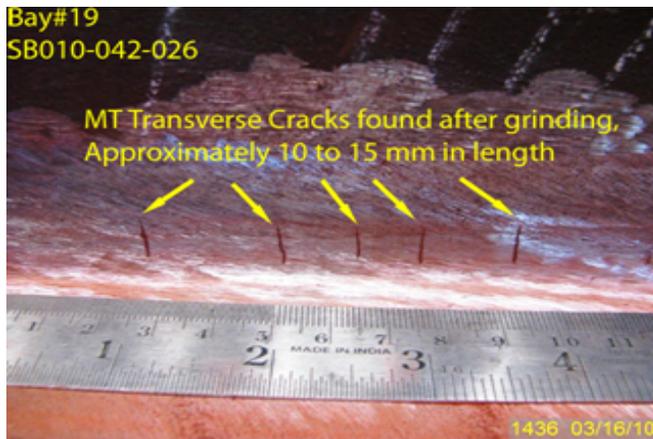
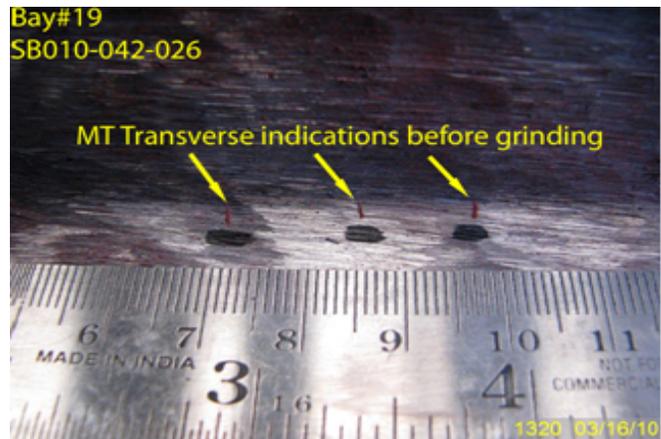
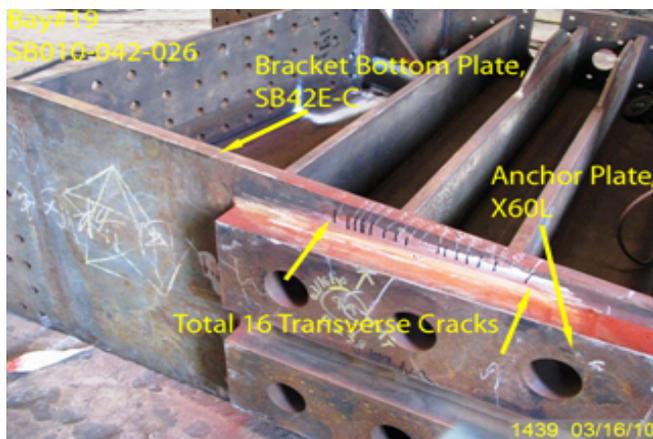
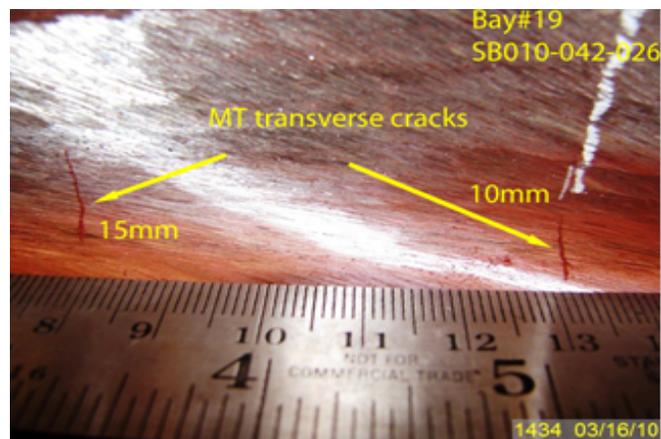
During random Quality Assurance (QA) Magnetic Particle Testing (MT) review of the Suspender Bracket welds, this QA Inspector discovered the following issue:

- A Total of sixteen (16) MT transverse indications measuring approximately 10mm to 15mm in length after grinding.
- The weld is a seal weld joining the bracket bottom Plate (SB42E-C) to the anchor plate (X60L) and is identified as SB010-042-026.
- The indication is located inside the area that has been previously tested and accepted by ZPMC Quality Control (QC) personnel.
- The component is located in OBG fabrication Bay 19. The Notice of Witness Inspection Number (NWIT) is 005352.

It should also be noted that a total of fifteen (15) transverse cracks, on the same weld, were found and repaired by ZPMC personnel utilizing the SMAW process on 03-15-2010 without the prior approval of the engineer and critical weld repair (CWR) report. (Reference Incident Report# 1223 written 03/15/10) Subsequently, ZPMC submitted the B-CWR 1336 on 03-17-2010 which was for the already repaired weld joint with the 15 transverse cracks.

- This B-CWR 1336 was not submitted prior to the weld repair of 15 transverse cracks on 03/15/10.
- On 03-15-2010, the ZPMC QC and welders performed the 15 transverse cracks weld repair without having an approved CWR.

Reference Resolution: ZPMC has repaired the indications found in accordance with the critical weld repair report and is providing the NDT to show that the weld is now acceptable.

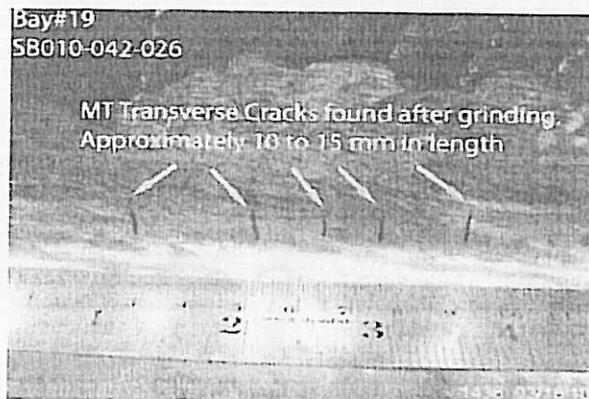
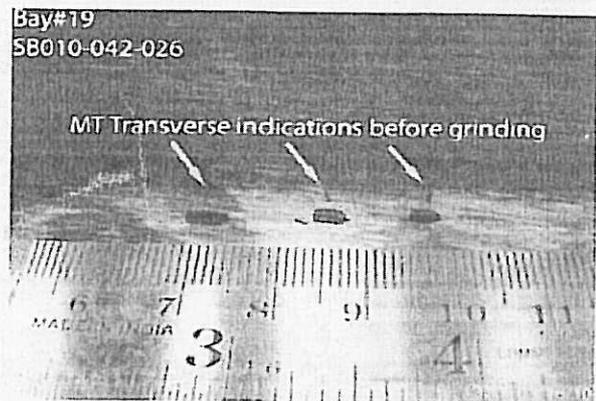
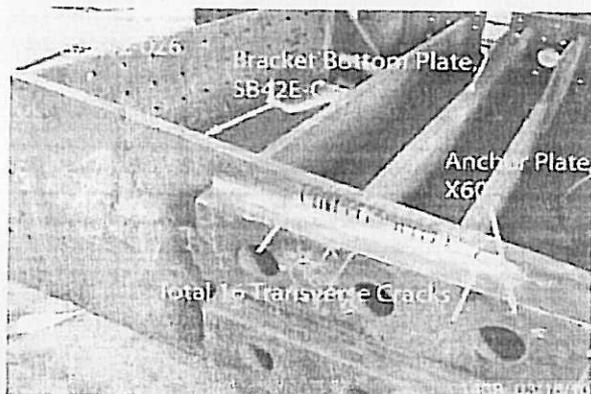
During random Quality Assurance (QA) Magnetic Particle Testing (MT) review of the Suspender Bracket welds, this QA Inspector discovered the following issue:

-A Total of sixteen (16) MT transverse indications measuring approximately 10mm to 15mm in length after grinding.

-The weld is a seal weld joining the bracket bottom Plate (SB42E-C) to the anchor plate (X60L) and is identified as SB010-042-026.

-The indication is located inside the area that has been previously tested and accepted by ZPMC Quality Control (QC) personnel.

-The component is located in OBG fabrication Bay 19. The Notice of Witness Inspection Number (NWIT) is 005352.

It should also be noted that a total of fifteen (15) transverse cracks, on the same weld, were found and repaired by ZPMC personnel utilizing the SMAW process on 03-15-2010 without the prior approval of the engineer and critical weld repair (CWR) report. (Reference Incident Report# 1223 written 03/15/10) Subsequently, ZPMC submitted the B-CWR 1336 on 03-17-2010 which was for the already repaired weld joint with the 15 transverse cracks.

Repair said indication and perform NDT required to verify weld quality.

Contractor submitted post repair NDT documentation verifying weld has been repaired and is in conformance with Contract weld quality requirements.
