Contract #: 04-0120F4Cty: SF/ALA Rte: 80 PM: 13.2/13.9File #: 69.25B**QUALITY ASSURANCE -- NON-CONFORMANCE REPORT****Location:** Changxing Island, Shanghai, P.R. China**Report No:** NCR-000702**Prime Contractor:** American Bridge/Fluor Enterprises, a JV**Date:** 24-Mar-2010**Submitting Contractor:** Zhenhua Port Machinery Company, Ltd (ZPMC), Changxing Island**NCR #:** ZPMC-0669**Type of problem:**

Reference Description: ZPMC personnel applied paint upon surfaces that were not prepared in accordance with SP-10 and while ambient conditions were unsuitable for painting.

During in-process coating inspection of Lift 6 East Internal Bottom Plate field repair areas from Panel Points 41-43, this Caltrans Quality (QA) Inspector observed the following issues:

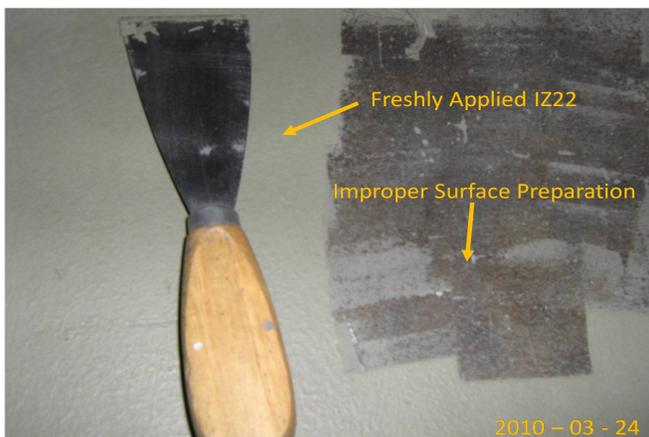
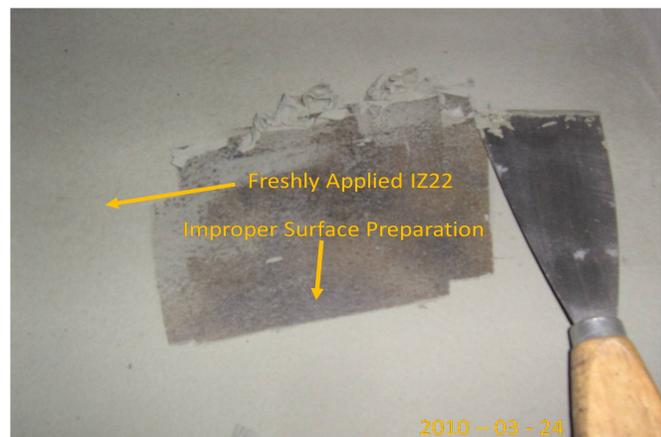
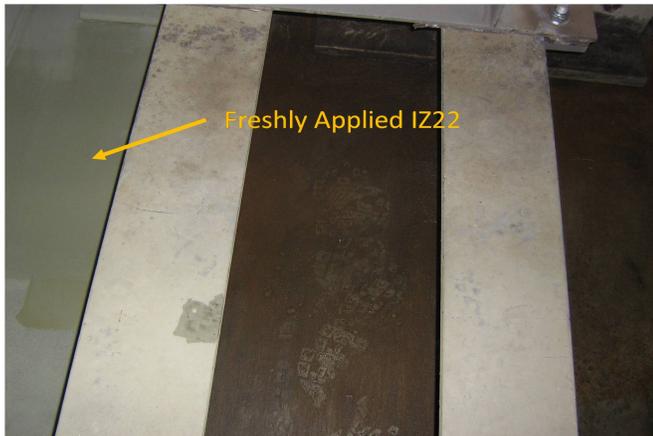
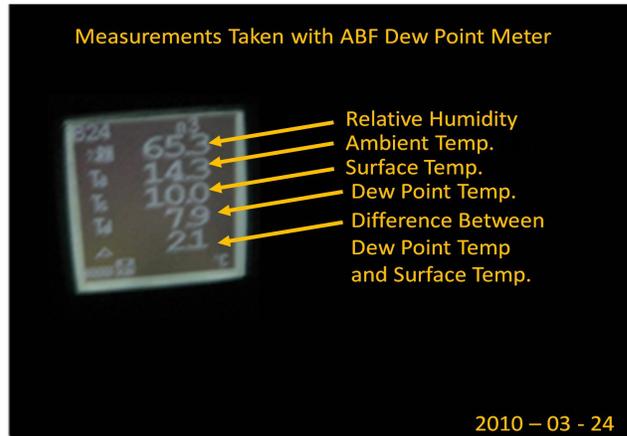
- ZPMC personnel applied inorganic zinc rich primer undercoating upon surfaces which were not prepared in accordance with SSPC SP-10 Surface Preparation Standard.
- ZPMC personnel applied inorganic zinc rich undercoating during non-compliant ambient conditions. The difference between the surface temperature of the steel which the coating was applied to and the dew point temperature was measured to at 2.1° Celsius.

Surface temperature must always be a minimum of 3°C (5°F) above dew point.

Perform pull tests on areas in question to verify adhesion properties.

Contractor performed pull tests and paint was found to be in compliance with Contract adhesion requirements.

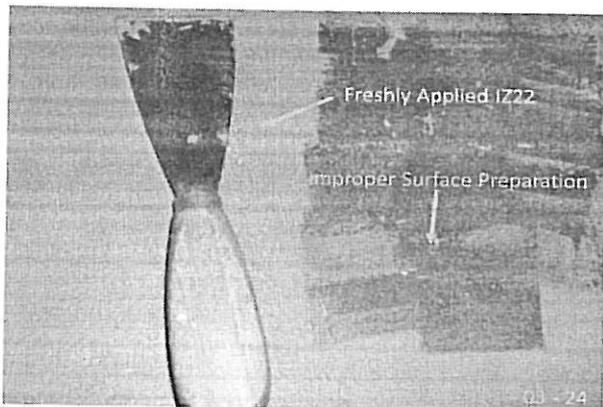
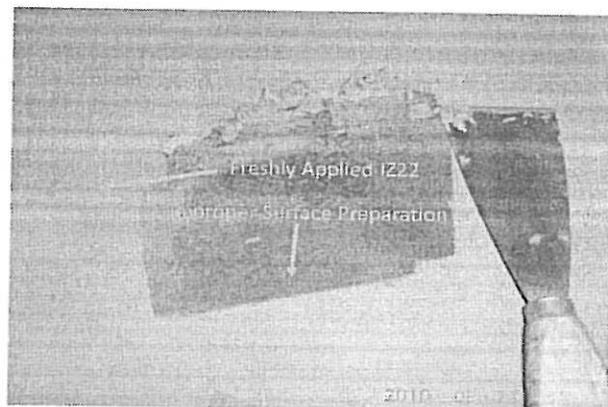
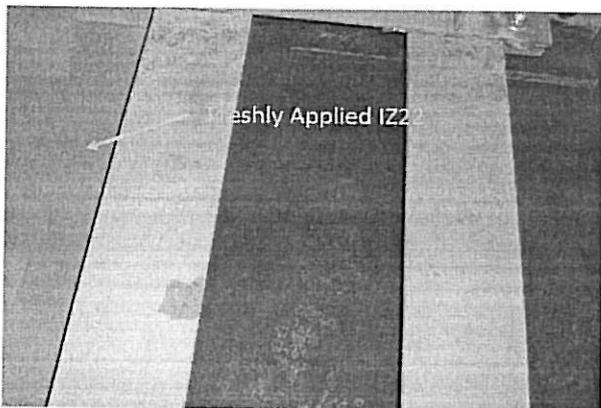
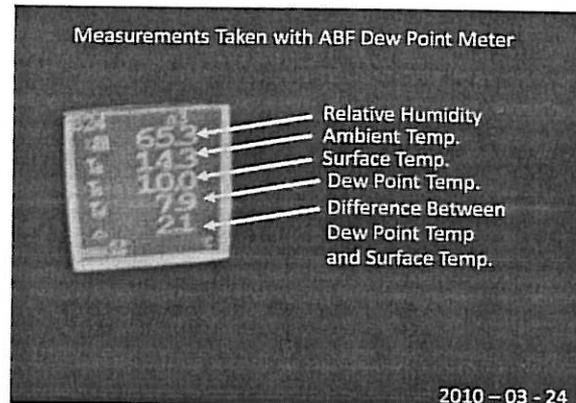
During in-process coating inspection of Lift 6 East Internal Bottom Plate field repair areas from Panel Points 41-43, this Caltrans Quality (QA) Inspector observed the following issues:

- ZPMC personnel applied inorganic zinc rich primer undercoating upon surfaces which were not prepared in accordance with SSPC SP-10 Surface Preparation Standard.
- ZPMC personnel applied inorganic zinc rich undercoating during non-compliant ambient conditions. The difference between the surface temperature of the steel which the coating was applied to and the dew point temperature was measured to at 2.1° Celsius.

Surface temperature must always be a minimum of 3°C (5°F) above dew point.
