**QUALITY ASSURANCE -- NON-CONFORMANCE REPORT**

**Location:** Changxing Island, Shanghai, PRC **Report No:** NCR-000706  
**Prime Contractor:** American Bridge/Fluor Enterprises, a JV **Date:** 06-Apr-2010  
**Submitting Contractor:** Zhenhua Port Machinery Company, Ltd (ZPMC), Changxing Island **NCR #:** ZPMC-0673

<b>Welding</b>	<b>Concrete</b>	<b>Other</b>	
<b>Welding</b>	<b>Curing</b>	<b>Procedural</b>	<b>Bridge No:</b> 34-0006
<b>Joint fit-up</b>	<b>Coating</b>	<b>Other</b>	<b>Component:</b> North Tower Lift 4, D/E Corner Seam weld
<b>Procedural</b>	<b>Procedural</b>	<b>Description:</b>

**Reference Description:** 4th time repair without Engineer and prior approved

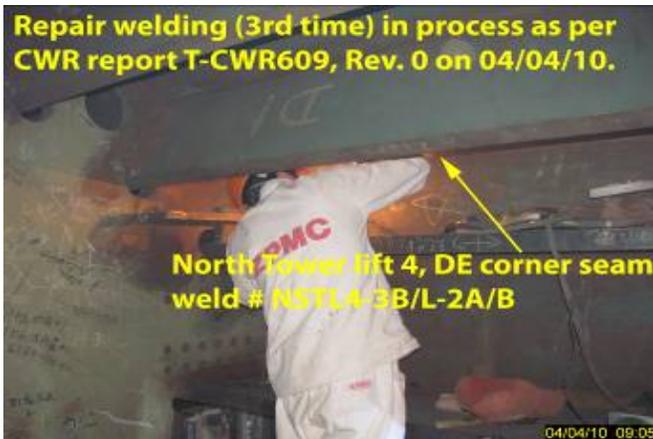
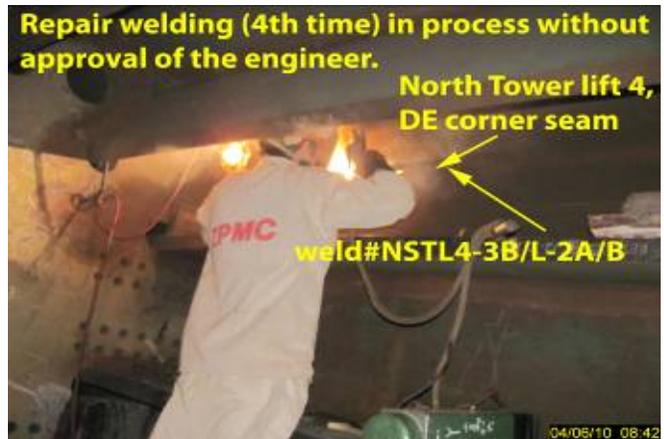
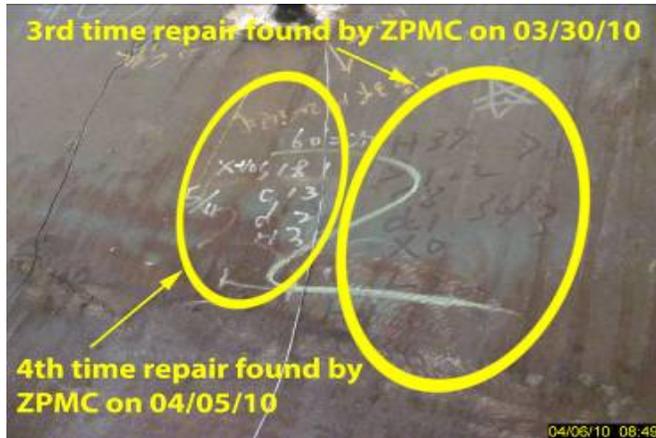
During random in-process verification of D/E corner seam of North Tower Lift 4, this QA Inspector discovered the following issues:

- Observed Shielded Metal Arc Welding (SMAW) for repair on D/E corner seam of North Tower Lift 4.
- This repair welding (4th time) has been performed without prior approval of the engineer.
- This repair was previously (3rd time) performed at the same location as per CWR report T-CWR609, Rev. 0 dated April 4, 2010.
- ZPMC NDT personnel rejected the 3rd time repair by Ultrasonic Testing (UT) at this same location.
- The weld number is identified as NSTL4-3B/L-2A/B.
- The Y location of the repair is identified as 1630mm
- The welder is identified as #052493.
- The member is located in Bay 10.

AWS D1.5 Section: 3.7.4: "Prior approval of the Engineer shall be obtained for repairs to base metal (other than those required by 3.2), repair of major or delayed cracks, repairs to ESW and EGW welds with internal defects, or for a revised design to compensate for deficiencies."

Special Provisions 8-3: "The Engineer shall be notified immediately in writing when welding problems, deficiencies, base metal repairs, or any other type of repairs not submitted in the WQCP are discovered and also the proposed repair procedures to correct them."

Propose a resolution for the identified non-conformance, address the failure by both Production and Quality Control in proceeding with the repair of the weld without prior approval from the Engineer. Provide documentation of the steps/actions taken by Production and Quality Control to prevent future occurrences.

As CWR 609 R1 was submitted and approved on 04/07/10, subsequent to the occurrence, acceptability of the weld repair will be determined and documented through the QC-QA process.

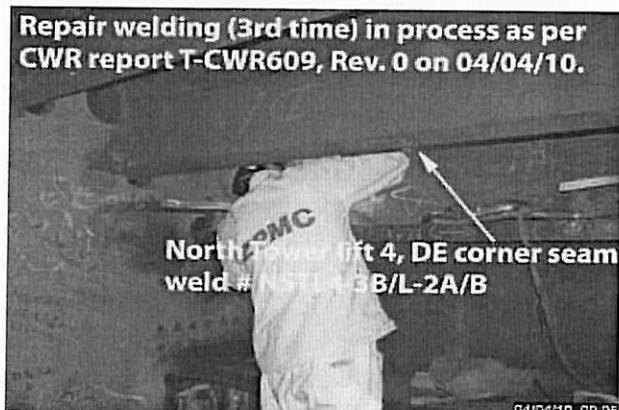
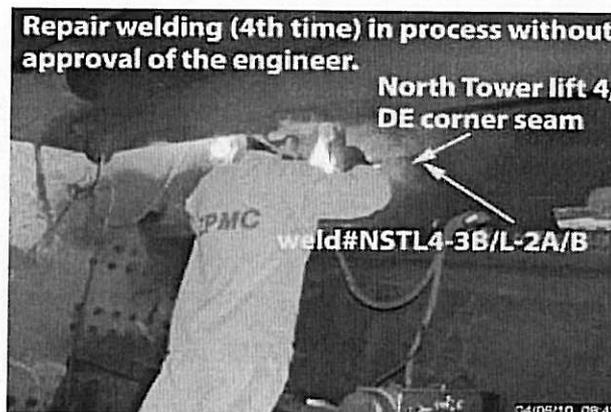
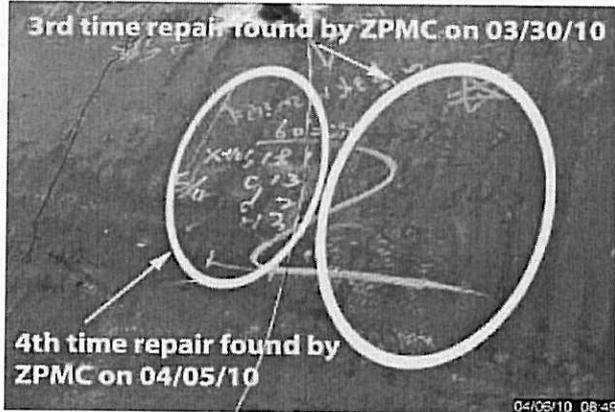
During random in-process verification of D/E corner seam of North Tower Lift 4, this QA Inspector discovered the following issues:

- Observed Shielded Metal Arc Welding (SMAW) for repair on D/E corner seam of North Tower Lift 4.
- This repair welding (4th time) has been performed without prior approval of the engineer.
- This repair was previously (3rd time) performed at the same location as per CWR report T-CWR609, Rev. 0 dated April 4, 2010.
- ZPMC NDT personnel rejected the 3rd time repair by Ultrasonic Testing (UT) at this same location.
- The weld number is identified as NSTL4-3B/L-2A/B.
- The Y location of the repair is identified as 1630mm
- The welder is identified as #052493.
- The member is located in Bay 10.

AWS D1.5 Section: 3.7.4: "Prior approval of the Engineer shall be obtained for repairs to base metal (other than those required by 3.2), repair of major or delayed cracks, repairs to ESW and EGW welds with internal defects, or for a revised design to compensate for deficiencies."

Special Provisions 8-3: "The Engineer shall be notified immediately in writing when welding problems, deficiencies, base metal repairs, or any other type of repairs not submitted in the WQCP are discovered and also the proposed repair procedures to correct them."

ZPMC stopped the repair in progress and submit a new CWR to represent the work being done. ZPMC QA to educate the operators and QC about the importance of using and verifying the documents on hand before repair begin.

WRR for the repair was submitted and NDT reports for the repaired area also submitted confirming the repair was acceptable. ZPMC agreed to increase CWi presence to strengthen supervision to prevent future occurrence.

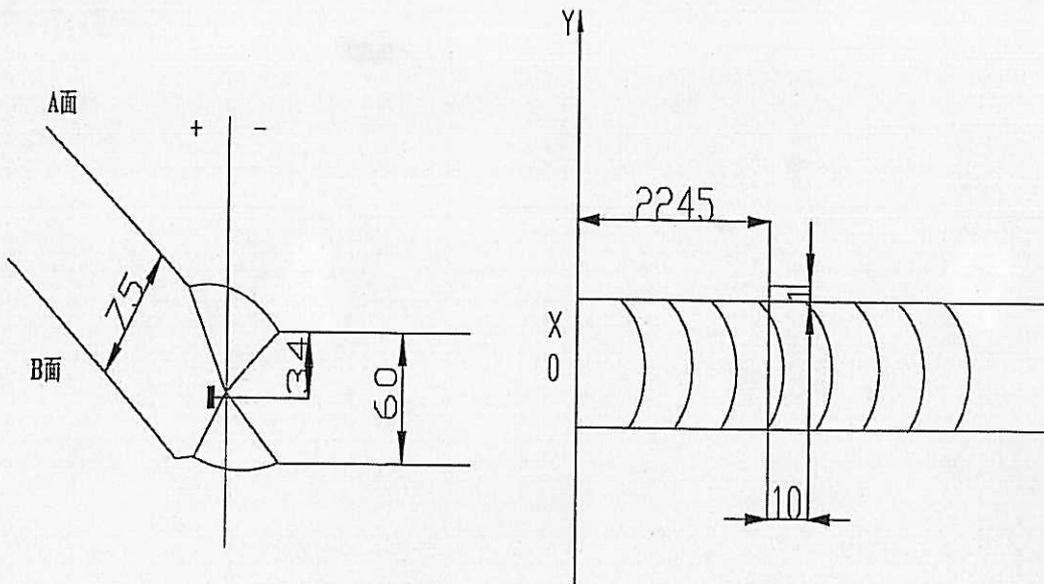
WELD NUMBER: NSTL4-3B/L-2A/B

Rejectable indications were found by ultrasonic inspection for a fifth repair (UT探伤返修第5次) NSTL4-3B/L-2A/B

1. 焊缝的位置比较狭窄, 碳刨时, 不能准确的将缺陷刨出.
  2. 打磨工在打磨时, 不够仔细, 没有将所有的缺陷去除.
1. The access space was quite narrow resulting in making it difficult to arc-gouge the defects effectively.
  2. The grinder was not observant during the grinding operation resulting in the indications not being completely removed.

1. QC /CWI shall monitor and direct all gouging, grinding and welding during the repair procedure.
  2. Remove defects by gouging and /or grinding. If gouging is used, preheat the repair area to a minimum temperature of 65°C.

3. Prepare excavation according to the approved repair WPS.
  4. Grind the repair area to a smooth and shiny surface.
  5. Verify that no defects are present by VT and MT prior to welding.

6. Clean excavation of all loose debris and MT powder.
  7. Weld according to the approved WPS.
  8. Preheat and maintain interpass temperature control in accordance to the approved WPS.

9. QC shall ensure all slag has been removed prior to the deposition of the next pass.
  10. Blend the weld repaired areas into the adjacent weld or base metal by grinding.

11. Perform VT, MT and UT inspection to the repaired areas.
1. QC 和 CWI 应当监督和指导所有碳刨、打磨和焊接工作;
  2. 使用碳刨和打磨方式去除缺陷, 如果使用碳刨方式, 则在碳刨前须将返修区域预热到 65° C;
  3. 根据返修 WPS 准备合适的刨槽;

1. 碳刨打磨后, 要圆滑过度, VT和MT确认所有的缺陷已经去除, ;
  2. 教导在烧熔透焊缝和焊道清理时, 焊工必须负责任;
  3. 关键焊缝返修时, 主要的QC负责人要在现场:
1. Grind smoothly transition after gouging. Perform VT and MT to ensure all the defects have been removed.
  2. Instruct the welder that it is his responsibility to produce sound welds and perform interpass cleaning.
  3. Greater QC presence during critical welding operations.
