QUALITY ASSURANCE -- NON-CONFORMANCE REPORT

Report No: NCR-000708

Reference Description: Missed MT Indications by QC on OBG Segment 9CE Deck Panel to Diaphragm Weld

Dear: Mr. Charles Kanapicki
Job Name: SAS Superstructure

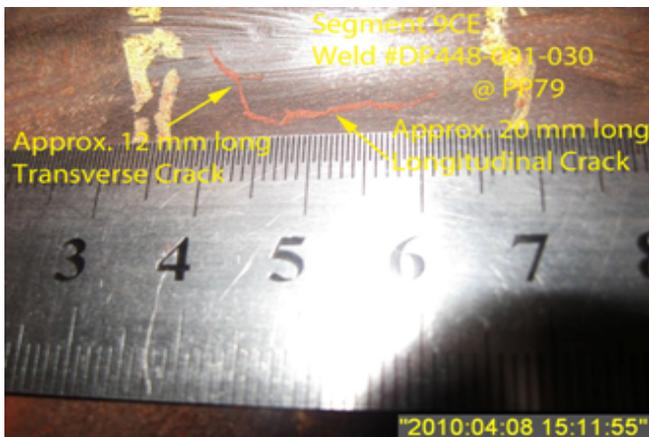
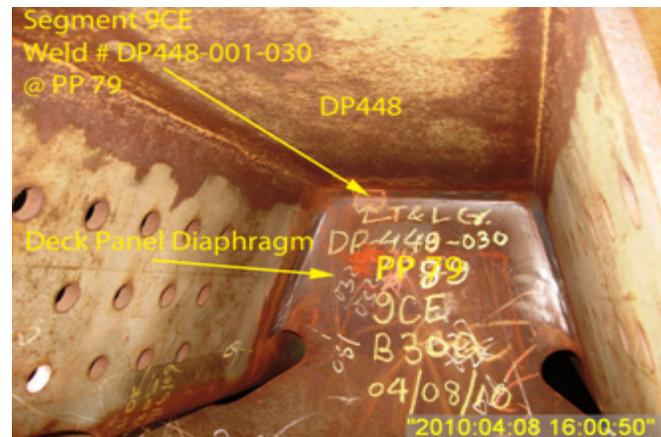
During the Quality Assurance (QA) Magnetic Particle Testing (MT) review of welds located on Segment 9CE, this QA Inspector discovered the following issues:

- One (1) Transverse linear indication (crack) measuring approximately 12 mm in length.
- One (1) Longitudinal linear indication (crack) measuring approximately 20 mm in length.
- The weld is identified as: DP448-001-030 @ Panel Point-079.
- The weld is a Fillet Weld type joining DP448 to Deck Panel Diaphragm plate X1C.
- The OBG 9CE segment is located at the back side of Bay # 13.

The Notice of Witness Inspection Number (NWIT) is 005476. The indication is located inside the area that has been previously tested and accepted by ZPMC Quality Control (QC) personnel. ZPMC's QC personnel are required to perform twenty five (25%) percent MT inspection of this weld.

-AWS D1.5 (02) Section 6.26.2 – “Welds that are subject to MT in addition to visual inspection shall have no cracks.

Propose a resolution for the identified non-conformance with revised procedures to prevent future occurrences. A response for the resolution of this issue is expected within 7 days.

Reference Resolution: ZPMC has repaired the indications referenced in the NCR and is providing the NDT report to show that the weld is now acceptable. Based on this ZPMC requests closure of this NCR.
