Contract #: 04-0120F4
 Cty: SF/ALA Rte: 80 PM: 13.2/13.9
 File #: 69.25B

QUALITY ASSURANCE -- NON-CONFORMANCE REPORT

Report No: NCR-000714

Reference Description: Missed MT transverse indications by QC on Segment 7CE Bottom Panel to T-Rib

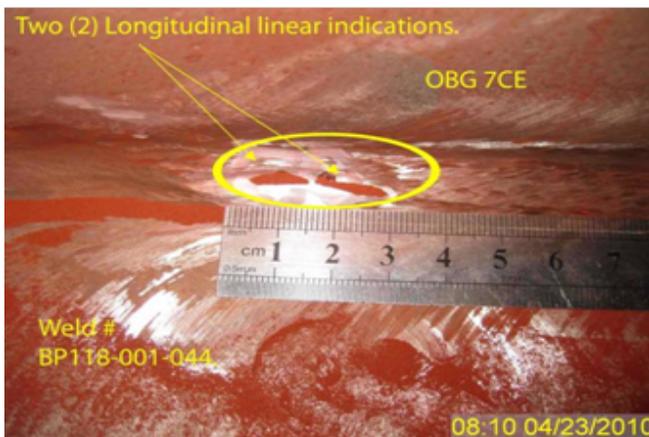
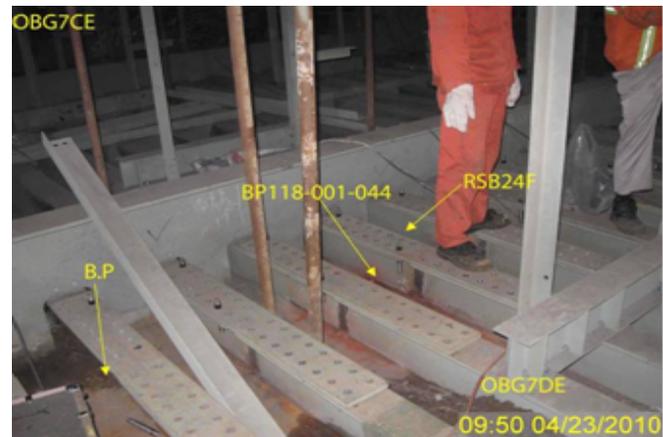
- Two (2) Longitudinal linear indications in the hold back weld between "T" Rib and Bottom panel.
- The longitudinal linear indications are located at Y locations 260mm and 277mm when measured from the end of the hold back fillet weld.
- The weld designation is BP118-001-044.
- The rib stiffener is identified as RSB24F.
- The indications are clearly marked on or near the weld.
- Length of indications measured approximately 14mm and 12mm.
- The OBG segment 7CE is located in the trial assembly.
- The Notice of Witness Inspection (NWIT) No. is 005581. The indications are located in an area previously tested and accepted by ZPMC Quality Control (QC) personnel.

After grinding, these linear indications were confirmed to be porosities. ZPMC is providing the NDT record shows these rejections have been removed and repaired and tested to be acceptable. Based on this, ZPMC is requesting closure of this NCR.

Reference Resolution: ZPMC has removed the indications by grinding and is submitting the NDT report to show that the weld is acceptable. Based on this ZPMC requests closure of this NCR.

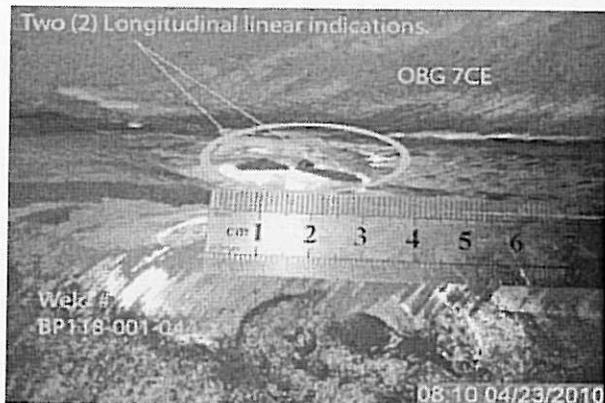
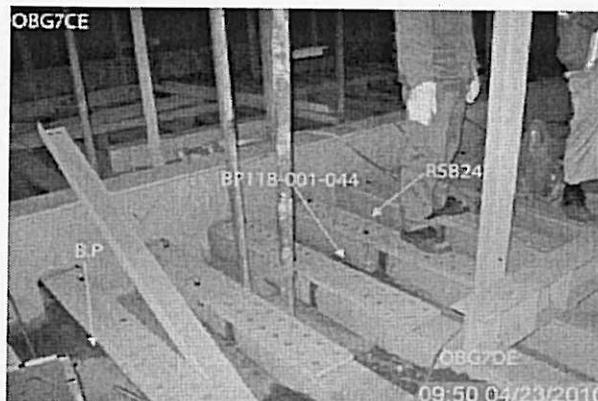
- Two (2) Longitudinal linear indications in the hold back weld between "T" Rib and Bottom panel.
- The longitudinal linear indications are located at Y locations 260mm and 277mm when measured from the end of the hold back fillet weld.
- The weld designation is BP118-001-044.
- The rib stiffener is identified as RSB24F.
- The indications are clearly marked on or near the weld.
- Length of indications measured approximately 14mm and 12mm.
- The OBG segment 7CE is located in the trial assembly.
- The Notice of Witness Inspection (NWIT) No. is 005581. The indications are located in an area previously tested and accepted by ZPMC Quality Control (QC) personnel.

Remove indications by grinding and perform NDT required to verify weld quality.

Contractor submitted NDT record verifying indications were successfully removed by grinding.
