Contract #: 04-0120F4Cty: SF/ALA Rte: 80 PM: 13.2/13.9File #: 69.25B**QUALITY ASSURANCE -- NON-CONFORMANCE REPORT****Location:** Changxing Island, Shanghai, P.R. China**Report No:** NCR-000717**Prime Contractor:** American Bridge/Fluor Enterprises, a JV**Date:** 25-Apr-2010**Submitting Contractor:** Zhenhua Port Machinery Company, Ltd (ZPMC), Changxing Island**NCR #:** ZPMC-0684**Type of problem:**

Reference Description: QC Missed 2 MT Transverse Indications on Segment 9EE U-Rib Deck Diaphragm welds

QUALITY ASSURANCE -- NON-CONFORMANCE REPORT

| Subject: | NCR No. ZPMC-0684 | Document No: | 05.03.06-000674 |

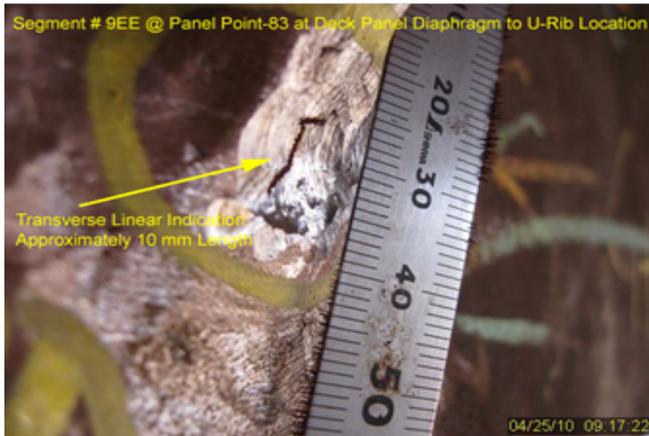
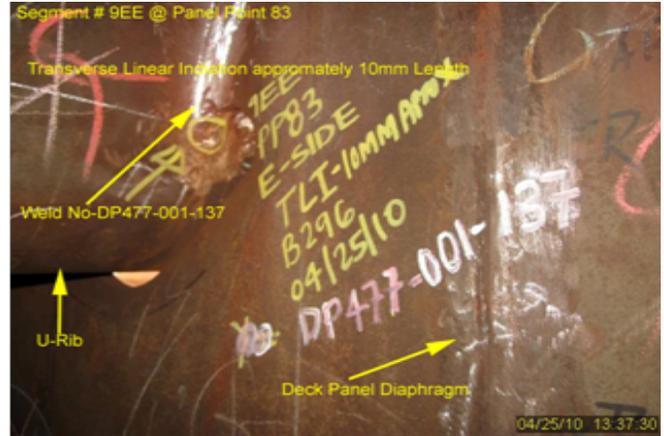
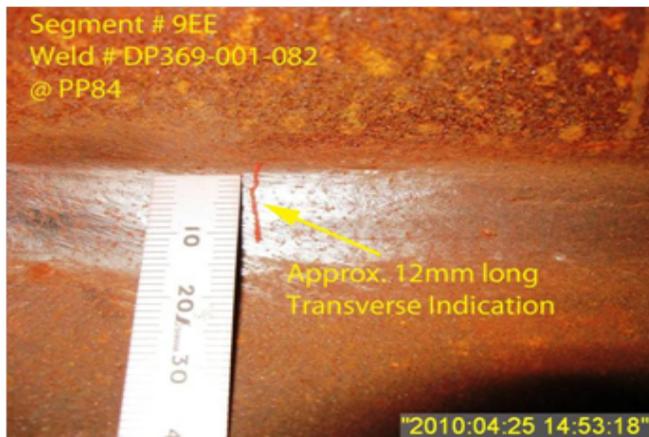
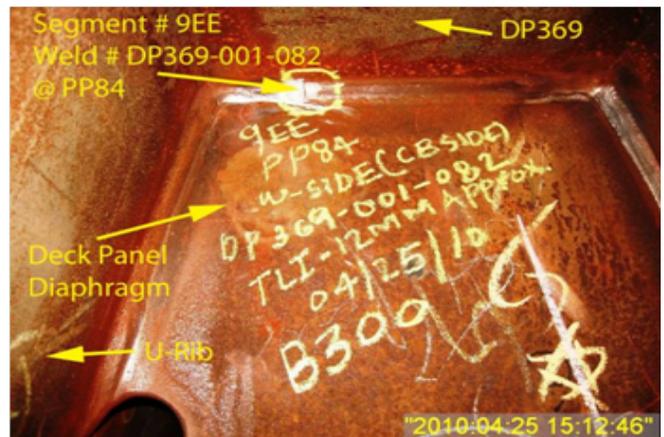
During the Quality Assurance (QA) Magnetic Particle Testing (MT) review of welds located on Segment 9EE, this QA Inspector discovered the following issues:

- One (1) Transverse linear crack like indication measuring approximately 12 mm in length.
- The weld is identified as DP369-001-082 @ Panel Point-084.
- The weld is a Fillet Weld T-joint joining the Deck Plate (DP369) to Deck panel diaphragm plate.
- OBG 9EE segment is located at the front side of OBG Blast Shop-1.

- One (1) Transverse linear indication measuring approximately 10 mm in length.
- Weld is a Complete Joint Penetration (CJP) Weld joining the Deck panel Diaphragm to U-Rib.
- Weld Identification number is DP477-001-137 @ Panel Point-083.
- Deck panel Diaphragm is identified as X1E.
- U-Rib is Identified as R18D.
- Location Panel Point (PP83).
- The OBG 9EE Segment is located at the back side of Painting Shop.

- The Notice of Witness Inspection Number (NWIT) is 005583.
- The indication is located inside the area that has been previously tested and accepted by ZPMC Quality Control (QC) personnel.

AWS D1.5 (02) Section 6.26.2 – “Welds that are subject to MT in addition to visual inspection shall have no cracks

Reference Resolution: ZPMC has repaired the welds in question and is providing NDT documentation to show that the welds are acceptable. Based on this ZPMC requests closure of this NCR.

This proposed resolution is acceptable. The documentation received is sufficient and the Department concurs that Non-Conformance ZPMC-0684 is closed.

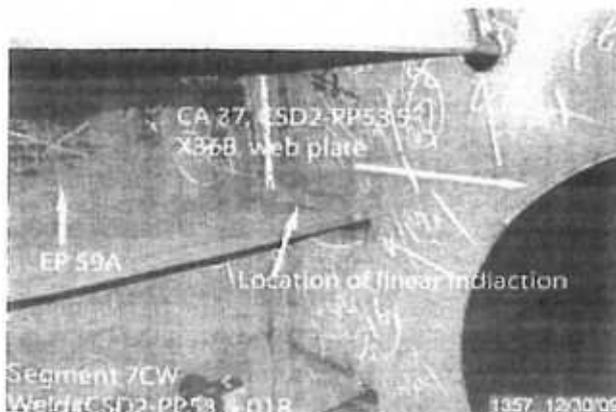
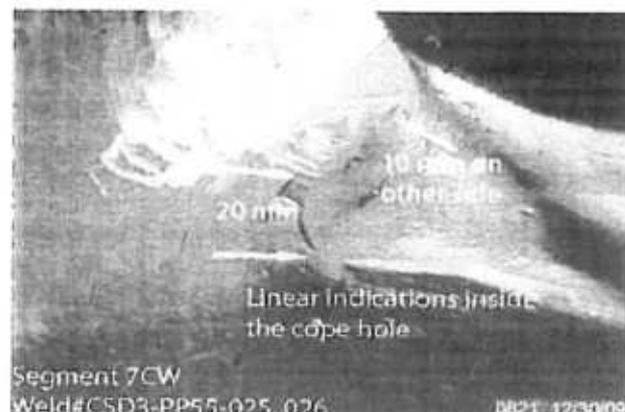
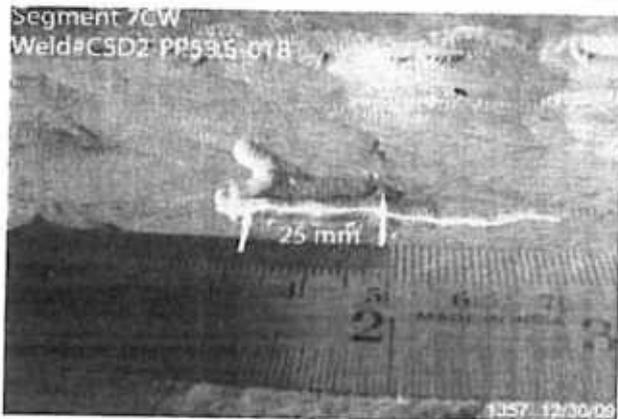
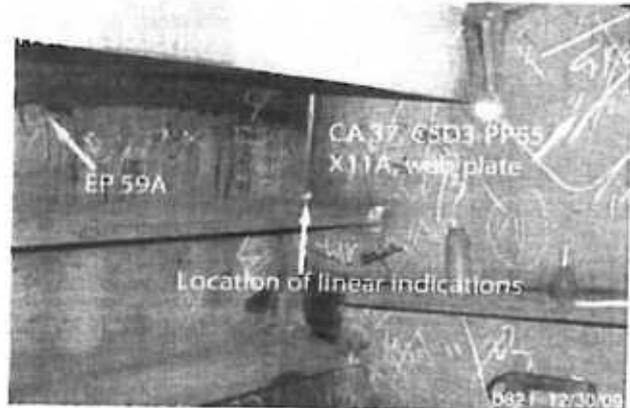
During the Quality Assurance Magnetic Particle Testing (MT) review of welds located on Segment 7CW, this Quality Assurance Inspector (QA) discovered the following issues:

- Two (2) Longitudinal linear indication measuring approximately 20mm and 25mm in length.
- The welds are identified as: CSD3-PP55-025, 026 (30 mm) and CSD2-PP53.5-018 (25 mm).
- The welds are a Fillet Weld type joining the Edge Plate (EP59A) stiffeners to Corner Assembly (CA37A) web plates.
- The OBG 7CW segment is located at in front of Blast Shop.

The Notice of Witness Inspection Number (NWIT) is 004947. The indication is located inside the area that has been previously tested and accepted by ZPMC Quality Control (QC) personnel. ZPMC's QC personnel are required to perform twenty five (25%) percent MT inspection of this weld.

AWS D1.5 (02) Section 6.26.2 – “Welds that are subject to MT in addition to visual inspection shall have no cracks.

Submit a repair procedure to the engineer for approval. Provide the ZPMC MT technician additional training and equipment to ensure these types of indications are identified in the future.

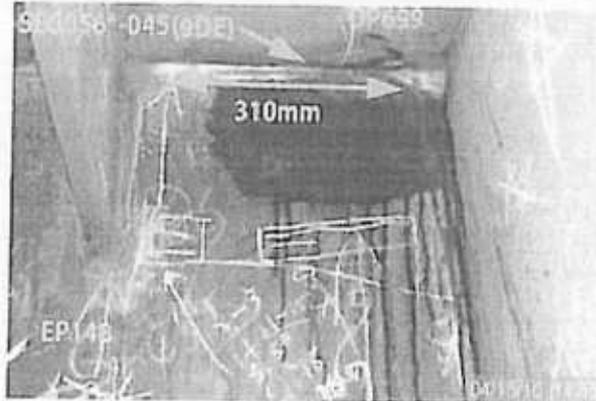
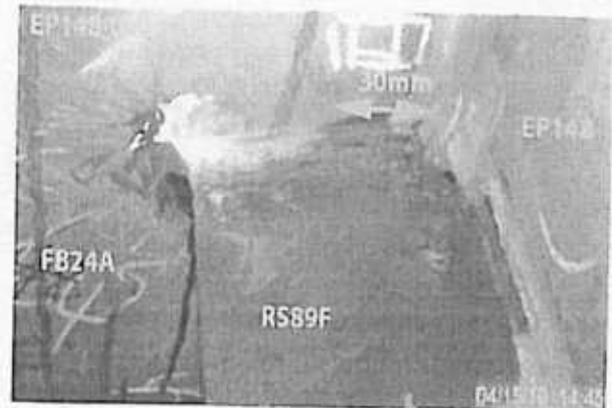
During the Quality Assurance (QA) Ultrasonic Testing (UT) review of welds located on Orthotropic Box Girder (OBG) Segment 9DE, this QA Inspector discovered the following issues:

- Two (2) longitudinal linear indications measuring approximately 310mm and 30mm in length.
- The indications dBs rating are +6 and +4.
- Material thickness is 18mm.
- The depth of the indications is approximately 11mm and 13mm.
- The welds are identified as SEG056*-045 at Panel Point (PP) PP81.5 and EP148-022 at PP 81.
- The welds are designated as Seismic Performance Critical Material (SPCM).
- The indications are clearly marked on or near the weld.
- The Y distance for the indications are 50 mm from PP81.5 and 0 mm from EP148A.
- Weld SEG056*-045 is a Complete Joint Penetration (CJP) Corner joint, joining the Edge Plate PL1336C(SPCM) to Deck Plate PL1314A (Non SPCM).
- Weld EP148-022 is a Complete Joint Penetration (CJP) "T" joint, joining the Edge Plate stiffener RS89F (Non SPCM) to FB24A plate PLX24D (SPCM).
- Segment 9DE is located outside of Paint shop.

AWS D1.5-02 Section 6; Table 6.3 specifies a class "A" indication as having a rating of 10dBs and under for material thicknesses 8mm through 20mm.

Propose a resolution for the identified non-conformance to prevent future occurrences. A response for the resolution of this issue is expected within 7 days.

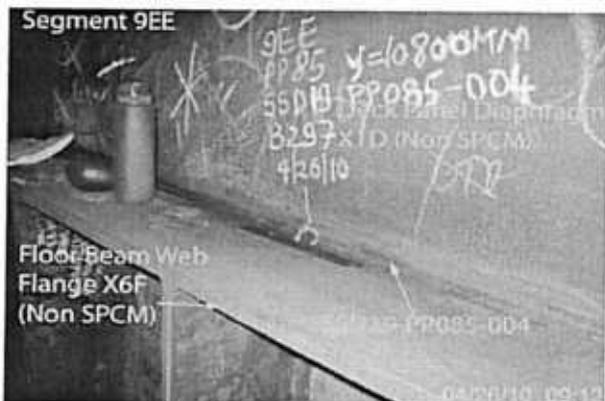
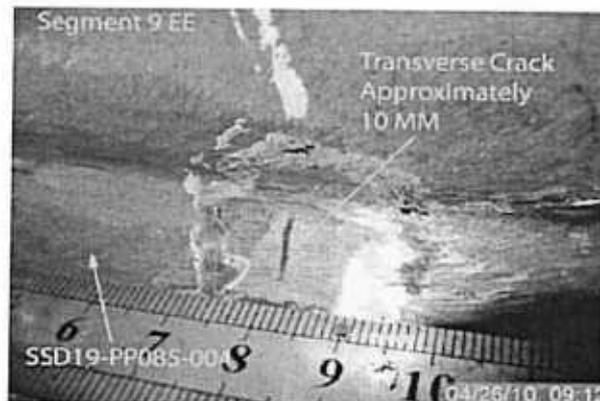
During the Quality Assurance (QA) Magnetic Particle Testing (MT) review of welds located on Segment 9EE, this QA Inspector discovered the following issues:

- One (1) transverse crack measuring approximately 10mm in length in the fillet weld joining the Deck Panel Diaphragm (X1D) to Floor Beam Web Flange (X6F) at panel point 85.
- The Y location is 10800mm from the termination of the weld on the crossbeam side.
- The indication is clearly marked near the weld.
- The weld is identified as: SSD19-PP085-004.
- OBG segment 9EE is located north of the blast shop.
- The Notice of Witness Inspection Number (NWIT) is 005583. The indication is located within the area that has been previously tested and accepted by ZPMC Quality Control (QC) personnel.

AWS D1.5 (02) Section 6.26.2 – “Welds that are subject to MT in addition to visual inspection shall have no cracks.

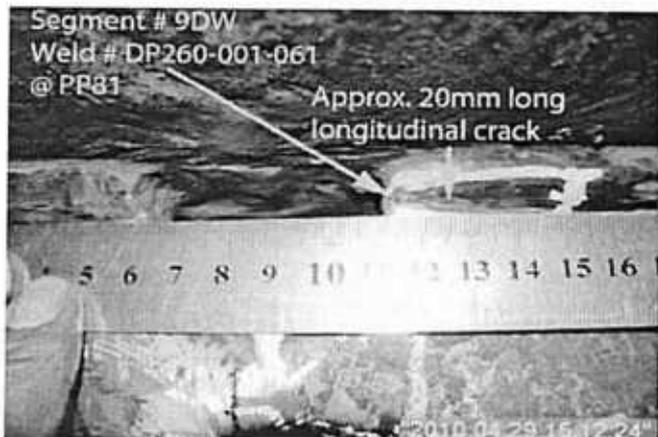
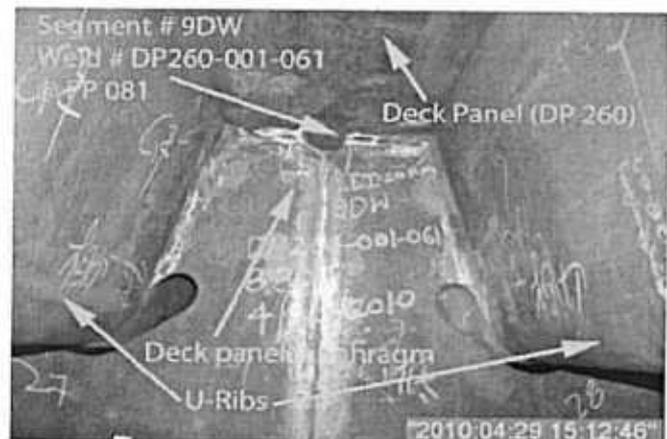
During the Quality Assurance (QA) Magnetic Particle Testing (MT) review of welds located on Segment 9DW, this QA Inspector discovered the following issue:

- One (1) Longitudinal linear crack like indication measuring approximately 20 mm in length.
- The weld is identified as DP260-001-061 @ Panel Point 081.
- The weld is a Fillet Weld T-joint joining the Deck Plate to Deck Panel Diaphragm plate.
- The plate number for Deck Plate is identified as PL307A (Non SPCM).
- Deck panel diaphragm plate is identified as X1E (Non SPCM).
- The indication is clearly marked on the material near the weld.
- OBG Segment 9DW is located at the back side of OBG Bay #14.
- The Notice of Witness Inspection Number (NWIT) is 005616. The indication is located inside the area that has been previously tested and accepted by ZPMC Quality Control (QC) personnel. Per the contract documents ZPMC's QC personnel are required to perform 100% MT inspection of this weld.

AWS D1.5 (02) Section 6.26.2 – “Welds that are subject to MT in addition to visual inspection shall have no cracks.

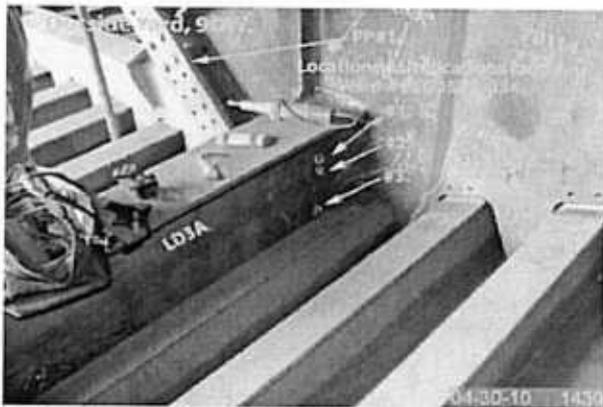
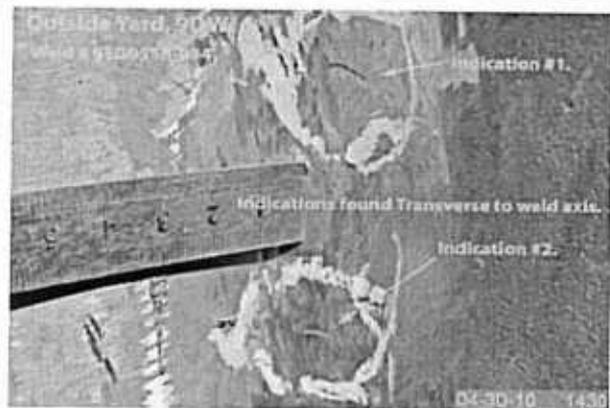
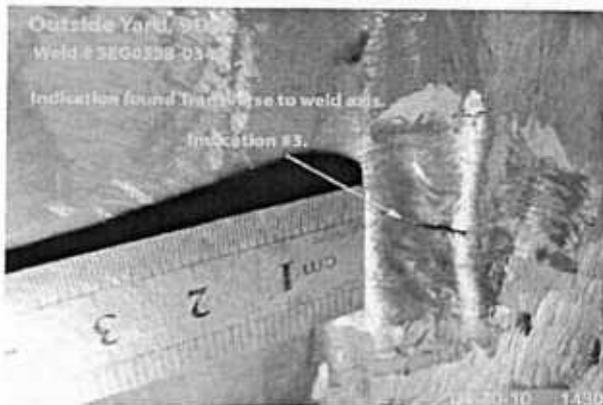
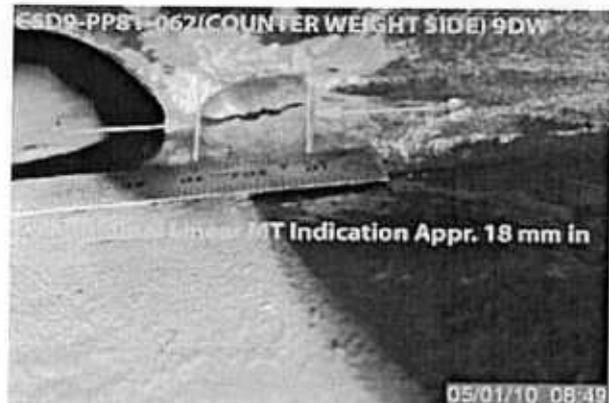
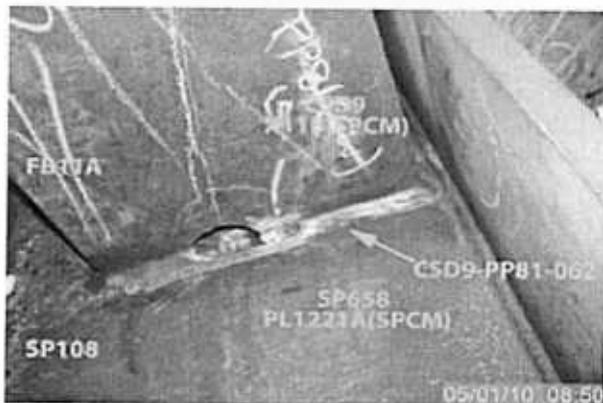
- Three transverse linear indications, one measuring approximately 9mm and two indications measuring approximately 5mm in length at Longitudinal Diaphragm (LD) LD3A to Floor beam (FB) FB11A.
- Weld is identified as SEG055B-034 and designated as a Fracture Critical Weld (FCW).
- The weld is a 14mm Complete Joint Penetration (CJP) T-joint joining LD 3A shear plate identified as X39B to FB web plate identified as X47C (Seismic Performance Critical Material SPCM).
- The indications are clearly marked on the material.

AWS D1.5 (02) Section 6.26.2 – "Welds that are subject to MT in addition to visual inspection shall have no cracks."
