Contract #: 04-0120F4Cty: SF/ALA Rte: 80 PM: 13.2/13.9File #: 69.25B**QUALITY ASSURANCE -- NON-CONFORMANCE REPORT****Location:** Changxing Island, Shanghai, P.R. China**Report No:** NCR-000724**Prime Contractor:** American Bridge/Fluor Enterprises, a JV**Date:** 30-Apr-2010**Submitting Contractor:** Zhenhua Port Machinery Company, Ltd (ZPMC), Changxing Island**NCR #:** ZPMC-0687**Type of problem:**

**Reference Description:** Improper procedures in welding in 7CW/7DW Side and Bottom Panel without a CWR

**Dear:** Mr. Charles Kanapicki  
**Job Name:** SAS Superstructure

**Subject:** NCR No. ZPMC-0687

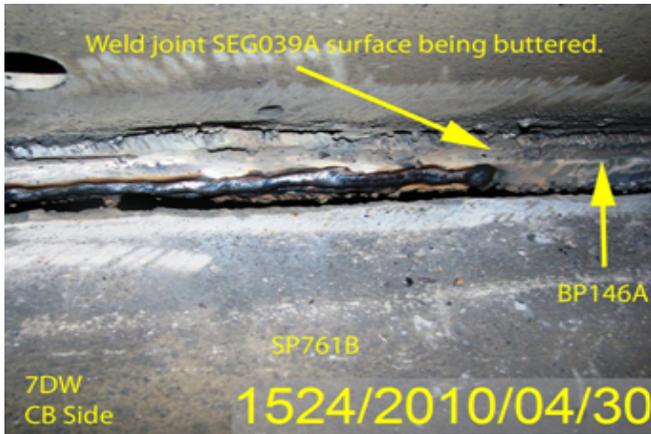
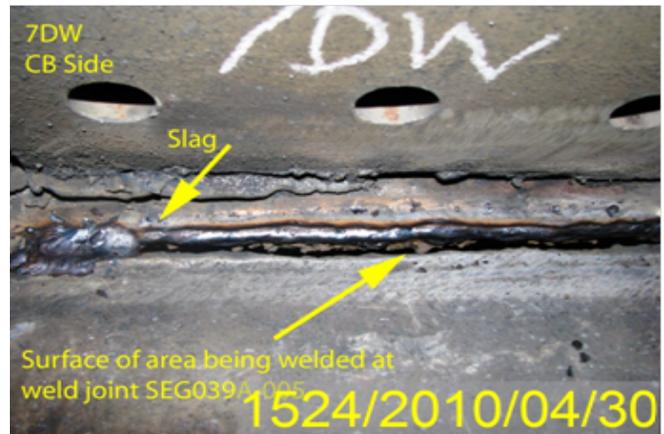
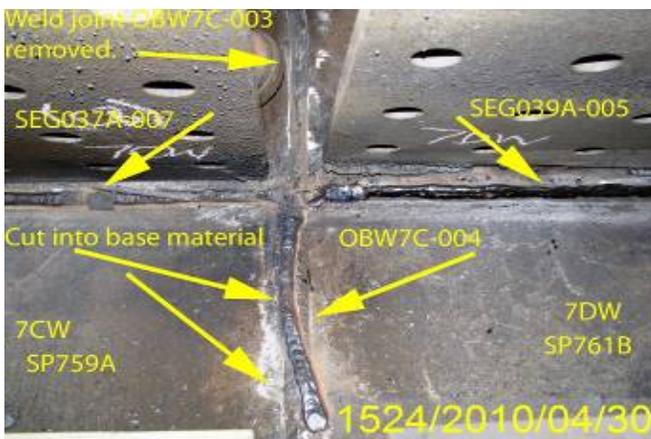
- ZPMC welding personnel cut apart weld joints and performed Critical Weld Repair (CWR) welding on Seismic Performance Critical Members (SPCM) without an approved CWR procedure.

- In the welding of joint OBW7C-004, a section of the weld has been unzipped and rewelded. It was noted that the cut and repaired base metal was partially in the base metal of SP761B and BP146A.

- It appeared that the surfaces to be welded had not been properly cleaned, beveled or prepared prior to the weld repairs. The original welds had not been completely removed and the burn slag (dross) was still visible.

- The weld joints that were cut apart to adjust for a misalignment are identified as: SEG037A-007, SEG039A-005, OBW7C-003 and OBW7C-004.
- These weld joints are Complete Joint Penetration (CJP) welds.

**Reference Resolution:** To resolve the NCR, ZPMC has removed the welds, re-welded and tested them and found them acceptable. Based on this ZPMC requests closure of this NCR.

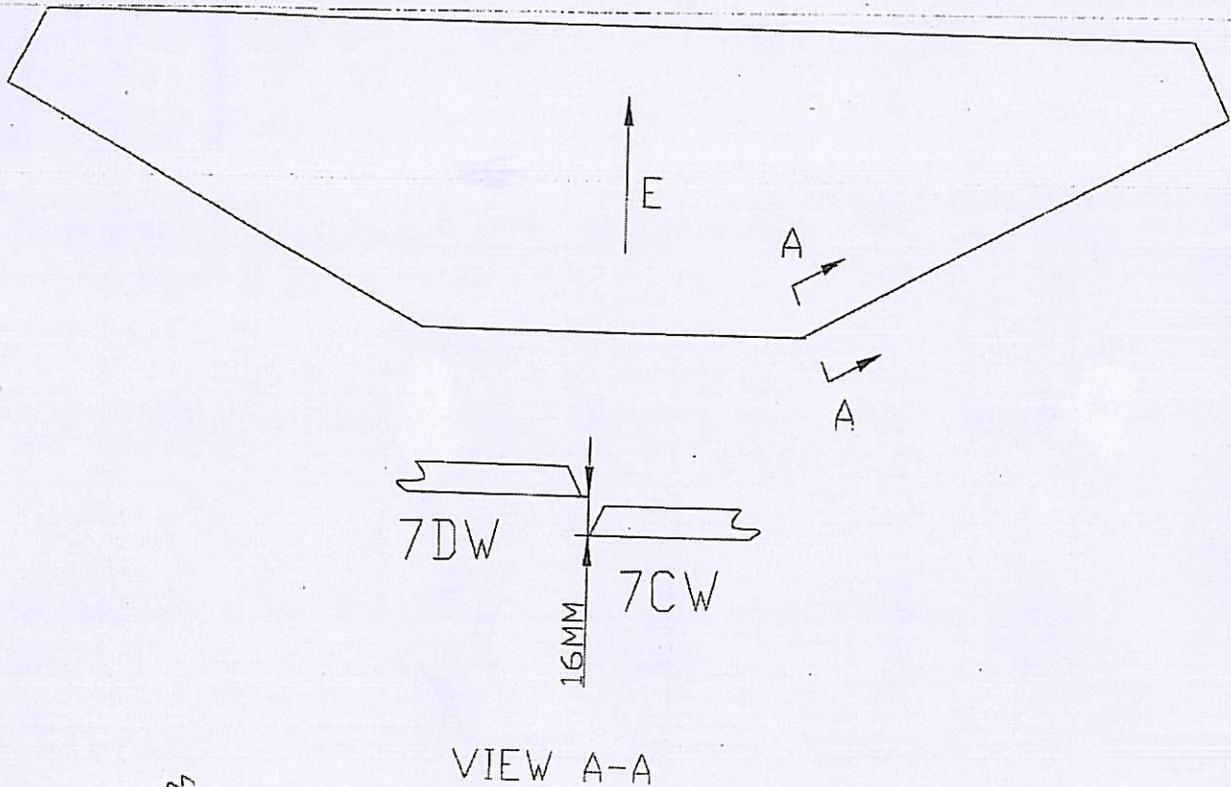
Draft of welding discontinuity

7CW+7DW端口环缝, T肋对接焊接结束后, 测量联系梁侧底板斜底板拐角的错边量, 发现数据超标, 最大达16mm。  
(可能涉及的焊缝OBW7C-004, SEG037A-007, SEG039A-005; SP759-001-044, SP759-001-054)

After T ribs on 7DW and 7CW were butted together, it was found that corners between bottom plate and side plate have misalignments, the largest of which is 16mm in length.

Welding deformation and assembly error.

1. Remove the welds where the straightness is out of tolerance between LD and bottom plate by the way of gouging or Oxygen, then the weld between side plate and bottom plate with length of L (The L, L' length is confirm by actual condition), Preheat according to the WPS prior to gouging.

2. Adjust the misalignment and the straightness to meet the tolerance by outer force and ensure the straightness to meet the tolerance.
3. Perform 100%VT and MT inspection to the metal cutting area in the bottom plate to ensure no defects exist;

4. Fit up and weld LD the weld between side plate and bottom plate according to the relevant WPS with check the flatness sometime, and then weld the welding line between LD and side plate;

5. Repair and perform related NDT inspection according to the repair WPS if the edge of LD was destroyed.
6. Grind the weld flush to the adjacent weld or base metal.

7. Check the weld according to the shop drawings.
